MEMORANDUM FOR THE RECORD**SUBJECT: 24BON011 MFR BON FG3-31 Diffuser Hatch Failure**

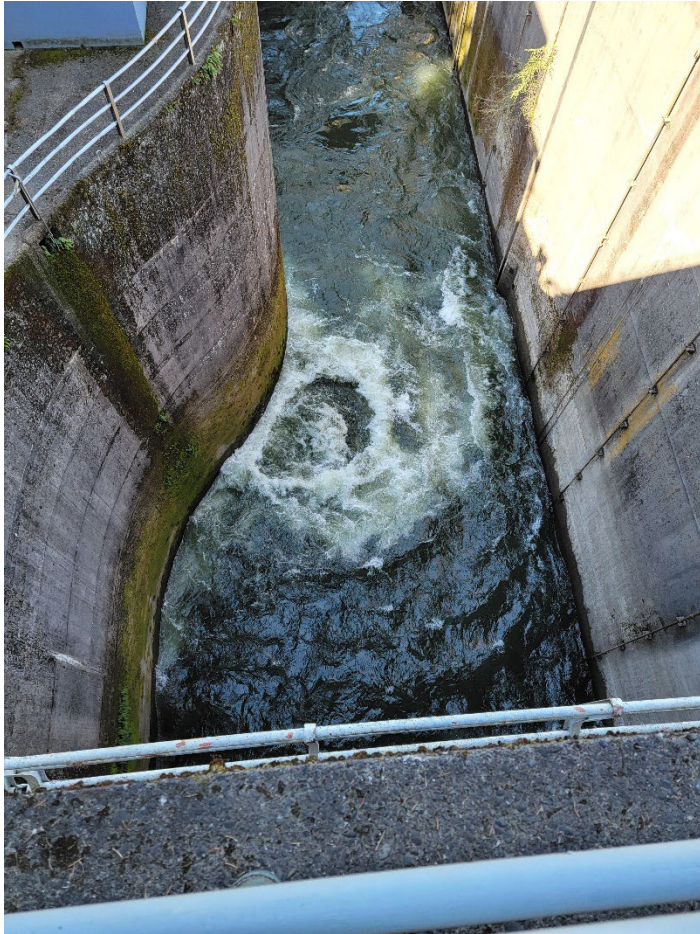
On the morning of 02 April 2024, Project Biologists discovered very turbulent water near Bradford Island Diffuser FG 3-31 in the B-Branch Entrance Bay (Figure 1). Attempts were made to reduce the amount of water flowing through FG 3-31 by opening diffuser FG 3-32 and lowering FV 4-4 from approximately 5.2' open to 3.8' open. However, the water flow produced from FG 3-31 remained extremely turbulent which led Project Biologists to suspect that it had blown grating above the diffuser pit.

Figure 1. Turbulent water in Bradford Island Fishway Entrance Bay on 02 April 2024

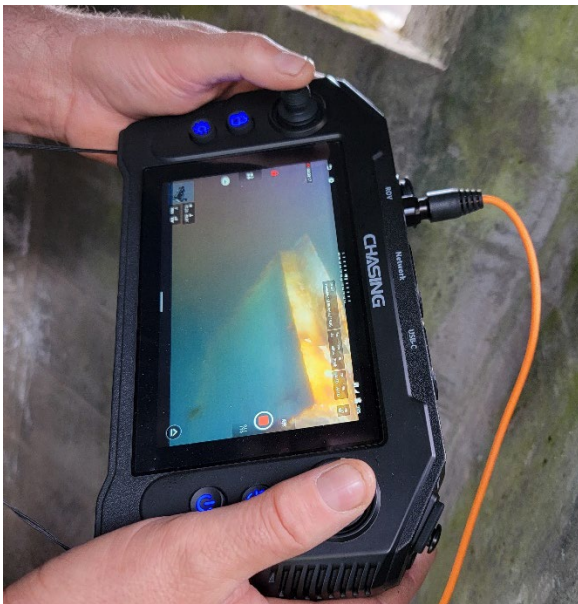
An ROV inspection of the area was conducted on 03 April 2024 from approximately 1300 to 1330. The ROV inspection required the closure of FV 4-3 and FV4-4 for effective use of the ROV in the Bradford Island B-Branch Entrance Bay. The closure of both Fish Valves reduced the attraction flow to the Bradford Island B-Branch entrance below 1', not complying with section 2.4.2.4 of the FPP "Maintain head on all entrances in the range of 1'-2' (1.5' preferred)." Attraction flow was restored at 1330 when both fish valves were opened. The ROV inspection determined that the FG 3-31 diffuser access hatch had blown out of place (Figures 2 and 3).

Figure 2. BI B-Branch FG 3-31 diffuser chamber access hatch dislodged and damaged on 03 April 2024.

A dive operation was conducted on the morning of 04 April 2024 with the coordination between the District Dive Team and Bonneville Staff (Figure 4). Divers were successfully able secure the hatch back in place over the hole using a metal strongback beam. It is recommended that each diffuser hatch in the fishways should have these strongback beams added during the next fishway dewater for winter maintenance as a preventative measure.

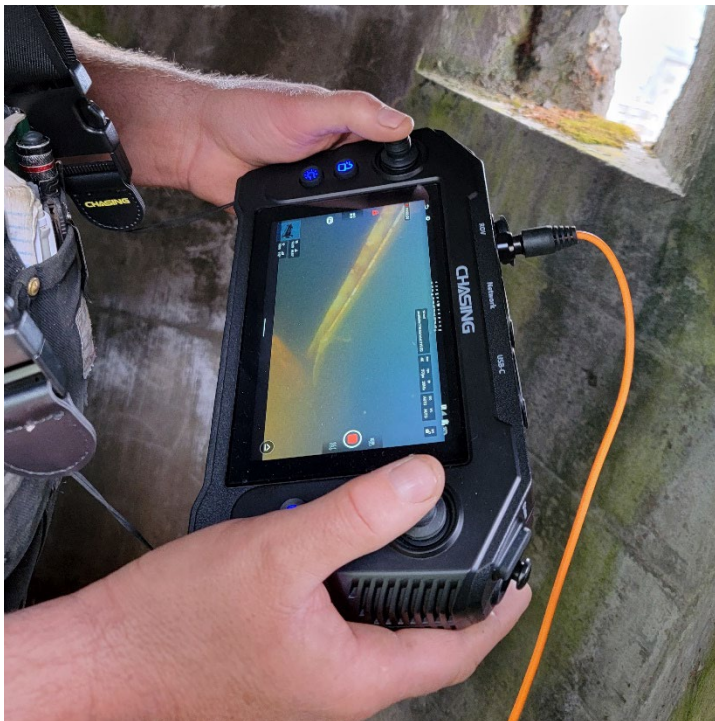
Figure 3. BI B-Branch FG 3-31 diffuser chamber access hatch dislodged and damaged on 03 April 2024.

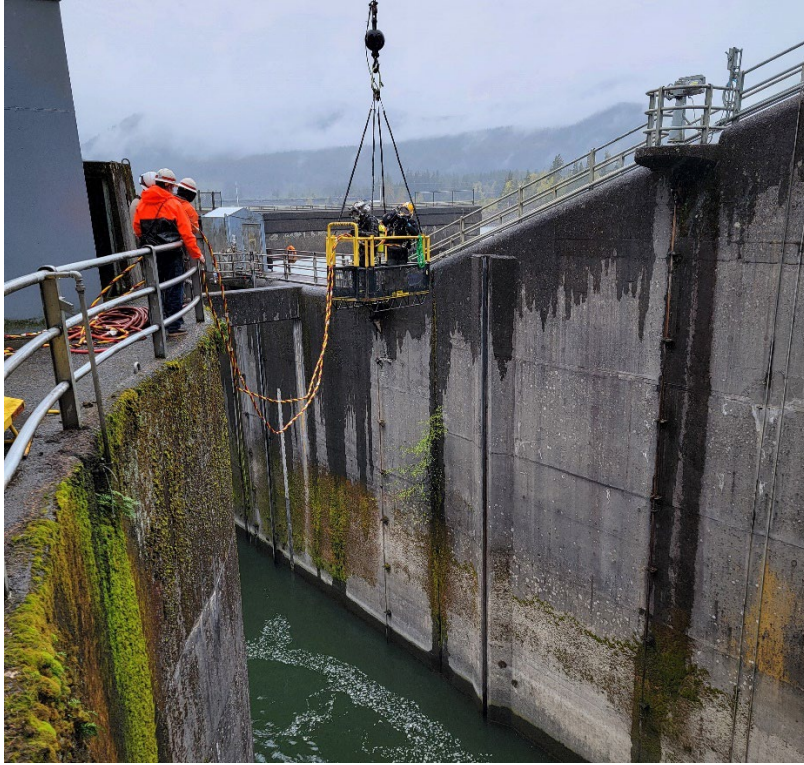
Figure 4. Divers accessing B-Branch Entrance Bay to make repairs on 04 April 2024.
