MEMORANDUM FOR THE RECORD 24BON014 Cascades Island LPS Lamprey Mortalities**SUBJECT: 24BON014 MFR Cascades Island LPS Lamprey Mortalities**

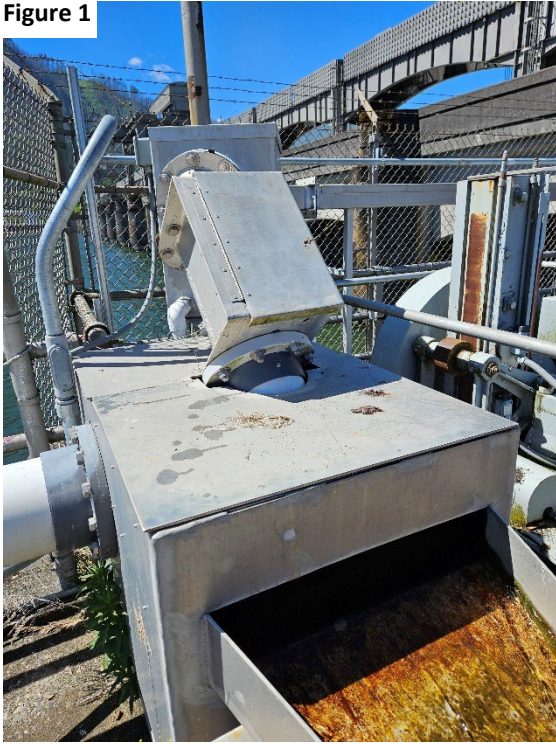
Figure 1

On the morning of 23 June, Project Biologists discovered that the Cascades Island Lamprey Passage System (LPS) was overflowing from the “pond” (*Figure 1*). The screen in the lamprey resting box that flows into the intake of the downstream section of the LPS had become clogged with debris. (*Figure 2*) The water was flowing freely from the top of the rest box which moved the lid and allowed Pacific Lamprey to escape. When Biologists happened upon this area, they noticed around 30 Lamprey on the ground. After cleaning the screen water levels reduced to normal levels inside of the LPS and the surviving lamprey were placed back into the rest box. There were 21 lamprey mortalities on 23 June (*Figure 3*), as well as 4 more mortalities found the morning of 24 June. (*Figure 4&5*)

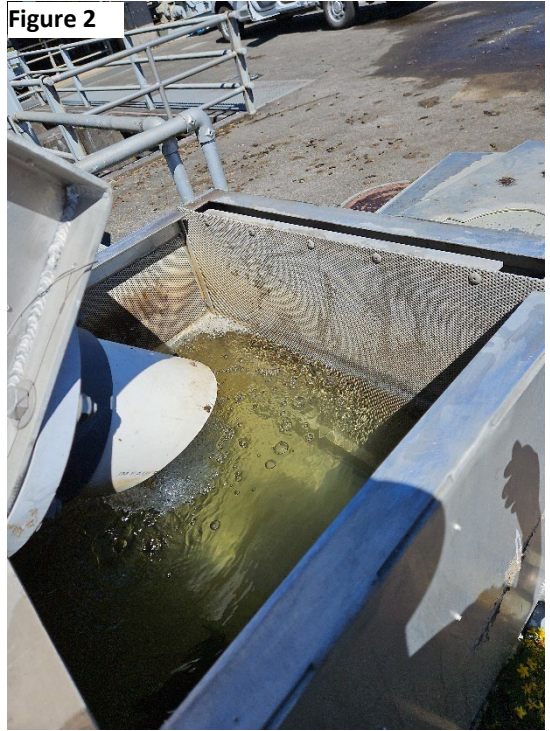
Figure 2

Sporadic alarms had come in on the Fishway PLC for the west lamprey upwelling box as early as 18 June without Project Fisheries being notified. Several repeating alarms for this box came in between 0130 on 22 June and 0300 on 23 June. Unfortunately, the alarms were regarded as nuisance alarms during these occurrences and no physical checks were made on the LPS at the time of the alarms. The upwelling box and pond are checked daily for lamprey mortalities and nothing unusual was found during these inspections. This problem has not surfaced in the past, and with not finding any unusual water flow, neither Project Fisheries or Operations thought to clean the screen separating the pond and intake.

- A. Species – Pacific Lamprey (*Entosphenus tridentatus*)
- B. Origin – Unknown
- C. Length – (*Figure 3*) 61-71 cm. (*Figure 4*) In ascending order 69.9 cm, 64.1 cm, 59.7 cm. (*Figure 5*) 67.3 cm
- D. Marks and tags – None
- E. Marks and Injuries found on carcass – None
- F. Cause and Time of Death – June 23 and 24th
- G. Future and Preventative Measures –
 - Routine cleaning of screen separating the pond and the intake of downstream LPS section.
 - Install a screened overflow drain on the pond.
 - Alarm Diligence.

1.1.1.24BON014 MFR Cascades Island LPS Lamprey Mortalities – Porter inquired about this event and why alarms were ignored. Flemmer indicated that alarms alerted but no apparent issues were found so continued alarms were not acted upon. This event occurred two days later. Failure points included fish biologists were not checking the alarm histories, electricians needed to calibrate the alarm better as the alarms were coming in consistently with every water fluctuation. Clogged screen in the LPS pond caused overflow. Screens will now be monitored and scrubbed regularly. Project is reviewing alarm history daily and alarm trigger has been changed to 30 seconds of low water.
