**OFFICIAL COORDINATION REQUEST FOR
NON-ROUTINE OPERATIONS AND MAINTENANCE**

COORDINATION TITLE- 13JDA05 JDA-N variable width weir inspection

COORDINATION DATE- 12 September 2013

PROJECT- John Day Dam

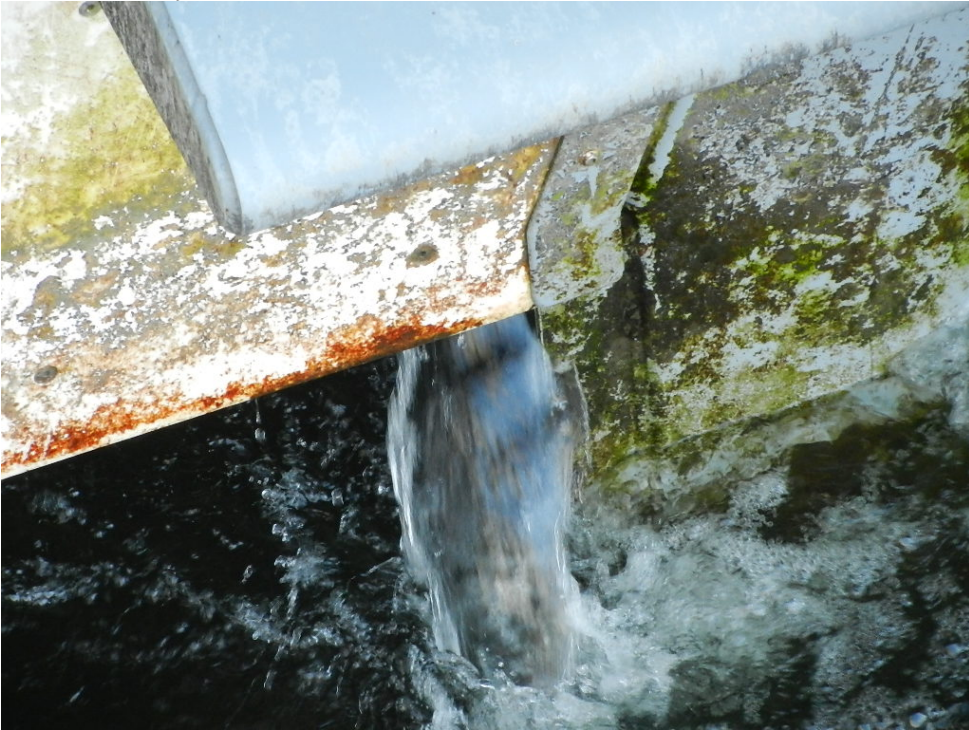
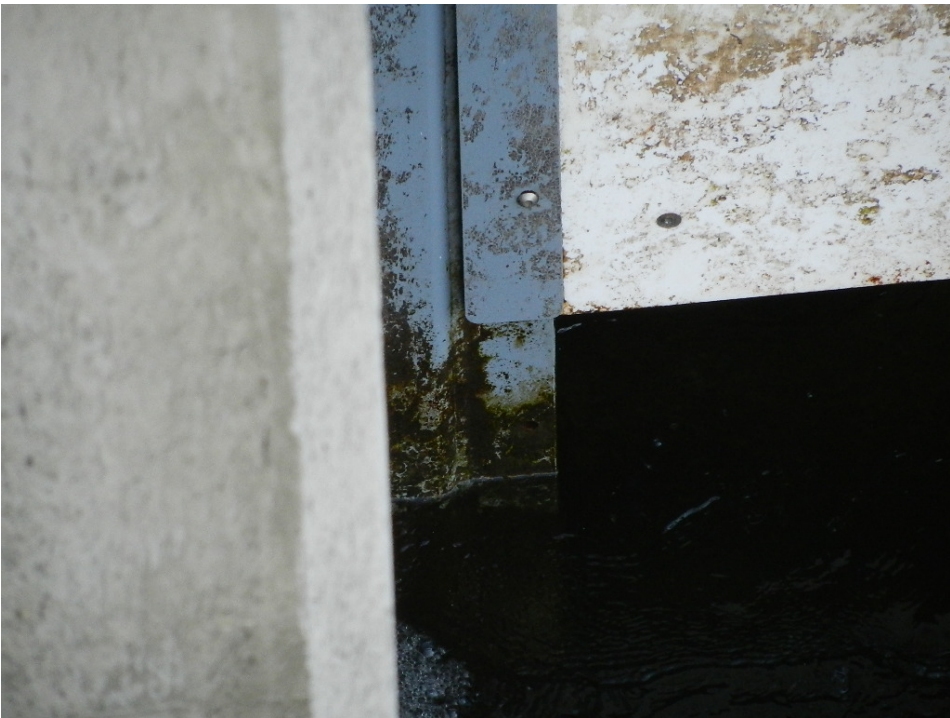
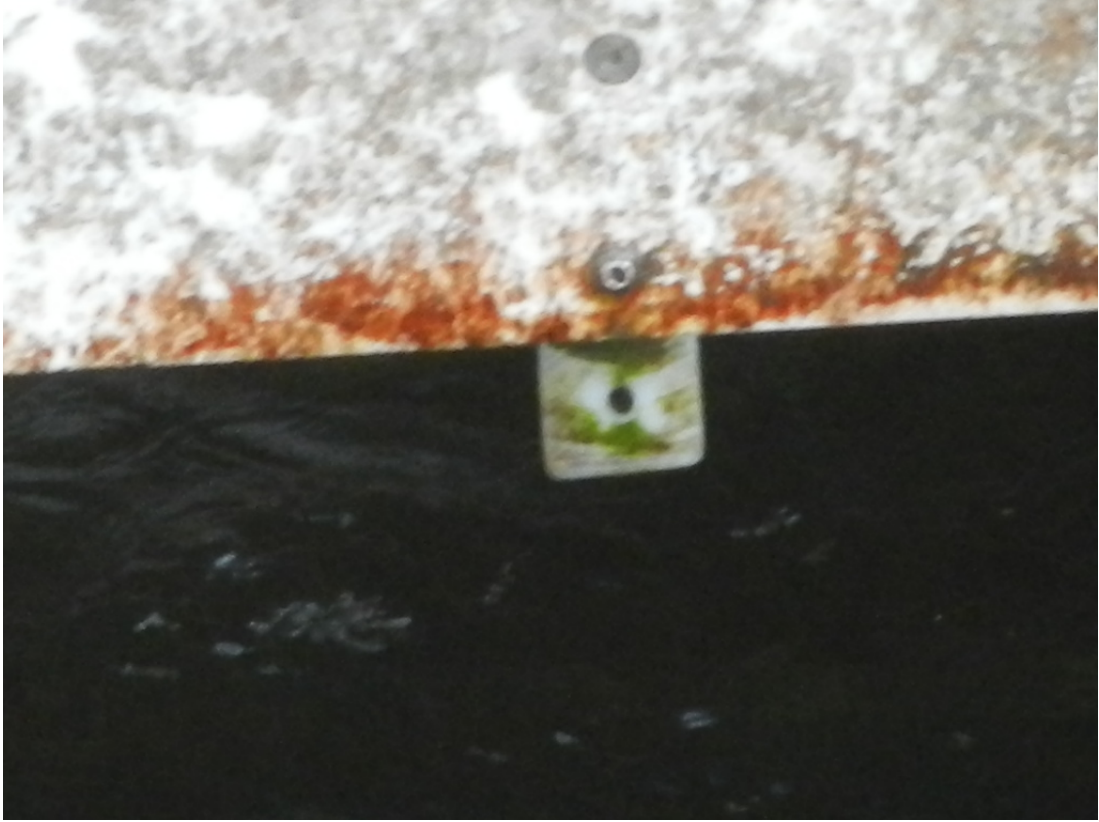
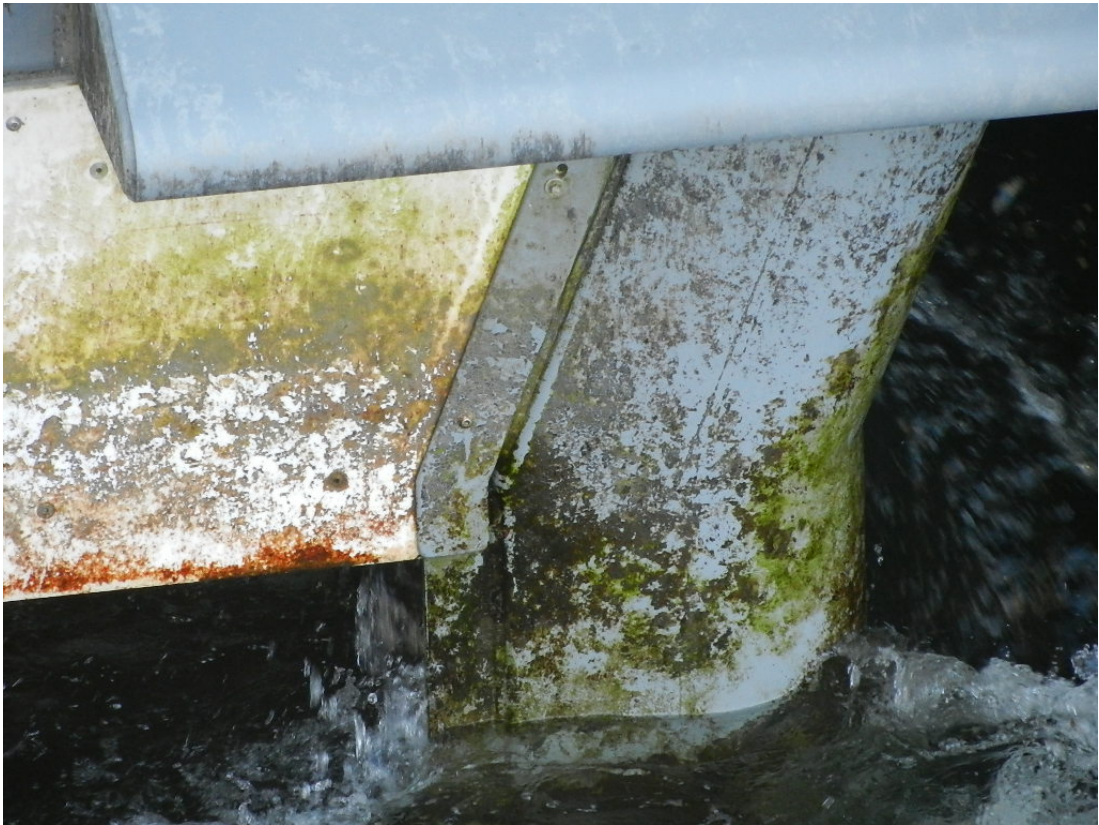
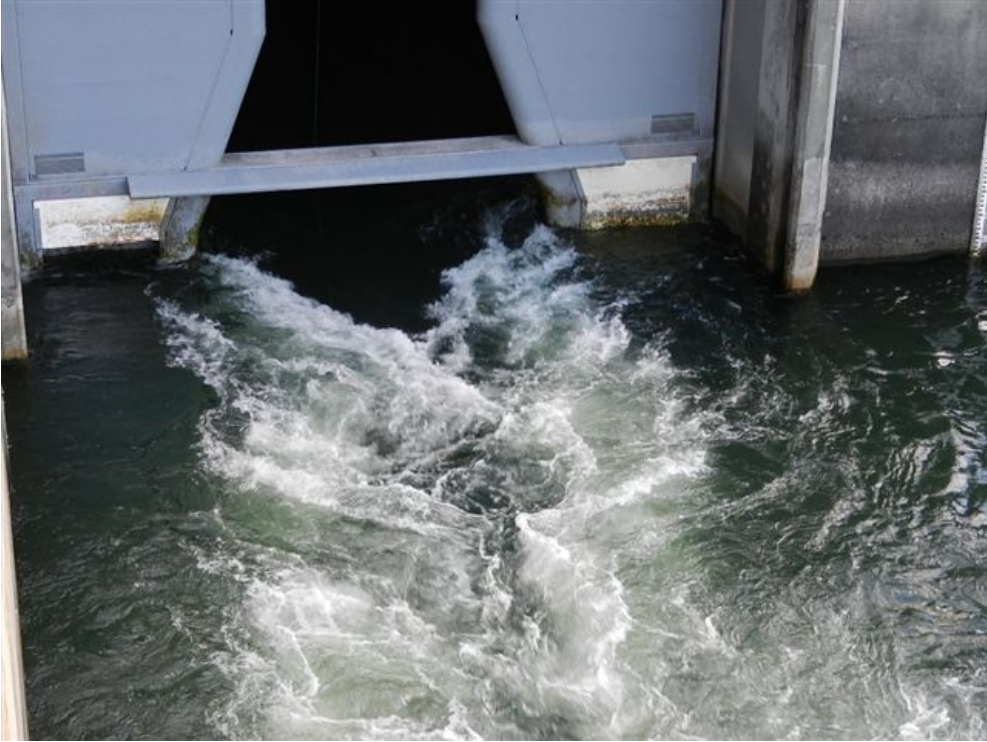
Description of the problem- The current configuration condition using steel keeper bars and UHMW panels on the John Day North Fish Ladder Variable Width Weir [VWW] Lower Piece was a modification to the JDNFL EI contract that was done during last winter when the fish ladder was dewatered. It is assumed that when the fix was done the machine screws were tightened down by the workers as standard practice. There is usually no reason to doubt that.

At the moment however there is little tiny bit of doubt now that the machine screws were tightened down enough as it doesn't seem to like the attachment machine screws would just come out. There is the possibility that there is enough water flow induced vibration occurring that makes the screws slowly turn themselves out but that sure seems to me like an unlikely circumstance. However we are not sure if that is even a valid possibility as it has never been seen before.

We don't really know why the panels have come off the VWW. NWP recommends inspecting the VWW out of water promptly; with the idea that any loose fasteners can be tightened on the spot. If this inspection with temporary fastener tightening fix is not done soon, we may discover that more panels have come off when the VWW is inspected a couple months from now at the end of the fish run season. NWP needs to go to John Day dam to see firsthand the VWW out of the water and maybe laying on the deck instead of hanging in the air. At that point we can try to get an idea of why the panels have come off.

While out of the water temporarily [perhaps a couple hours or so] the VWW can be viewed by NWP engineers and a solution for a permanent fix can be developed.
