MEMORANDUM FOR THE RECORD

SUBJECT: 17JDA15 MFR – Partial JDA SMF Dewatering for Emergency Joint Inspection near Tainter Gate

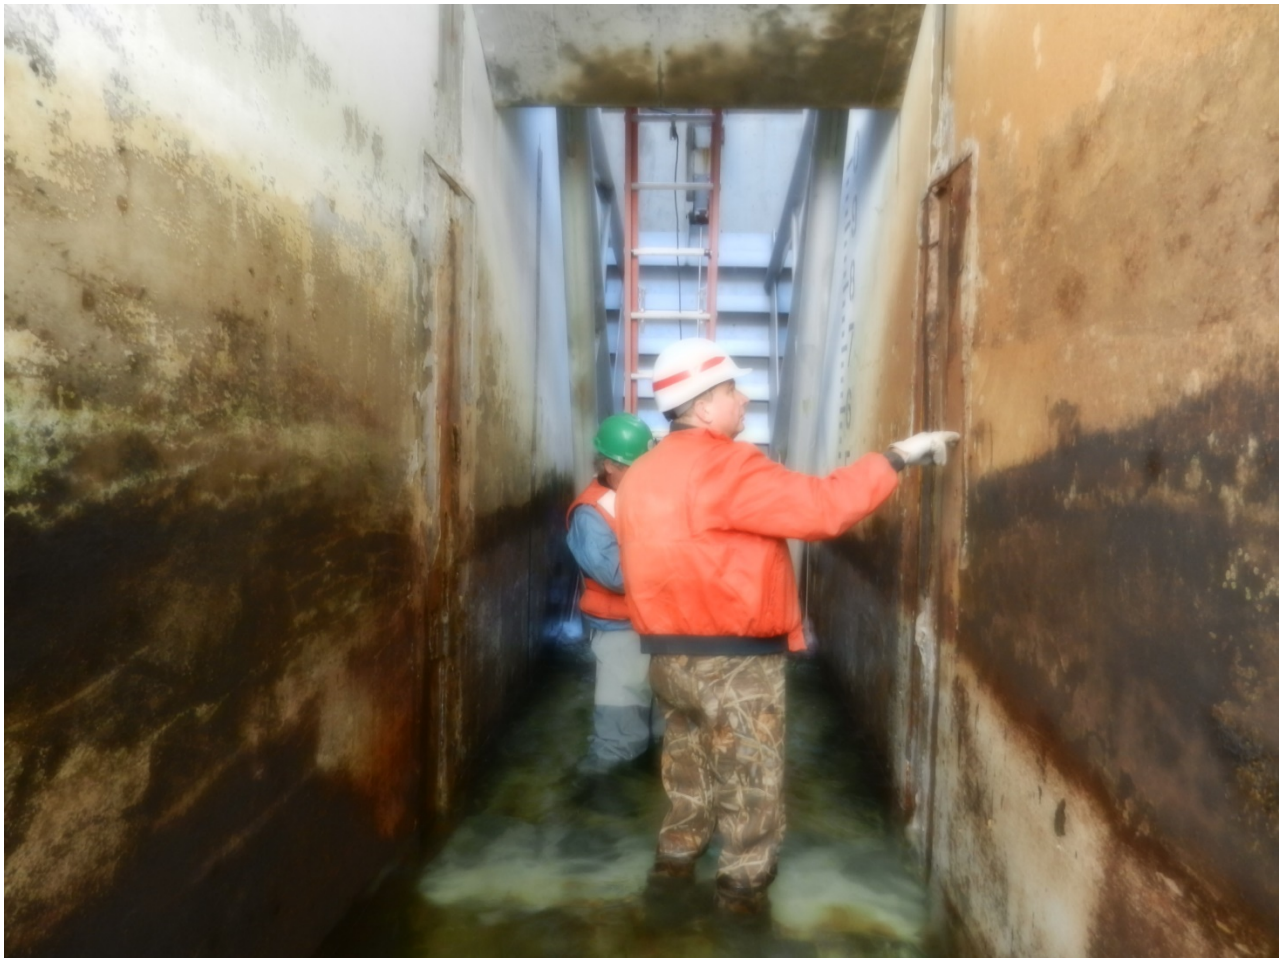
Upon inspection, it appeared that some soft, joint packing material has come out from the joint and it was bulging out in places, by one to two inches, into the flow. Some loose, surface caulking was quickly cut off with a knife, but overall this joint was determined to be acceptable to safe fish passage until the winter maintenance commences on 16 December 2017. This emergency JD JBS/SMF outage lasted approximately 2 hours, without any significant impact on the passing fish.

- A. Species – Juvenile and Adult Salmonids
- B. Origin – N/A
- C. Length – N/A
- D. Marks and tags – N/A
- E. Marks and Injuries found on carcass – N/A
- F. Cause and Time of Death – N/A
- G. Future and Preventative Measures – Ensure that this critical expansion joint's repairs are planned in advance by JD Maintenance and performed with proper care and attention to assure its structural integrity through the entire fish passage season.
