MEMORANDUM FOR THE RECORD

SUBJECT: 19JDA06 MFR South fish turbines 1 & 3 out of service

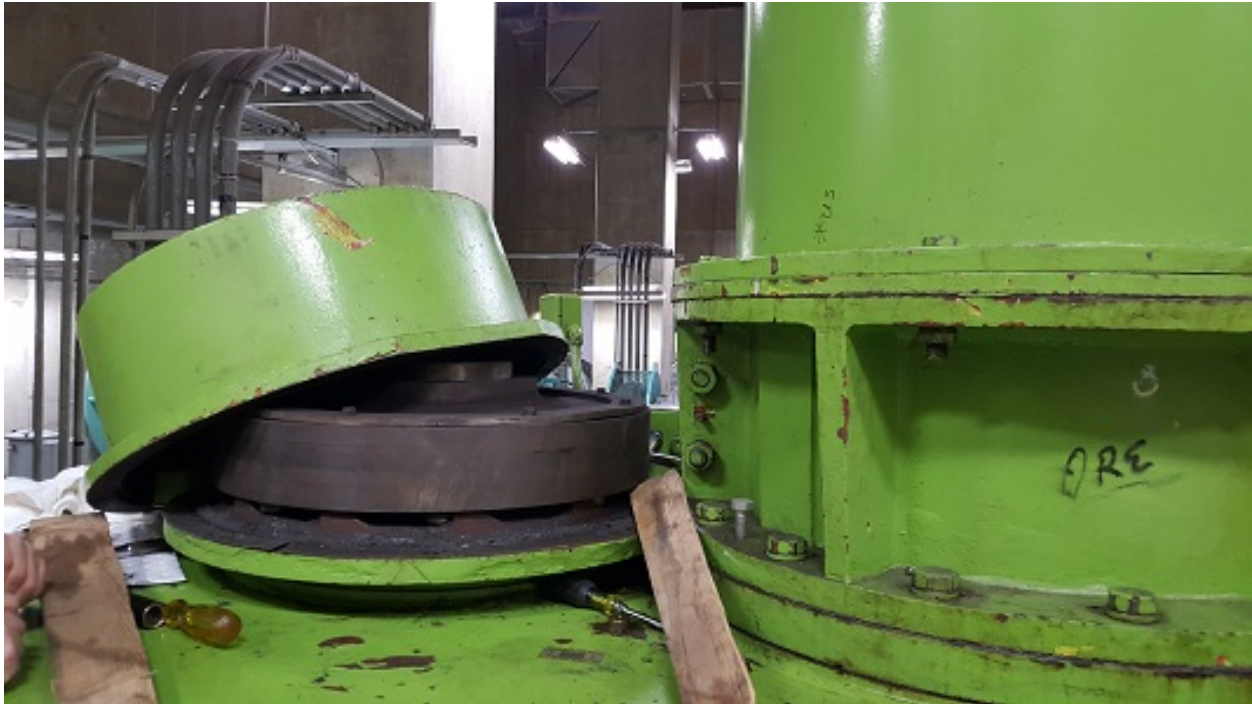
At 1330 on 9 April, a contractor working on a breaker on the SQO2 panel had a ground out which caused a breaker trip. The trip resulted in power lost to the FCQ2 panel which provides power to the South fish turbines oil and water pumps. As a preventative measure, the turbines automatically shut themselves down without any water cooling or oil lubrication. At 1500, JDA operations began starting fish turbines 1 & 2. During the startup of turbine pump 1, the operator heard a clanking noise and shut the turbine down for JDA maintenance to investigate.

During the initial shutdown, for reasons unbeknownst to JDA maintenance, anti-ratchet gear was damaged beyond repair. The anti-ratchet gear prevents the turbine from spinning the gearbox backwards and protects the gears from damage. It being damaged made the turbine inoperable.

Anti-Ratchet gear of fish turbine 1.

The clutch for fish turbine pump 3 should arrive on project 26 April. A spare anti-ratchet gear from the old gearbox from the rehab of fish turbine pump 3 is being pulled off and checked as a suitable replacement for turbine 1.

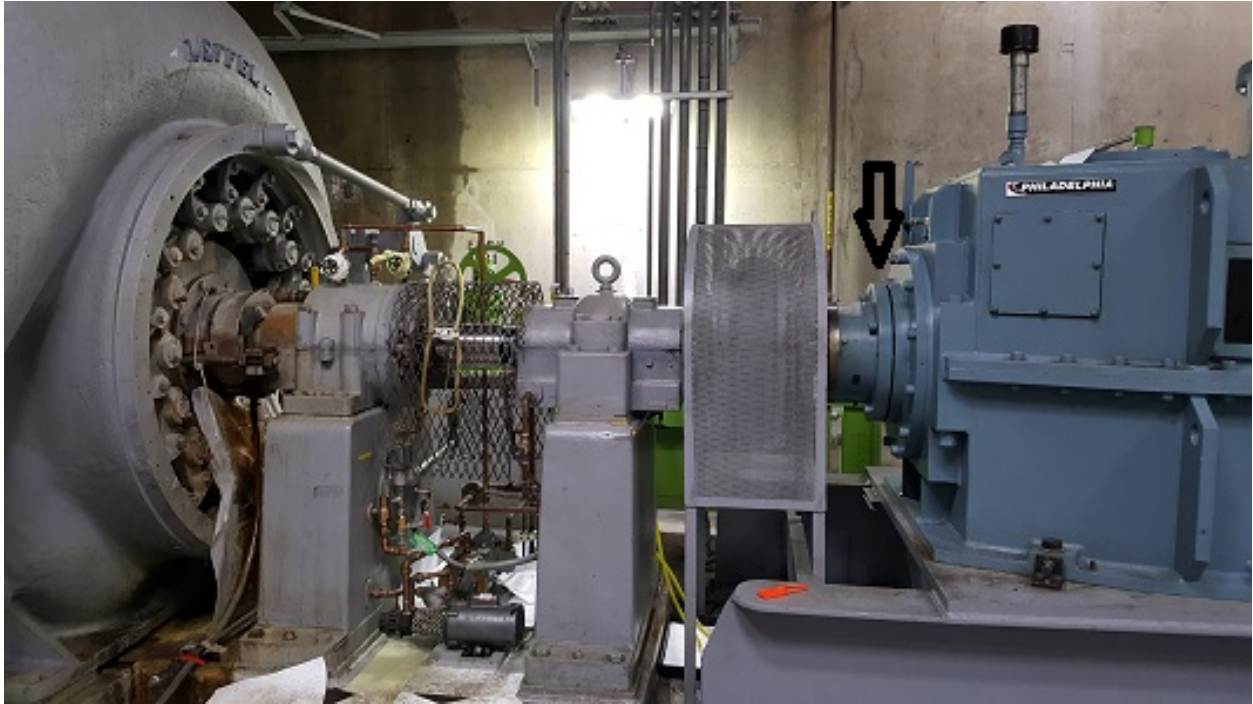
On 28 February, JDA operations started fish turbine pumps 2 & 3 for the start of adult passage season. While starting fish turbine pump 3, the operator heard an abnormal noise and had to shut the turbine down. JDA maintenance was notified of the problem. It was later discovered that the clutch was bad and after discussing the problem with manufacturer, running the turbine would cause severe damage to the gear box and the clutch would have to be replaced before being returned to service. As a result, fish turbine pump 1 was started to supply auxiliary water to the South fish ladder.

Clutch assembly of fish turbine 3.
