**MEMORANDUM FOR THE RECORD**

**SUBJECT: 20JDA01 MFR – Oil leak in SFL collection channel**

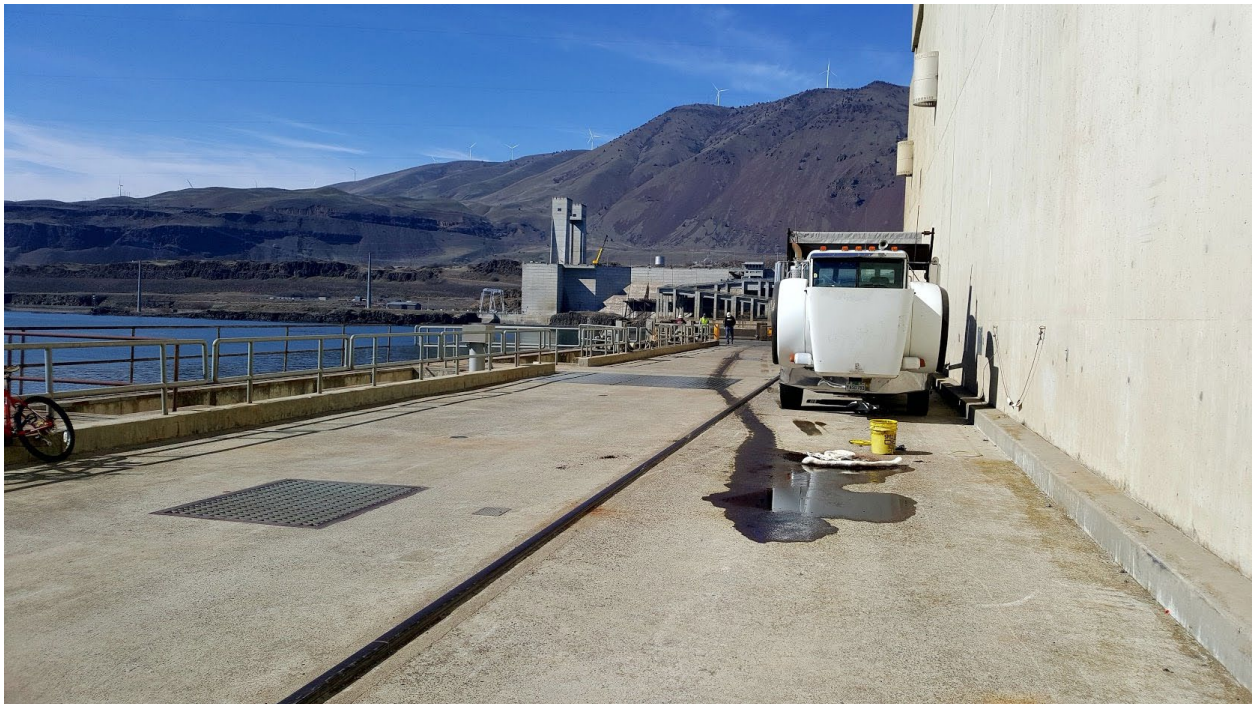
At 1415 on 17 March, project fisheries on its second daily inspection found a garbage truck parked near the North powerhouse fish entrance weirs with a blown hydraulic line. The truck had turned around at the end of the powerhouse just as the line broke and released an unknown amount of fluid (likely <2 gal) on the tailrace deck on top of the collection channel of the South fishway. The driver had a spill kit and immediately positioned absorbent material and litter. A small amount of oil likely fell into the fishway through the grating. Project fisheries notified the environmental compliance coordinator and the oil spill team and the spill was promptly cleaned up. No visible sheen of oil was observed in either the collection channel or tailrace.
