## **CENWP-OD-J**

## MEMORANDUM FOR THE RECORD

## SUBJECT: 20JDA07 Chinook Mortality Near Spill bay #20

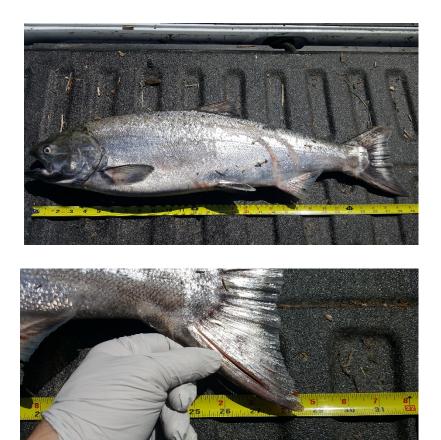
On Thursday, 21 May, JDA Fisheries discovered an adult Chinook mortality on the tailrace deck near spill bay 20. Similar occurrences happened in 2017 (See 17JDA03 and 17JDA04). The exact cause was unknown. It is believed to be a result of spill bay 20's discharge colliding with the opening at NE-3 weir (now unused). When it collides with the opening, an occasional (approximately once/ few minutes depending on flow) surge of water shoots strait up. If a fish got caught in the discharge, the velocity would be enough to force the fish out of the water and onto the deck. After the previous mortalities, a metal mesh was used to line the bottom of the guard rail overlooking NE-3. Since that time, no other instances have occurred. This is the first new observation since 2017, and only the 2<sup>nd</sup> year it has been seen. Increased spill at bay #20 is believed to be the root cause. Monitoring of the area will be ongoing.

- A. Species Chinook
- B. Origin Hatchery
- C. Length  $-\sim 26$ "
- D. Marks and tags none
- E. Marks and Injuries found on carcass Split caudal fin ray, marks similar to net patterns, some descaling
- F. Cause and Time of Death Stranded on tailrace deck, estimated to be early afternoon on May 21<sup>st</sup>.
- G. Future and Preventative Measures TBD, there was an issue in 2017 with a handful of fish getting stranded. Some metal mesh was put around the lower access area (below the guard rail) to help reduce instances.
