MEMORANDUM FOR THE RECORD

SUBJECT: 21JDA01 MRF South Fish Turbine #2 out of service

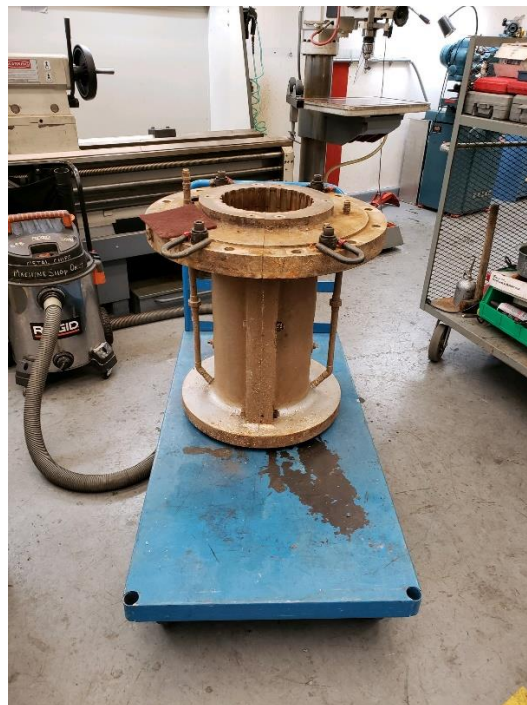
During the winter maintenance period of the South fish ladder at the John day project the #2 South fish turbine was inspected and found to have significant wear on the Teflon strips for the brass guide bearing of the lower guide bearing for the pump assembly. The guide bearing holds the shaft within the stay vanes while the impeller rotates pumping water into the auxiliary water supply conduit producing the attraction water in the collection channel of the South fish ladder.

Lower guide bearing

JD maintenance is expecting once parts arrive that the turbine pump can be returned to service within a week.

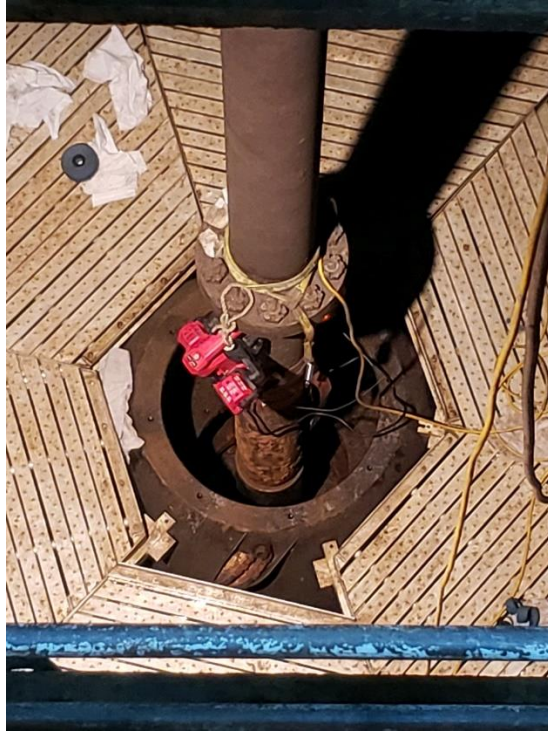
Pump shaft leading to impeller
