**MEMORANDUM FOR THE RECORD****SUBJECT: 22JDA03 South Fish Turbine Pump #2 out of service**

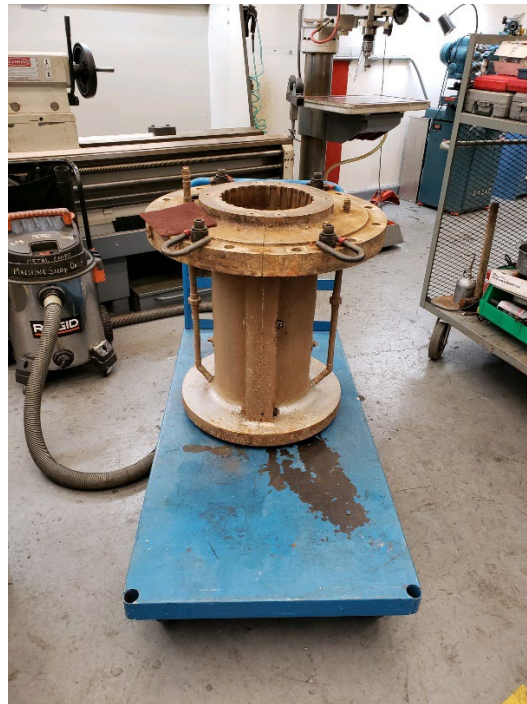
Lower guide bearing

At 1604 hours on 30 March South fish turbine pump #2 was forced out of service with an excessive vibration issue. John Day maintenance staff believe the vibration to be caused by the impeller shaft being out of alignment in the lower guide bearing pump assembly. This issue was addressed last year with the guide bearing being re-journaled with Teflon strips added to align the shaft properly(see:[21JDA01 MFR South Fish Turbine 2 out of service](#)).

- A. Species –
- B. Origin –
- C. Length –
- D. Marks and tags –
- E. Marks and Injuries found on carcass –
- F. Cause and Time of Death –
- G. Future and Preventative Measures – South fish turbine pump #2 needs an extensive overhaul. Repairs to the lower guide bearing by re-journaling are not a permanent solution.
