MEMORANDUM FOR THE RECORD

SUBJECT: 22JDA12 Spillbays 1-4 Out of Service for Routine Inspection

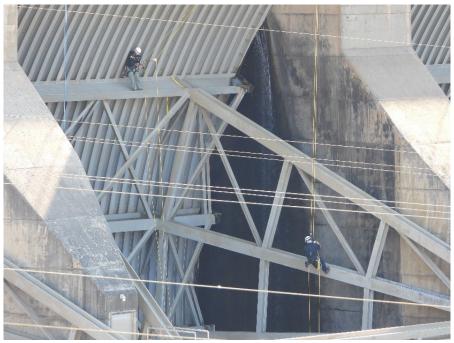
Figure 1: An inspection of the tainter gate at spillbay #3 (Note: the horizontal lines are not associated with the inspection; they are avian lines).
