MEMORANDUM FOR THE RECORD

SUBJECT: 22JDA15 Penstock trash rack crane oil leak

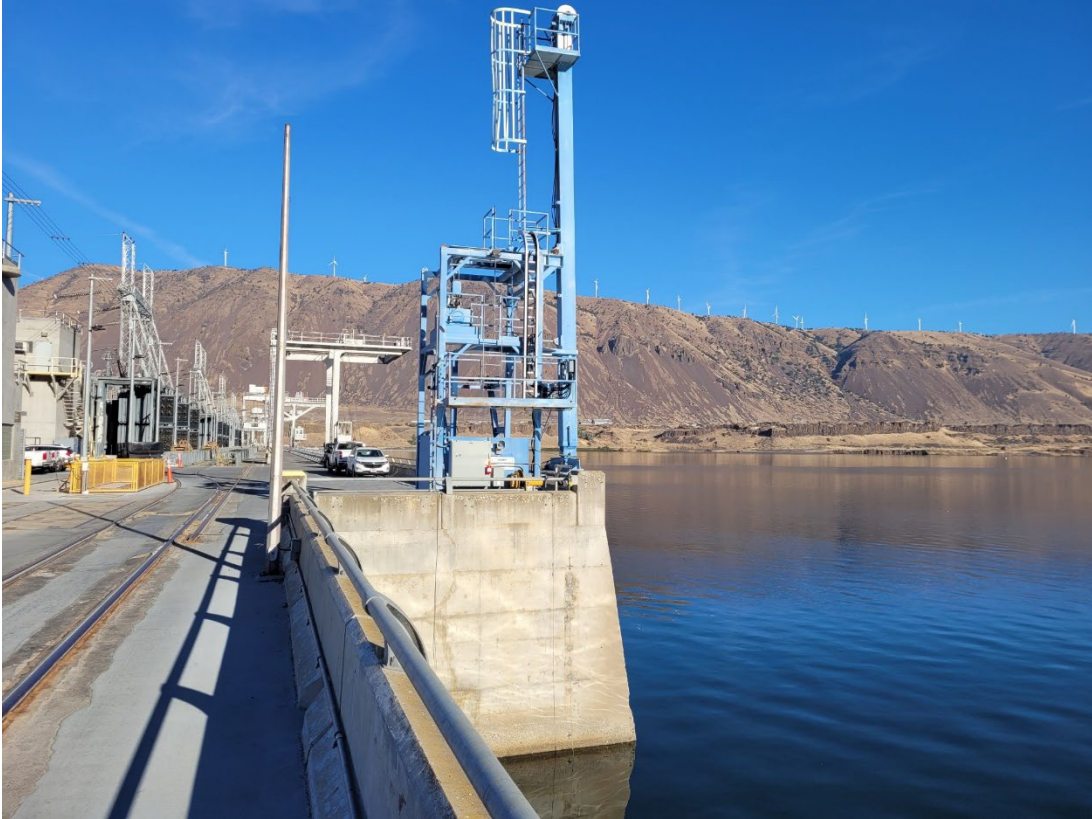
On the morning of 11 October 2022 at 0940, John Day maintenance personal were performing a routine preventative maintenance task on the South fish ladder turbine penstock trash rack crane (Fig1). During the inspection a breather plug on the crane discharged approximately ¼ cup of NLGI #2 gearbox grease into the forebay of the dam between main unit 1 and the South fish ladder exit.

Fig 1. The John Day penstock trash rack crane.

- A. Species – NA.
- B. Origin – NA.
- C. Length – NA.
- D. Marks and tags – NA.
- E. Marks and Injuries found on carcass – NA.
- F. Cause and Time of Death – NA.
- G. Future and Preventative Measures – An improved catch system is being developed to return excessive grease from the breather plug into the gearbox rather than out the breather plug as it was initially designed to do.
