MEMORANDUM FOR THE RECORD

SUBJECT: 23JDA03 MFR South Fish Turbine #3 out of service

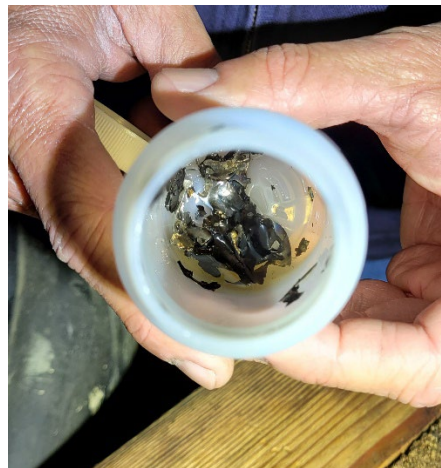
During an oil change of the gear box of South fish turbine #3, metal shavings were found in the filter. Upon draining 70 gallons of oil from the gearbox to inspect the gears and bearings, additional metal shavings and fragments were found on the bottom of the gearbox(fig1). Representatives from the Philadelphia gear company inspected the gear box on 22 February and determined the input shaft gear bearing to be the cause of the metal and recommend it be replaced before more significant damage occurs to other internal components.

Upon review of recommendations from the Philadelphia gear company and concurrence from JD project maintenance staff, South fish turbine #3 will be forced out of service until repairs can be made to the input shaft bearing in the gear box. It's determined that the gearbox is too unsafe to operate in its current condition and operating it will cause more permanent damage to the internal gearing of the gearbox and could eventually catastrophically fail.

Fig 1: Metal fragments pulled from gearbox

3.2.1.13.1. Grosvenor reported that the gear box manufacturer was on-site and gave the Fish Turbine #3 gear box a quick look. They provided a report so JDA now has a better understanding that the problem is related to the bearings. Philadelphia gear is working on alternatives to replace the bearing. The work is beyond the Project's ability. JDA is working on a plan and funding.

- A. Future and Preventative Measures – Estimates of repairs will be provided by Philadelphia gear company. The type of repair is beyond JD projects capabilities.

An inspection team from Philadelphia gear will be on site 11 March to scope out repair options to the gearbox. Once a quote is prepared and an option selected, JD project staff and NWP will prepare a UFR for emergency repair to return South fish turbine pump #3 ASAP.
