MEMORANDUM FOR THE RECORD**SUBJECT: 23JDA04 MFR South Fish Turbine # 2 forced out of service.**

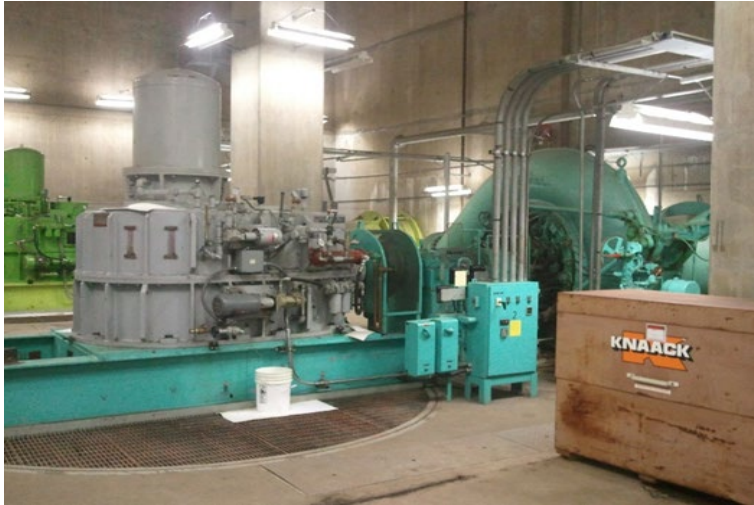
Fig 1: John Day South Fish Turbine Pump #2

John Day maintenance is dropping bulkheads into South fish turbine pump #2 to dewater the unit and investigate the vibration issue. The pumps lower guide bearing was repaired this past July and the vibration may be the cause of another failure. However, that has yet to be determined.

John Day maintenance has determined the cause of the vibration to be excessive wear on the lower guide bearing on the pump assembly of South fish turbine pump #2. The bearing was pulled out and journaled to reattach Teflon guide strips (Fig2) for the intermediate propeller shaft. Currently the bearing is being reattached to the pump assembly and the fish turbine pump is expected to return to service by 9 March.

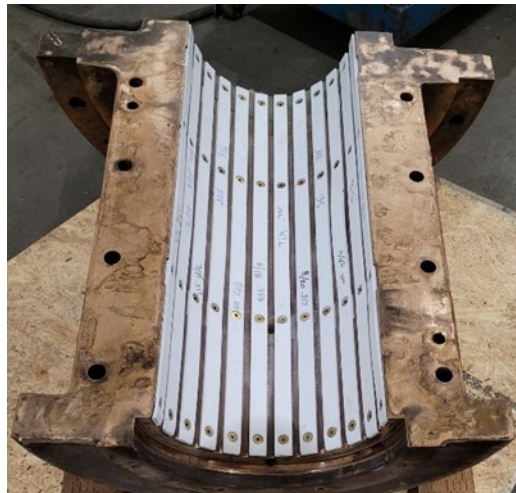
Fig 2: Lower guide bearing disassembled
