MEMORANDUM FOR THE RECORD**SUBJECT: 23JDA42 MFR Steelhead Mortality from SFL Dewatering**

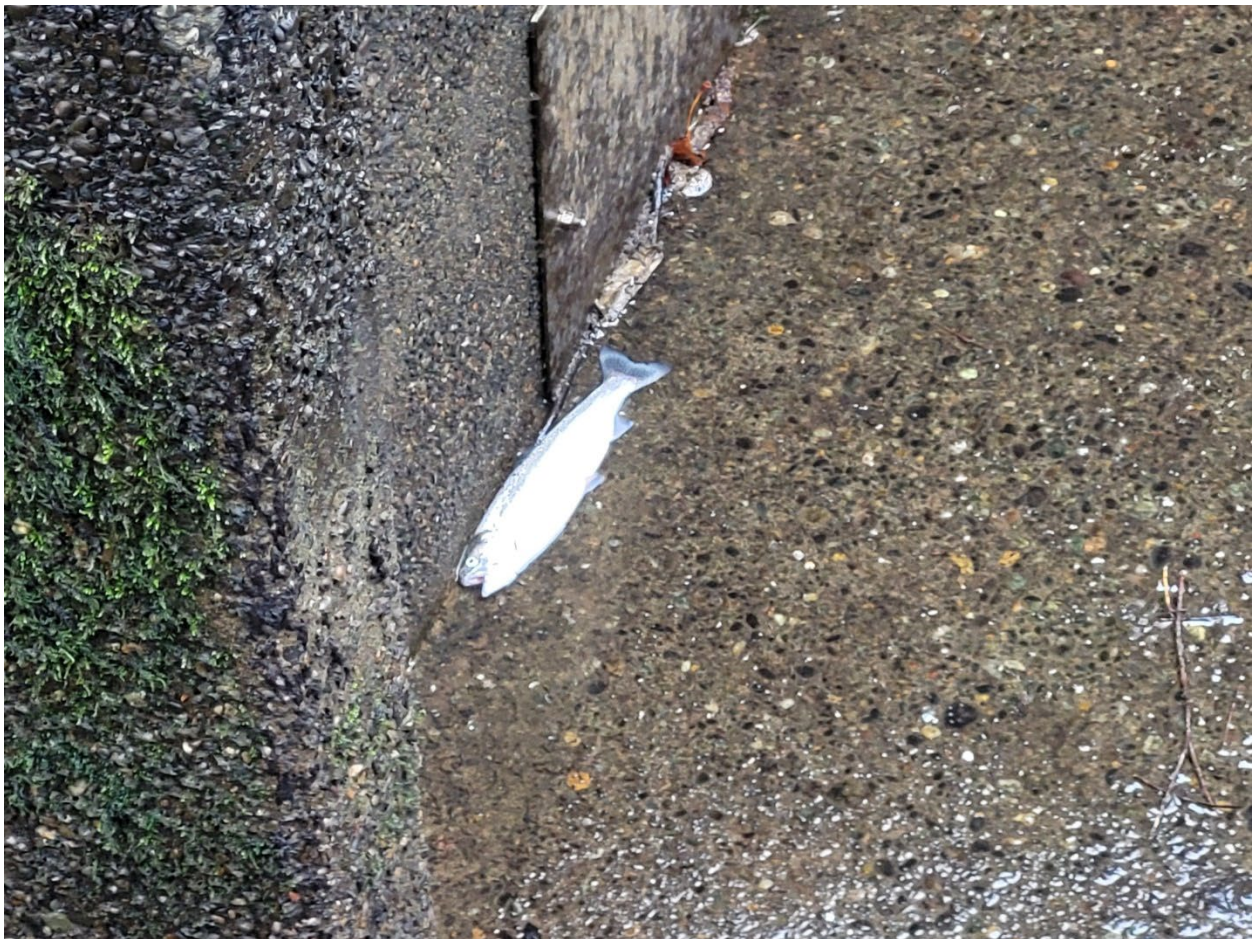
On 4 December 2023, JDF personnel dewatered the south fish ladder (SFL). Personnel went down the entire length of the ladder on skateboard and salvaged any fish that were left in the system. Unfortunately, on 5 December 2023, a steelhead was observed in the ladder that went unnoticed (Figure 1). Due to more stringent confined space regulations at JDA the steelhead has not been recovered to identify injuries/tags yet.

Figure 1: Steelhead Mortality in the JDA SFL on 5 December 2023.

- E. Marks and Injuries found on carcass –NA
- F. Cause and Time of Death – NA
- G. Future and Preventative Measures- Typically all fish are recovered during dewaterings. Due to illnesses and leave, an inexperienced salvager had to accompany fisheries personnel down the ladder. It's difficult to move ladder dewaterings when personnel are ill, but every effort will have to be made to ensure adequate fisheries personnel are available for scheduled dewaterings.
