MEMORANDUM FOR THE RECORD***SUBJECT: 24JDA04 Oil Sheen and Chinook Mort in Gatewell 1A***

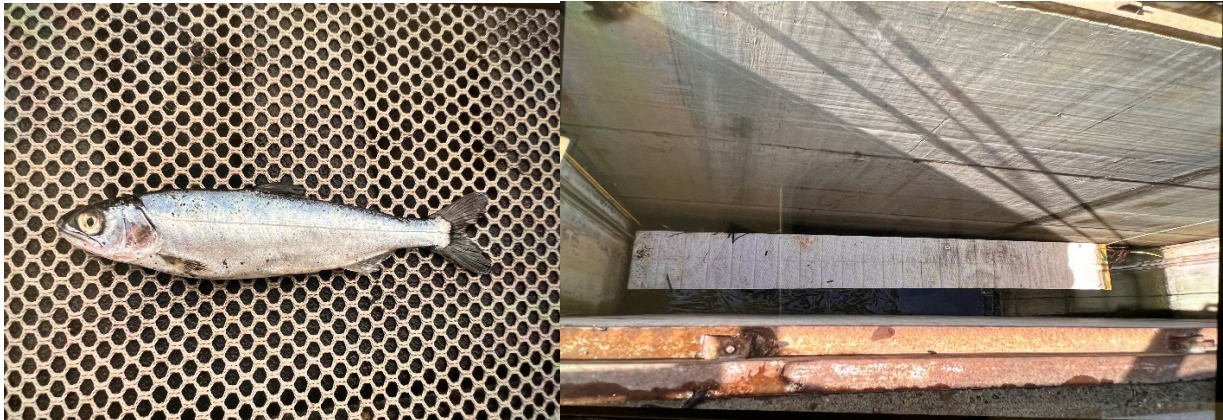
On 28 March 2024, at approximately 0930 JDF personnel noticed a clipped Chinook smolt mort on the absorbent pad in gatewell 1A (9-days after initial deployment). The mort was retrieved from the gatewell, scanned for PIT tags, and returned to the river. There were no noticeable injuries on the smolt, and it's presumed the smolt jumped onto the pad and became stranded.

- A. Species – Chinook
- B. Origin – NA
- C. Length – NA
- D. Marks and tags – clipped, no PIT tag
- E. Marks and Injuries found on carcass – none
- F. Cause and Time of Death – unknown
- G. Future and Preventative Measures- Continue to monitor gatewells daily and keep a close eye on gatewells with oil absorbents deployed. JDA personnel will work to determine how long oil absorbent pads need to be deployed in order to reduce exposure times for smolts. This method of absorbency has been used numerous times, and this is the first known occurrence of smolt stranding.
