**OFFICIAL COORDINATION REQUEST FOR  
NON-ROUTINE OPERATIONS AND MAINTENANCE**

**COORDINATION TITLE-** 24JDA05 – Installing the Lamprey Modified SE-1 Weir in JDA SFL  
During the Adult Fish Passage Season

**PROJECT-** John Day Dam

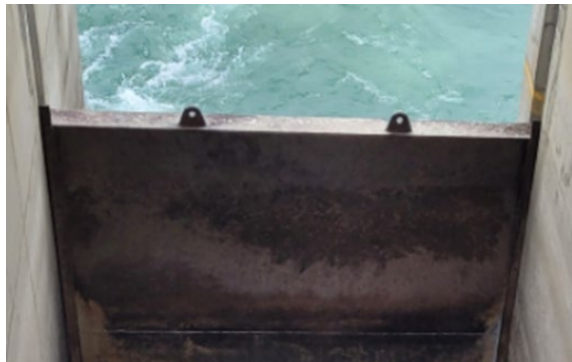
**Description of the problem** – The current John Day South Fish Ladder (SFL) entrance weir (SE-1) has a flat upper surface (Figure 1). This makes it difficult for lamprey to enter the SFL (on average about 60% of the lamprey pass JDA through the North Fish Ladder). Modifications are being made to a spare weir to allow for easier lamprey passage. These modifications include a rounded top (Figure 2), and a section of steel plating on the downstream face (Figure 3) for lamprey attachment. Additional modifications include painting, installing new guide wheels, new bushings, and replacing worn portions of the gasket.

Figure 1: The currently deployed SE-1 top. The flat surface makes it difficult for lamprey to enter the system.

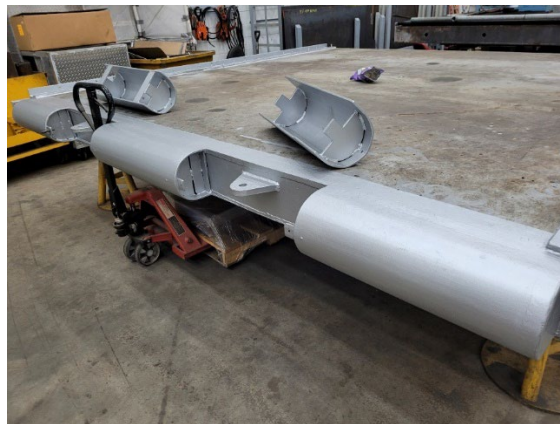
Figure 2: Picture of the rounded top on the newly modified SE-1 weir. The rounded top will make it easier for lamprey to enter the ladder. Once deployed the detached rounded sections (shown sitting on top of the weir) will mount over the lifting brackets.

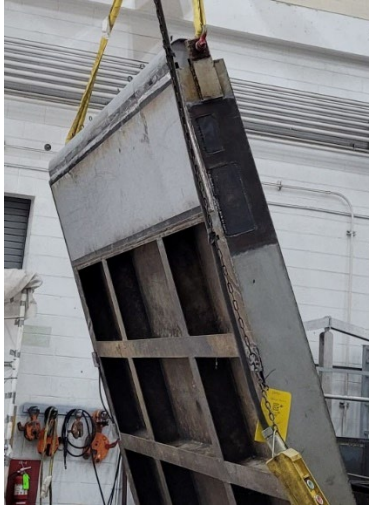
Figure 3: Picture of the steel plating installed on the downstream face of the newly modified SE-1 weir. The flat surface will provide an attachment point for lamprey before entering the SFL.

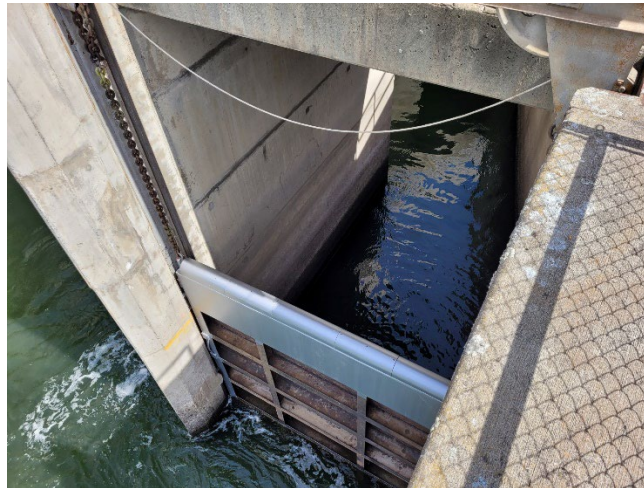
Figure 4. newly modified SE-1 weir installed.

The SFL pumps were shutoff at approximately 10:30 AM on 23 April. The weir was fully installed by the crew's 1400 break. However, the weir cable had to be completely greased (along with a couple points on the winch motor). Due to the way PMs are handled, it was actually advantageous to utilize this opportunity to grease the entire length of the cable. The weir was lowered to >8-feet at approximately 1445. Due to limited operator availability, the pumps weren't switched back on until approximately 1530. After the pumps came on, JDF set the weir to approximately 8.5-feet of depth. The weir depth was recorded in the office to ensure the depth is kept >8-feet until the programming can be calibrated to the new weir specs.
