MEMORANDUM FOR THE RECORD**SUBJECT: 15TDA13 MFR** – Fish Stranding in Fishlock

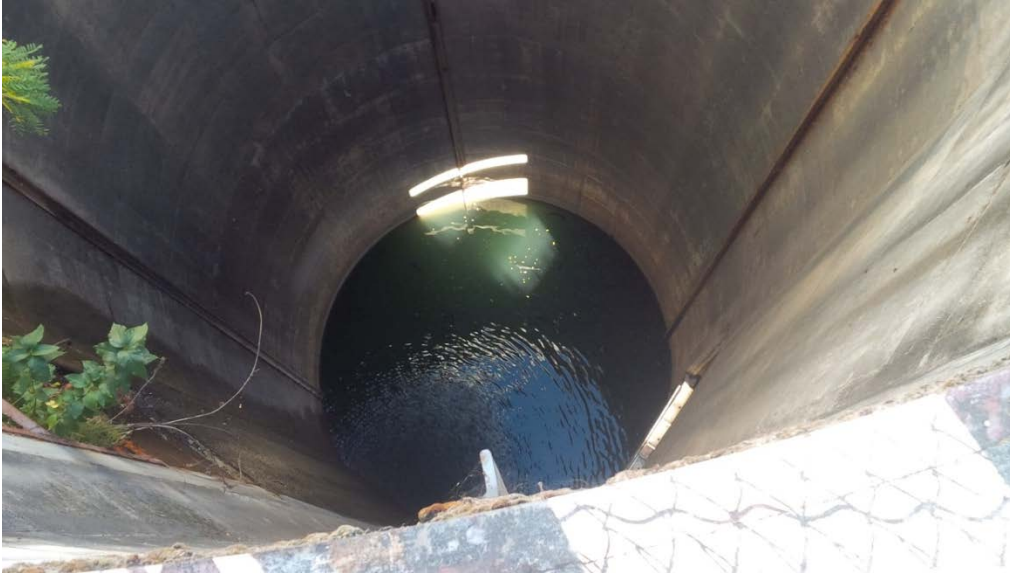
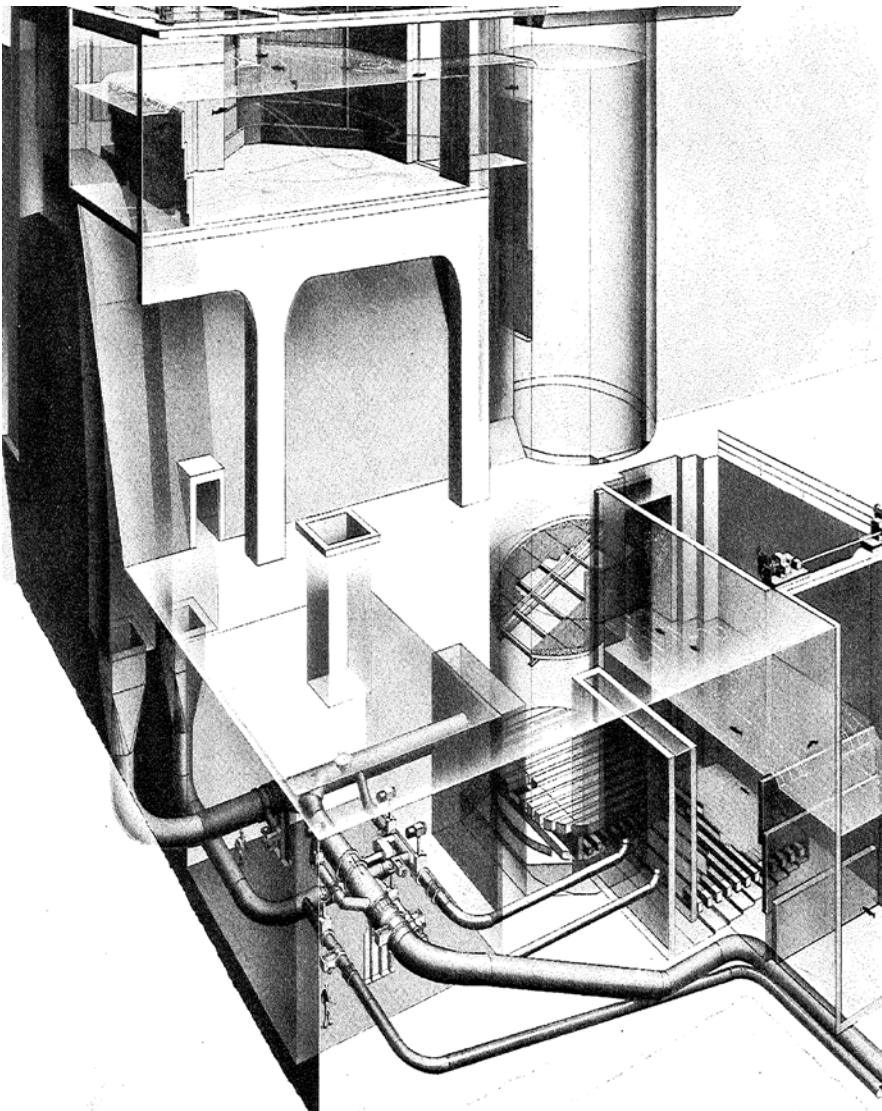
On further investigation it is believed the fish entered from the cul-de-sac into the fishlock discharge pipe. There is a closed butterfly valve in this section of pipe. However, the rubber seals are suspected to be degraded due to age and this has been an issue with other butterfly valves in this location. This leaves a several inch gap along the side of the valve, allowing access into the fishlock. A head pressure is normal for this system due to the need for irrigation at Patterson park. The entire system was thought to be contained and isolated from tailwater.

Schematic of piping and valves associated with fish lock. Large pipe exiting system (lower right) leads to outlet in cul-de-sac, where fish entry is suspected. Intake penstock (upper left) is location of bulkheads which were installed to stop flow. Cylindrical portion above baffle beams is location of fish observed.

Attempts were made to devise a trap for removal, but were unsuccessful after several days. The next step is to install forebay bulkheads to stop the leakage flow and prevent any further attraction to this area. We will assess feasibility to safely access this area for fish removal. Since this has never been done, many challenges are expected. We will need to determine a new operational plan for next season to prevent this from occurring again. This valve room is planned to be demolished and the intake pipe will be capped during the AWS backup contract work, scheduled for the winter of 2016 and 2017, which will correct the problem.

The forebay bulkheads were installed on 26 October to stop leakage flow and prevent any further attraction to this area. The area within the fishlock itself has no means of dewatering. An ROV was dropped in the cylindrical part of fish lock to assess structure and fish numbers. No fish were observed. Two levels of bubbler beams were encountered preventing further ROV depth beyond 12 feet. It has been determined that feasibility and safe access into the area cannot be achieved; therefore dewatering salvage is not an option. Modifications will be made to the fish trap. If fish are observed, hook & line method may be used.
