**MEMORANDUM FOR THE RECORD – 17 TDA 15 Fish Unit 2 forced out of service**

**SUBJECT: F2 outage and fishway impacts**

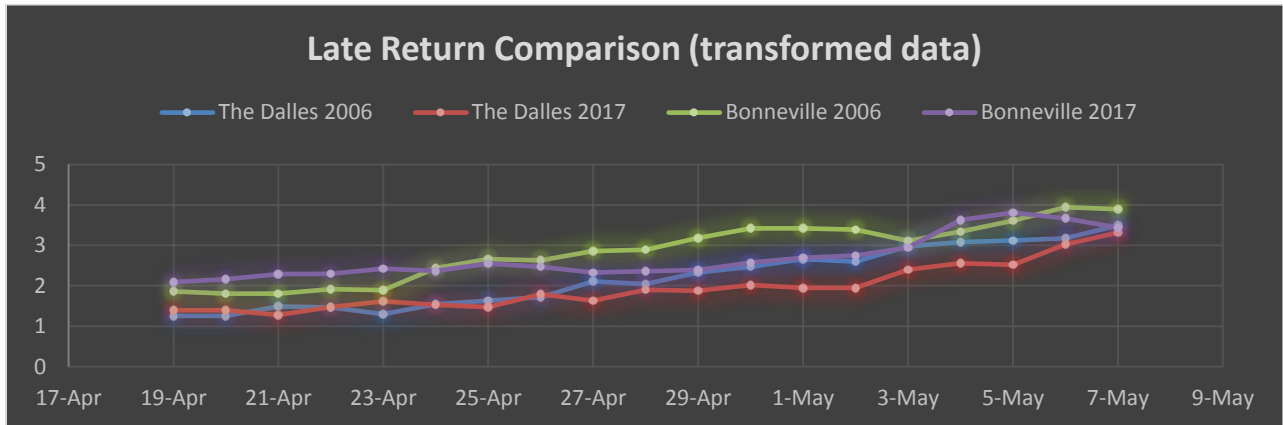
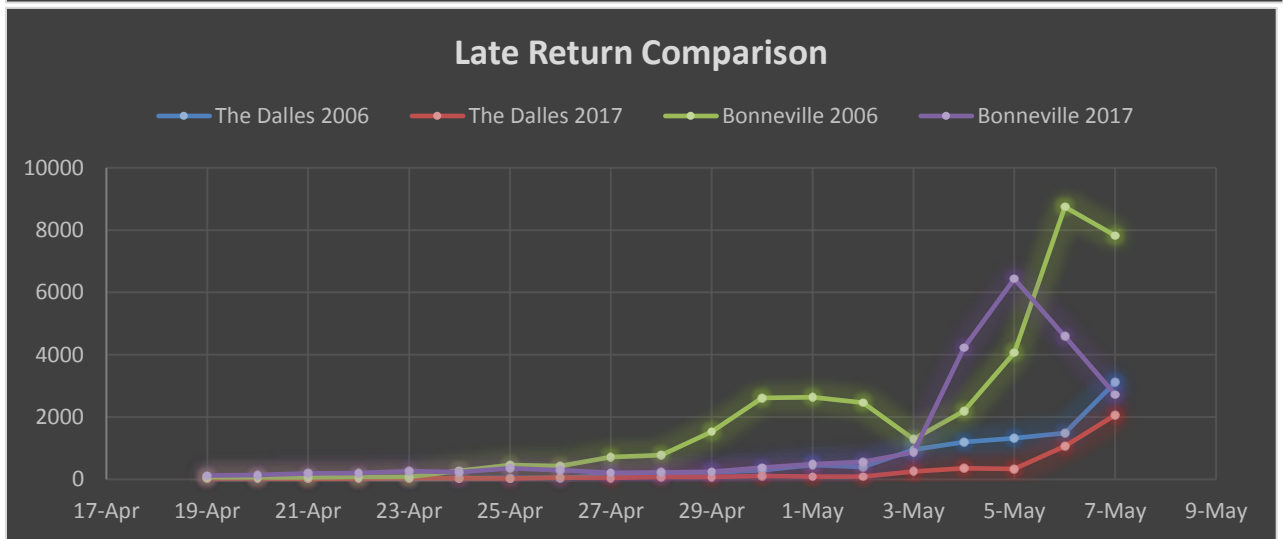
We analyzed count data to try and determine if there was a noticeable affect to fish passage under one fish unit operation. We compared 2017 to a similar late spring chinook return of 2006, which was still considerable more fish. There was no noticeable difference during that period (Apr23 – May2). However, due to the extremely low passage numbers, it would be difficult to identify passage delay. The log graph was an attempt to show the low numbers better in graph form.
