MEMORANDUM FOR THE RECORD –**SUBJECT: 17TDA28 East Fish way dewater lamprey mortality**

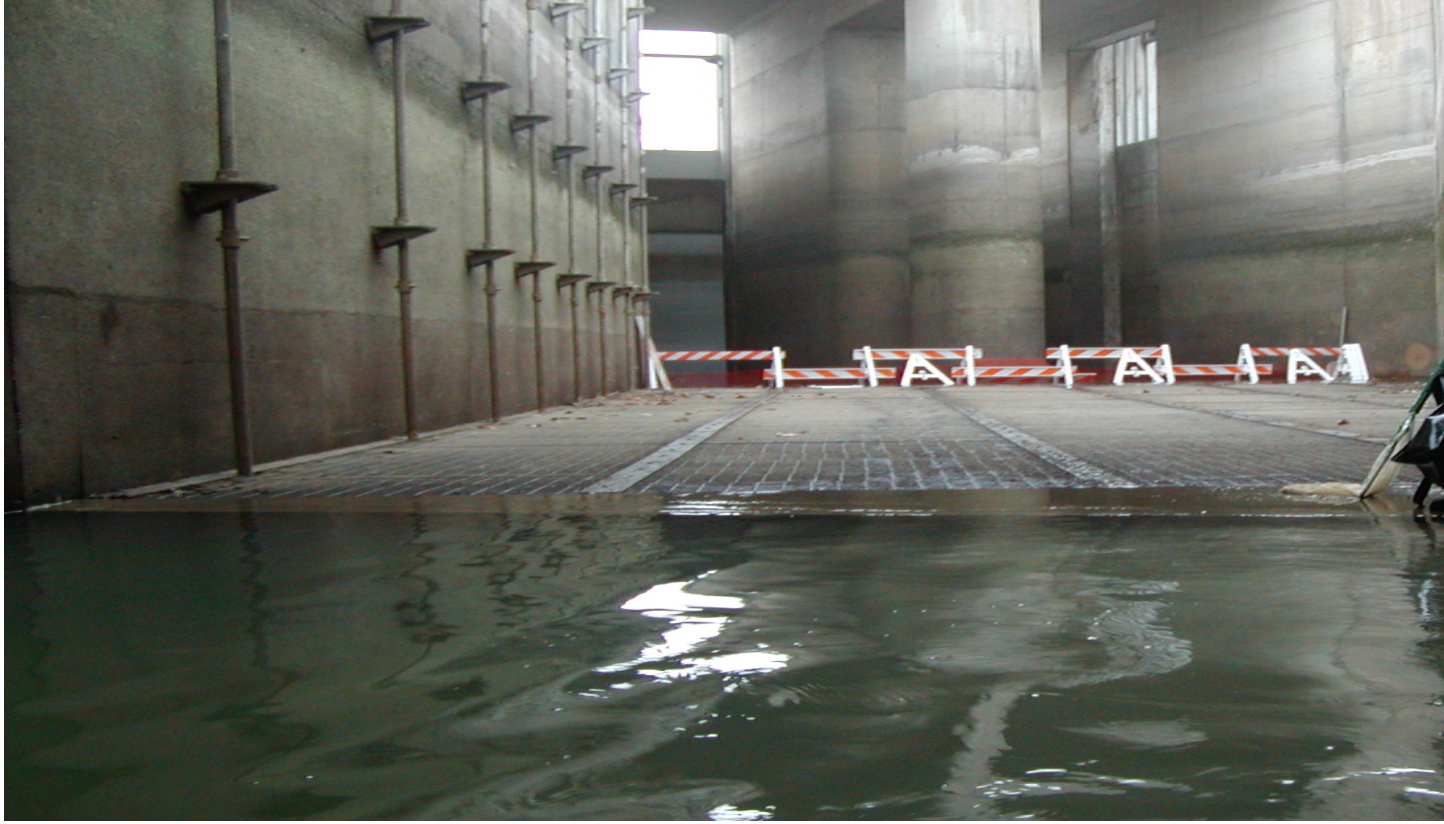
The east fish ladder was dewatered on 1 December. The associated channels and entrances were dewatered below tail water on 3 December. Approximately 90 lamprey were removed from various locations throughout the fish way and released to river. Five lamprey were observed under the diffuser grating near the south fish way entrance in an area that could not be readily accessed. An approximate 2” gap was noticed at the upstream end of the diffuser chamber where it meets the wall. Maintenance notified for corrective action, which will likely involve steel plate to close gap.

The gap is located under dip net and not visible in this picture. Lamprey were observed under grating near diffuser valve wall stems.

- A. Species – 8 Pacific Lamprey mortalities (*Entosphenus tridentatus*)
- B. Origin – unknown
- C. Length – unknown
- D. Marks and tags – unknown. None visible
- E. Marks and Injuries found on carcass – None
- F. Cause and Time of Death – stranding and pinching on Dec3
- G. Future and Preventative Measures – Close gap for access into diffuser chamber

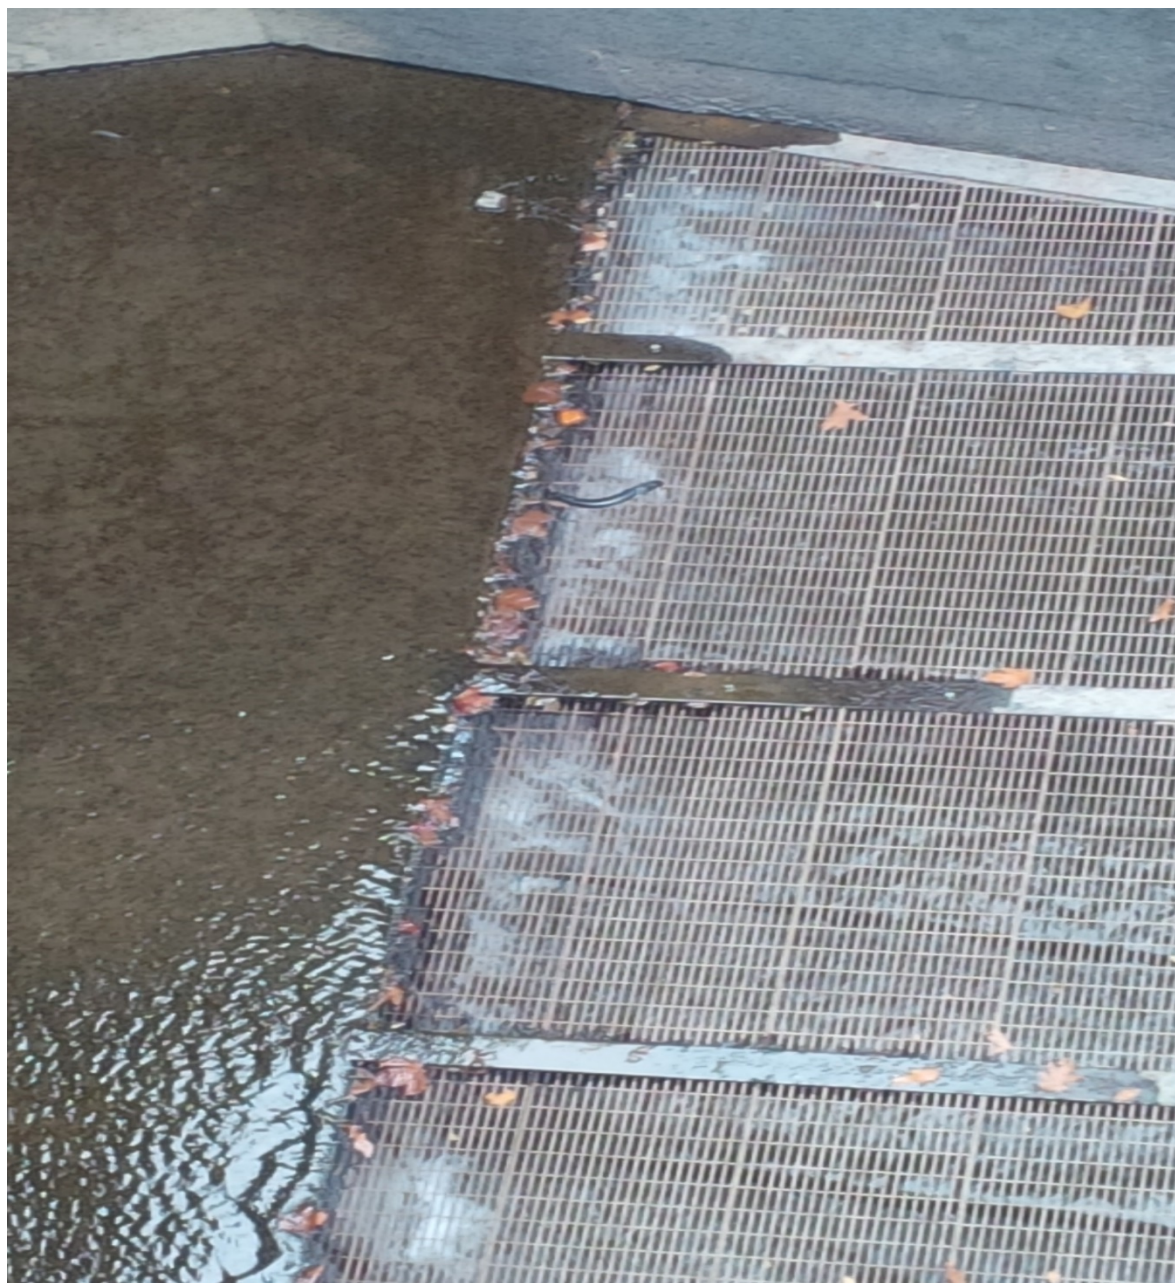
Update 12/20/17 - Two lamprey were discovered atop the south entrance grating and junction grating days following the dewatering. It could not be determined where they come from.

One of two lamprey found on the grating days later.
