MEMORANDUM FOR THE RECORD**SUBJECT: 18TDA08 - Lamprey mortalities at E2 & E3 weirs**

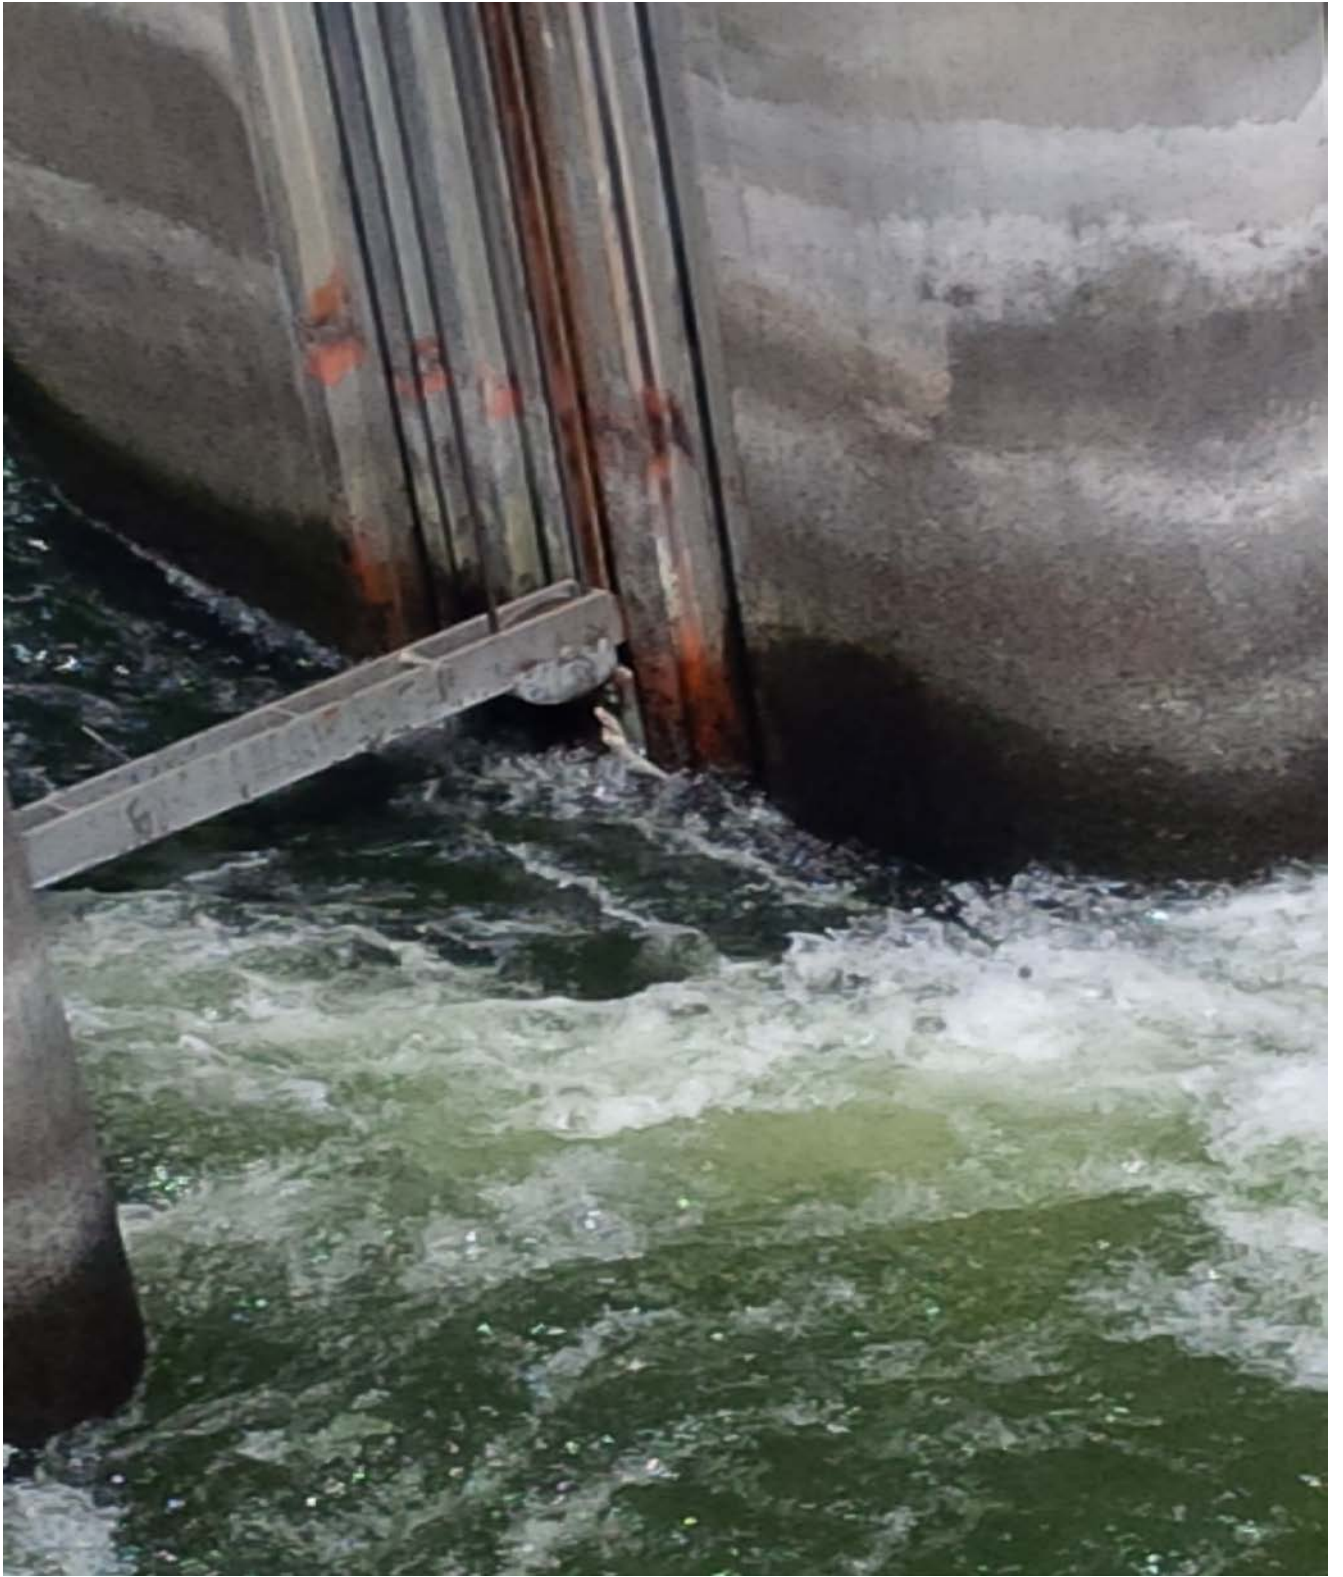
During a fishway inspection, adult lamprey were noticed impinged on the lift mechanisms of east entrance weirs. Weir E3 had 3 and weir E2 had 2 mortalities. This impingement was also observed last year during an annual ROV inspection in early August. Point of entry into the guide slot was not apparent. These weirs could not be pulled last winter due to the AWS construction activity. The plan is to pull these weirs next winter for the lamprey weir cap installation. The entire system will be closely inspected at that time.

- A. Species – Pacific Lamprey (*Entosphenus tridentatus*).
- B. Origin – Unknown.
- C. Length – Unknown.
- D. Marks and tags – Unknown.
- E. Marks and Injuries found on carcass – See photo
- F. Cause and Time of Death – The lamprey were pinched between the weir and guide.
- G. Future and Preventative Measures – The project will be installing the weir caps this winter (2018/19).
