**MEMORANDUM FOR THE RECORD****SUBJECT: 18TDA13 MFR East Fishway Dewatering CH and PL Mortalities**

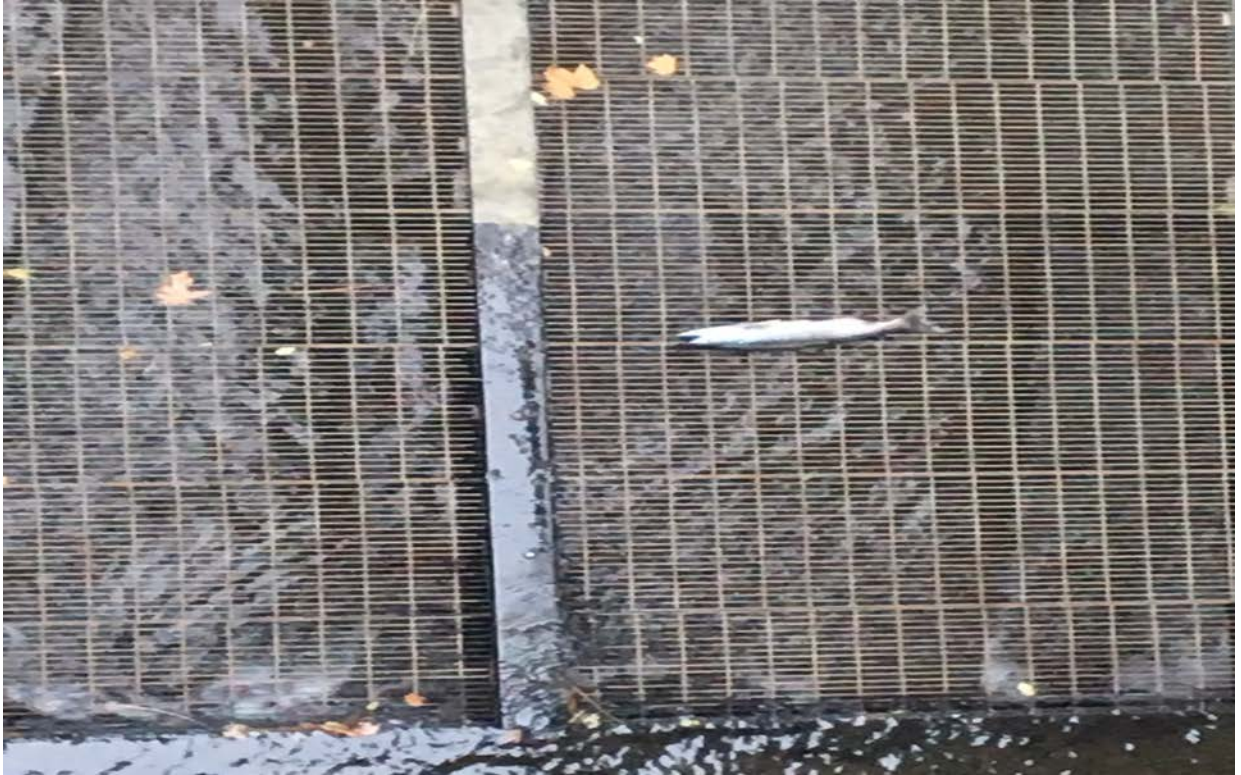
The east fish ladder was dewatered for annual maintenance on 03 December. The lower sections were dewatered below tail water on 06 December. Fourteen Salmonids, 47 Lamprey, 12 sturgeon, hundreds of shad/miscellaneous fish and one unhappy beaver were removed and released to river. After the initial fish salvage, a second walkthrough was done to recover anything missed, usually lamprey hiding in the rocky areas. Days following the dewatering, one Chinook and four lamprey mortalities were discovered. Two of the lamprey were on top of the grating in the lower ladder, which likely came out of the diffuser chambers. The chinook and other two lamprey were found on top of the grating at the south entrance. This area has been prone to fish mortality in the past. Multiple runs were made through it to remove all fish, but the water depth (~3.5') makes it difficult. Bulkhead leakage creates a problem for dewatering this area. Visibility is limited. Anchors were installed last year for a barricade to keep salmonids in the pool, which was thought to remedy the problem. No apparent gaps were seen in the barricade; it is assumed that the Chinook jumped over the top of the barricade. Preventative solutions will continue to be implemented until this problem is resolved.

- A. Species – Chinook and Lamprey
- B. Origin – unknown
- C. Length – Chinook was ~22"
- D. Marks and tags – None
- E. Marks and Injuries found on carcass – None
- F. Cause and Time of Death – Stranding
- G. Future and Preventative Measures – Determine better method for removal and/or containment
