## CENWP-OD-D

## MEMORANDUM FOR THE RECORD

## SUBJECT: 20TDA01 Fish Unit Trash rack Gaps

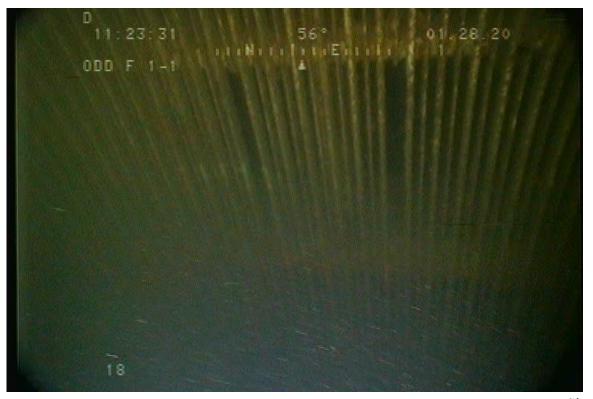
An ROV inspection of the powerhouse trashracks was conducted on Jan 28, 2020. Two vanes on trashrack F1-1 were found missing. These missing vanes increases the gap size from 7/8" to 2" in ~2'. The gap is approximately 20' from forebay surface. Small adult salmonids can feasibly enter this size gap.

It is determined a non-emergency repair for the following reasons: -fish need to pass by an entire powerhouse of 6" intake gaps on main units -attraction flow into a main unit is far greater than into a fish unit (13kcfs vs 2.5kcfs) -unit 1 has sluiceway open resulting in 2.5K attraction -studies revealed that the sluiceway passes 95% of adult size fish vs turbine units -out of time this season to take fish units off line for a repair

- A. Species small adult salmonids
- B. Origin NA
- C. Length short
- D. Marks and tags NA
- E. Marks and Injuries found on carcass NA
- F. Cause and Time of Death NA
- G. Future and Preventative Measures Repairs will be made on during the winter of 2020/21.
