Pacific States Marine Fisheries Commission
2325 River Road, #4
The Dalles, OR 97058

Memo

Re: Dewatering structure dewatering for annual outage.

Date: January 11, 2022

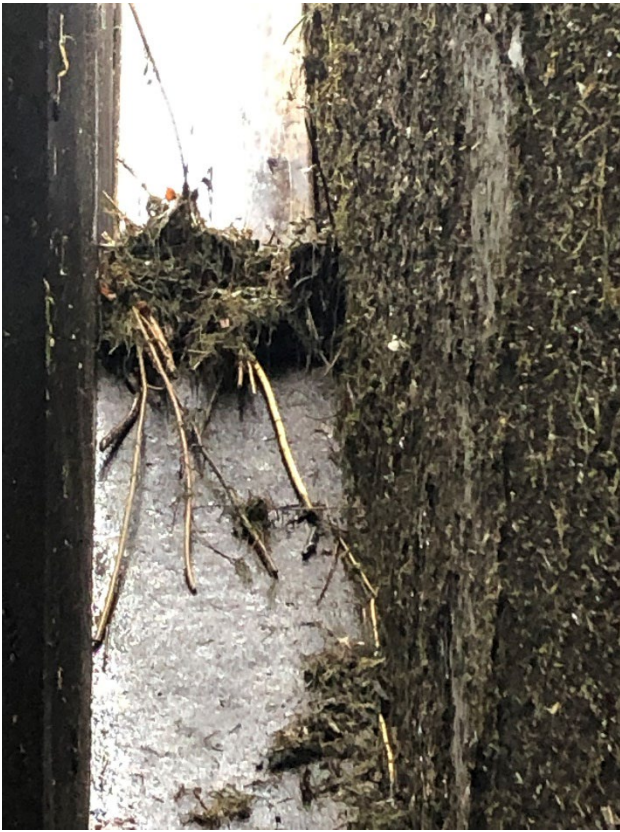
The photos below depict the debris accumulation, mostly grasses and beaver sticks. Obviously, if the exit is closed the debris is going to occlude the dewatering screens, especially at the downstream end, as shown in the pictures.

Debris accumulation at top of inclined floor, dewatering structure exit.

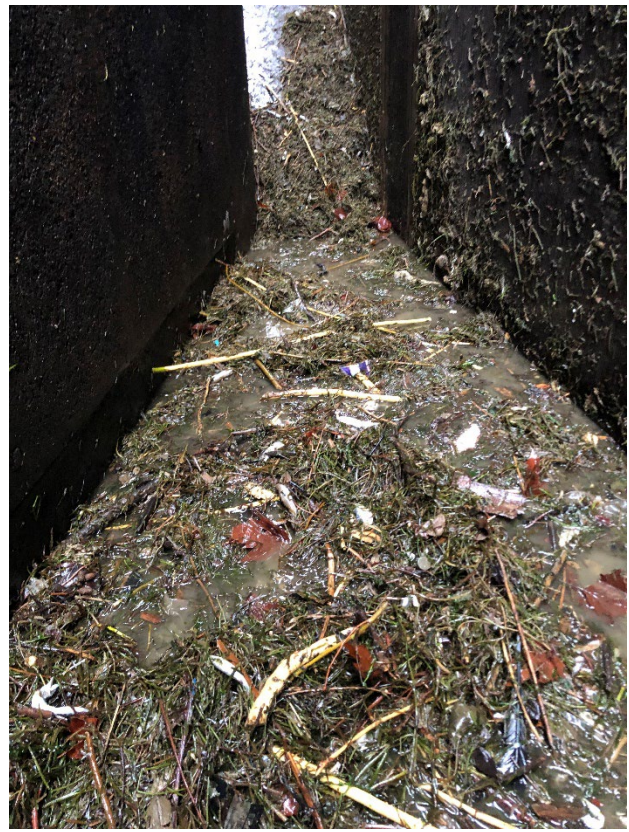
Debris and dead shad on floor at down stream end of dewatering structure.

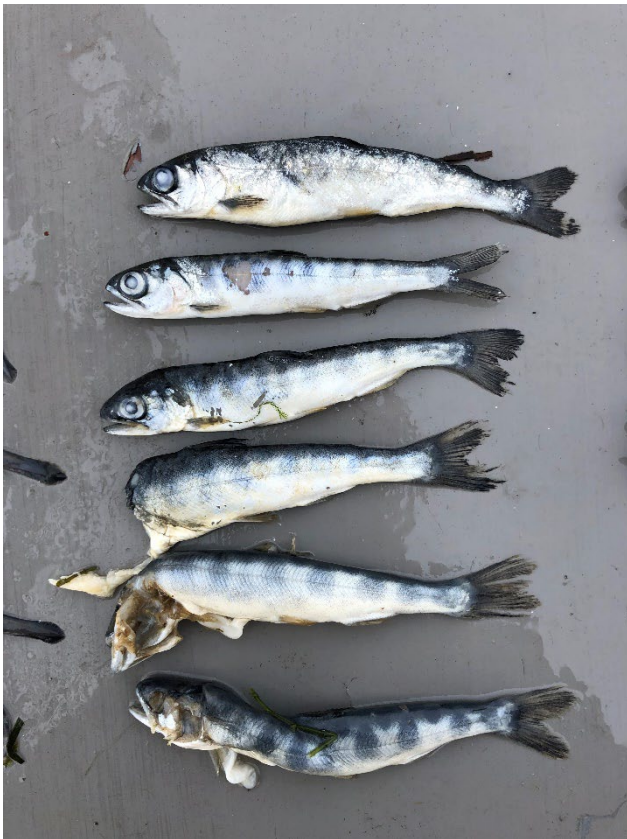
The morts in photo 1 are older and likely entered the dewatering structure some time ago. The morts in photo 2 are quite recent and may have been alive when the structure was dewatered, except for the fish at the bottom of the picture, it should have been lumped with the old morts. If the fish are stranded in an area with standing water (up to 1" in places) they can survive but if they are stranded in less water than that they likely will not survive unless the rescue effort is started immediately.

Photo 1. Older Chinook morts.

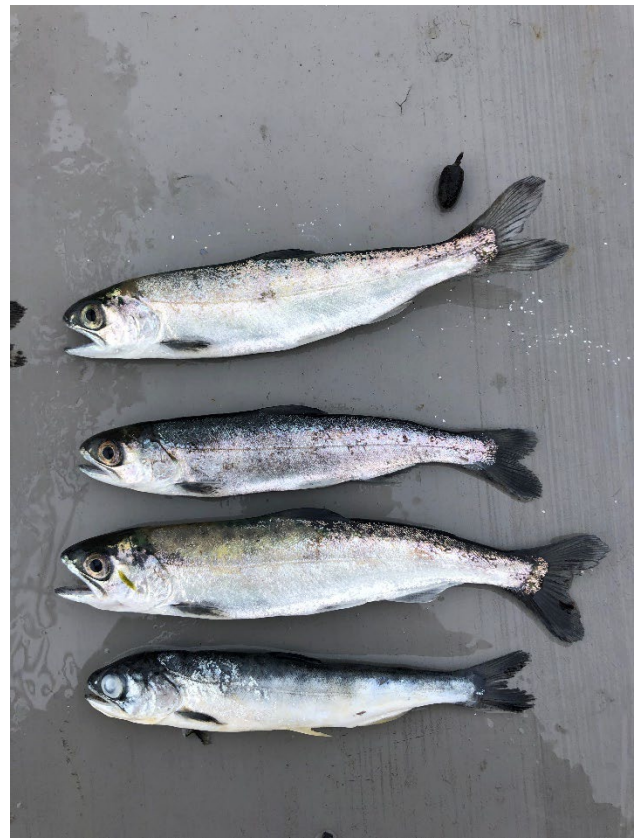
Photo 2. Fresh or more recent morts.

This year the rescue effort started about 2 – 2.5 hours after the structure was dewatered. This delay will be reduced as much as possible in future years.

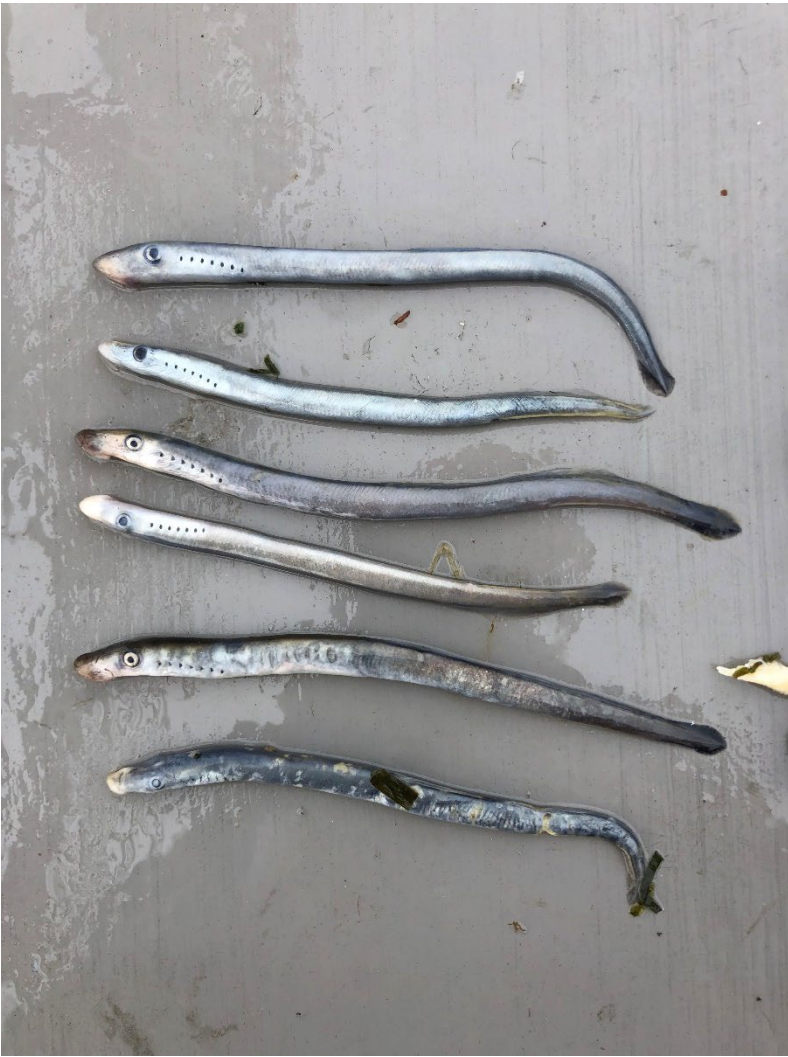
Photo 3. Pacific lamprey *macrophthalmia* morts.
