**MEMORANDUM FOR THE RECORD 22TDA04 MFR Wasco PUD test results**

***SUBJECT: Biological testing of bypass leg of switch gate at the new sampling facility being built at the PUD facility on the north shore of The Dalles Dam.***

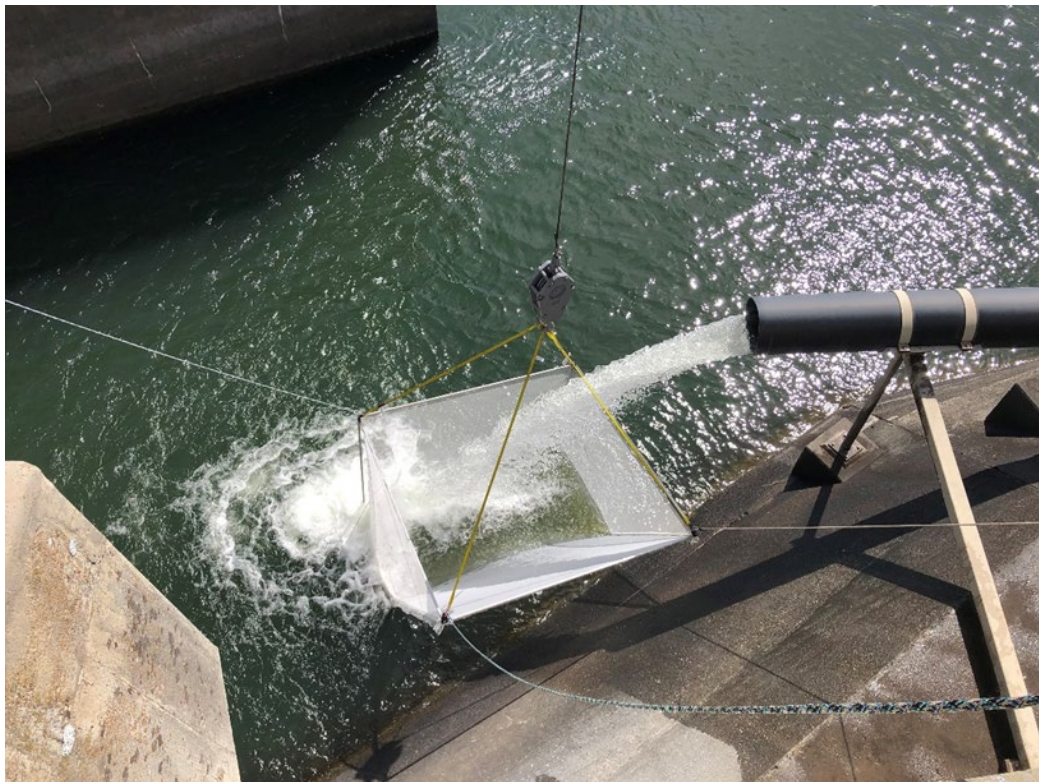
Positioning the net pen seemed to get increasingly difficult as we progressed with the testing. Bypass pipe discharge pushing the net pen around necessitated that the bypass pipe discharge be turned off for replicates 3 and 4. Also, the wind picked up as testing progressed and may have been a factor in the increasing difficulty of positioning the net pen. It is also possible that bypass pipe discharge increased. The dewatering structure weir gate is programmed to close if the unit is shut down so the discharge volume had to be "manually" set and measured with a tape measure. This was challenging and may have resulted in more water discharging from the bypass pipe than if the system had been in "auto".

Net pen improperly positioned under bypass discharge, too far out of the water. This problem increased as testing progressed, lowering the net resulted in it being pushed around out of position. Slings that were too short also made it difficult to position it as far into the water as desired.
