MEMORANDUM FOR THE RECORD 22TDA06**SUBJECT: East fishladder exit weir 155 failure**

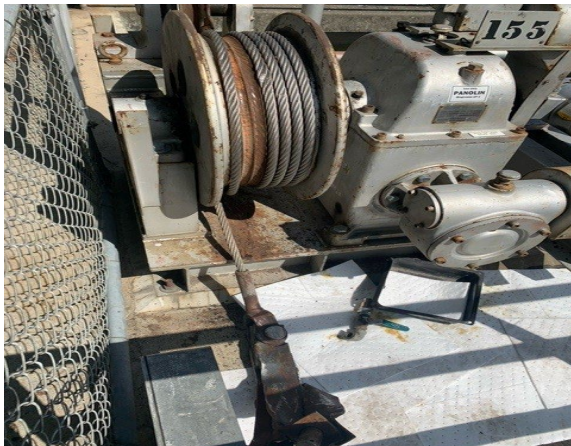
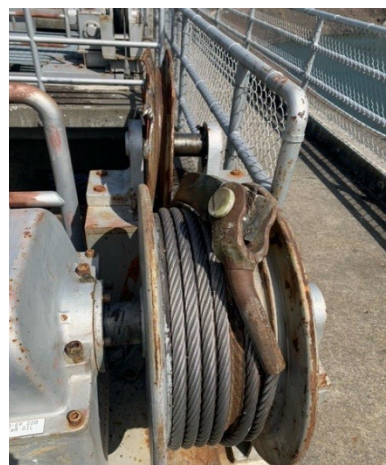
East ladder exit weir 155 failed. This is 1 of 4 weirs that are used for adjusting flow through the range of forebay elevations. The cause of failure is being investigated. The weir raised through its upper limits, pulling the weir attachment onto the drum. The hoist cables broke causing the weir to fall to the seated position. Its gearbox also failed resulting in approximately 1/2 gallon of gear oil to enter the fishway which was not recoverable. The weir is now stuck in the seated position. Criteria operation per Fish Passage Plan cannot be maintained at forebay less than 157.5'. A forebay restriction has been requested. A plan for repair will be made, but it is likely 155 will remain in this position through the remainder of the passage season.

- A. Species –All salmonids passage
- B. Origin –NA
- C. Length –NA
- D. Marks and tags –NA
- E. Marks and Injuries found on carcass –NA
- F. Cause and Time of Death –NA
- G. Future and Preventative Measures –Determine cause of failure and repair when possible.
This will take priority over other planned fish improvements.
