MEMORANDUM FOR THE RECORD

SUBJECT: 24TDA02 North Fishladder Rockfall

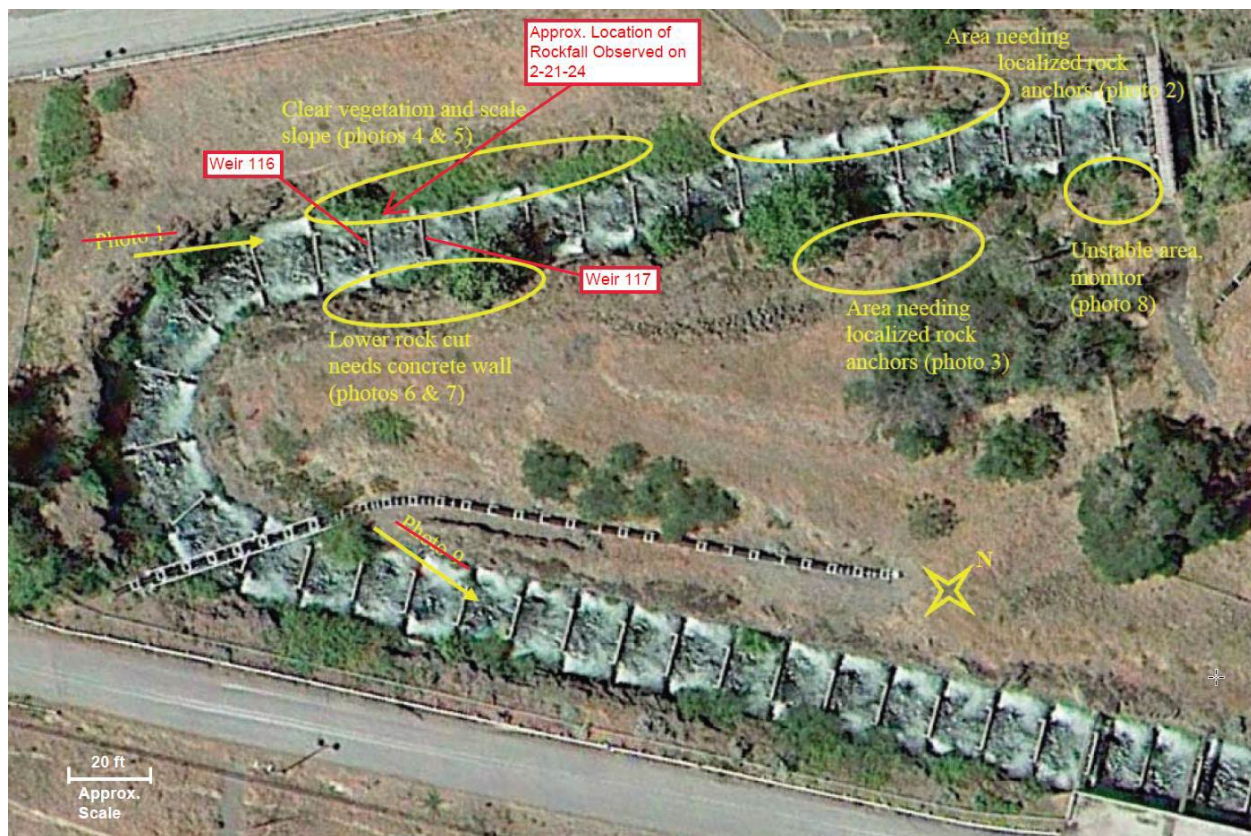
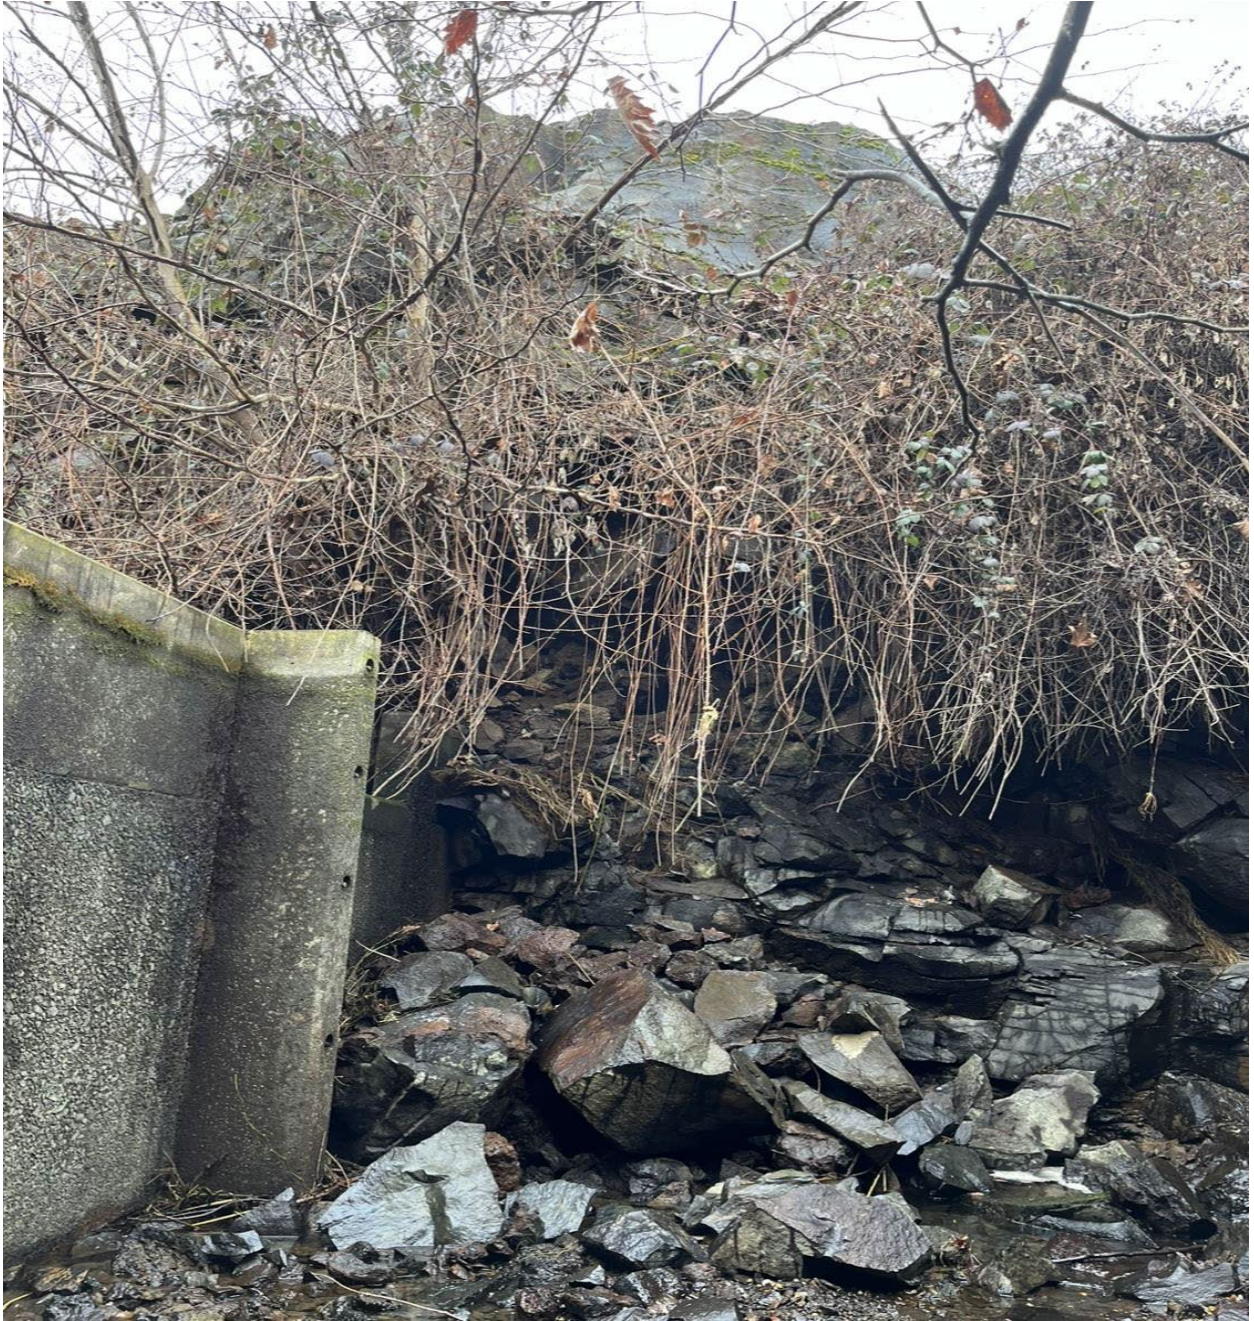
The Dalles north fishladder was dewatered mid-February for annual maintenance. A section of rock from the basalt wall sloughed onto the fish ladder floor, blocking 1 of 2 weir orifices. Work in this area was discontinued due to safety concerns. Geotech staff was involved in evaluating this area and provided a report. In summary 'Further sloughing of rocks pose as a significant safety risk to personnel or cause further blockage to the weir opening'.

Due to these safety concerns, future annual dewatering and maintenance will be impacted until stabilization and repair are completed.
