## **CENWW-ODD**

## MEMORANDUM FOR THE RECORD: 22 DWR 01

## SUBJECT: Dworshak Dam Operation December 21 and 27, 2021

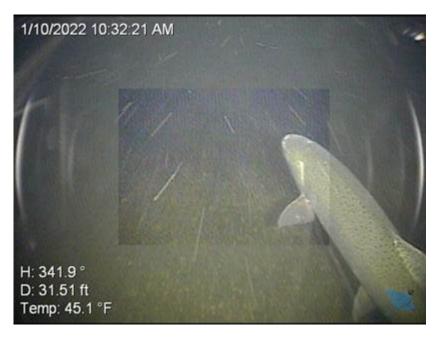
An ROV inspection of DWR unit 3 draftube was conducted January 11, 2022 with USACE Biologist Elizabeth Holdren and NPT Biologist Sherman Sprague observing. There was a significant amount of unexpected flow in the draftube and no fish mortalities were observed, although at least one live steelhead was observed swimming in the draftube. There was 4+ mortalities observed in the tailrace downstream of the powerhouse between the Unit 2 outflow and the spillway wall (see photos). Corps Biologists will be monitoring the Dworshak tailrace when Unit 3 is returned to service January 19 in hopes to gain information on what may have occurred during the December operations.

Photo 1. Live Steelhead in DWR Unit 3 draftube.

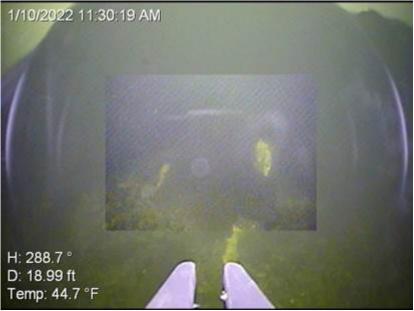
Photo 4. Fish mortalities in the tailrace downstream of DWR Unit 3.

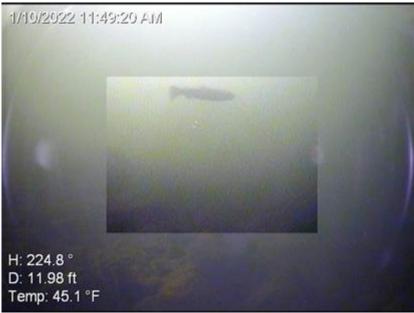
Photo 5. Live Steelhead swimming in the tailrace. There were several in the location.
