MEMORANDUM FOR THE RECORD: 16 IHR 006 – Spill gate 2 closure

SUBJECT: Ice Harbor spill gate 2 closed briefly to troubleshoot turbulent flow conditions through RSW

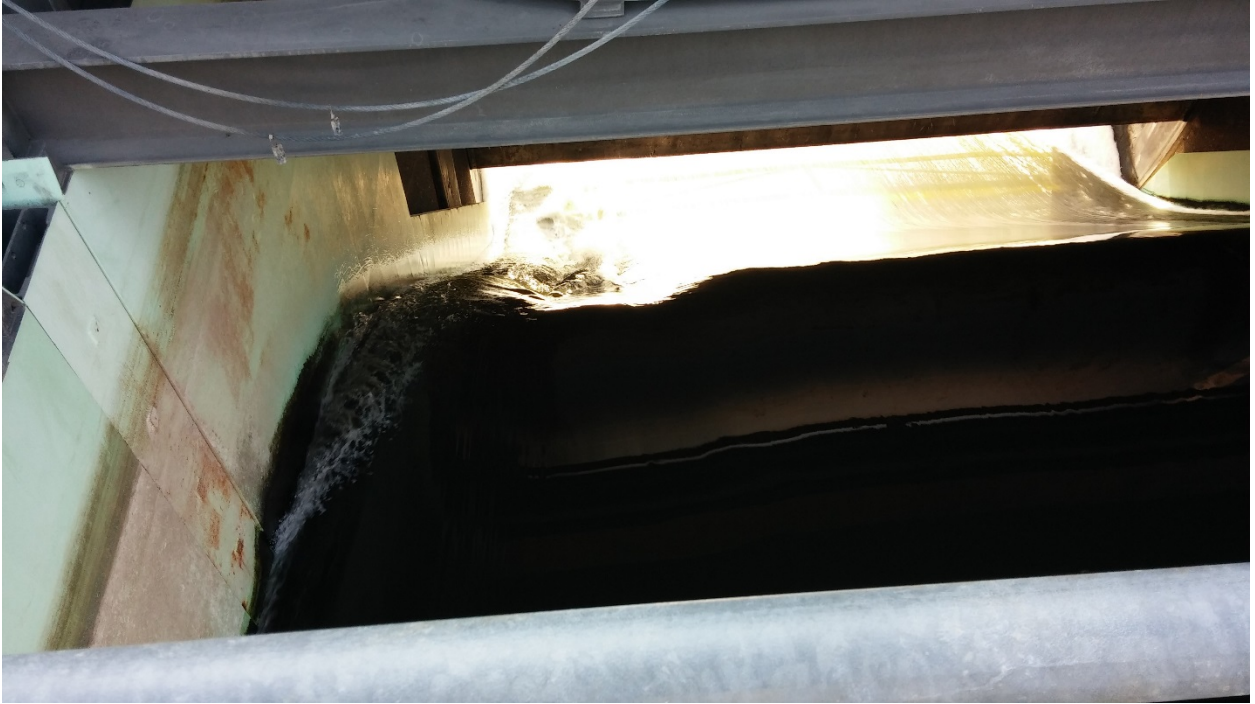
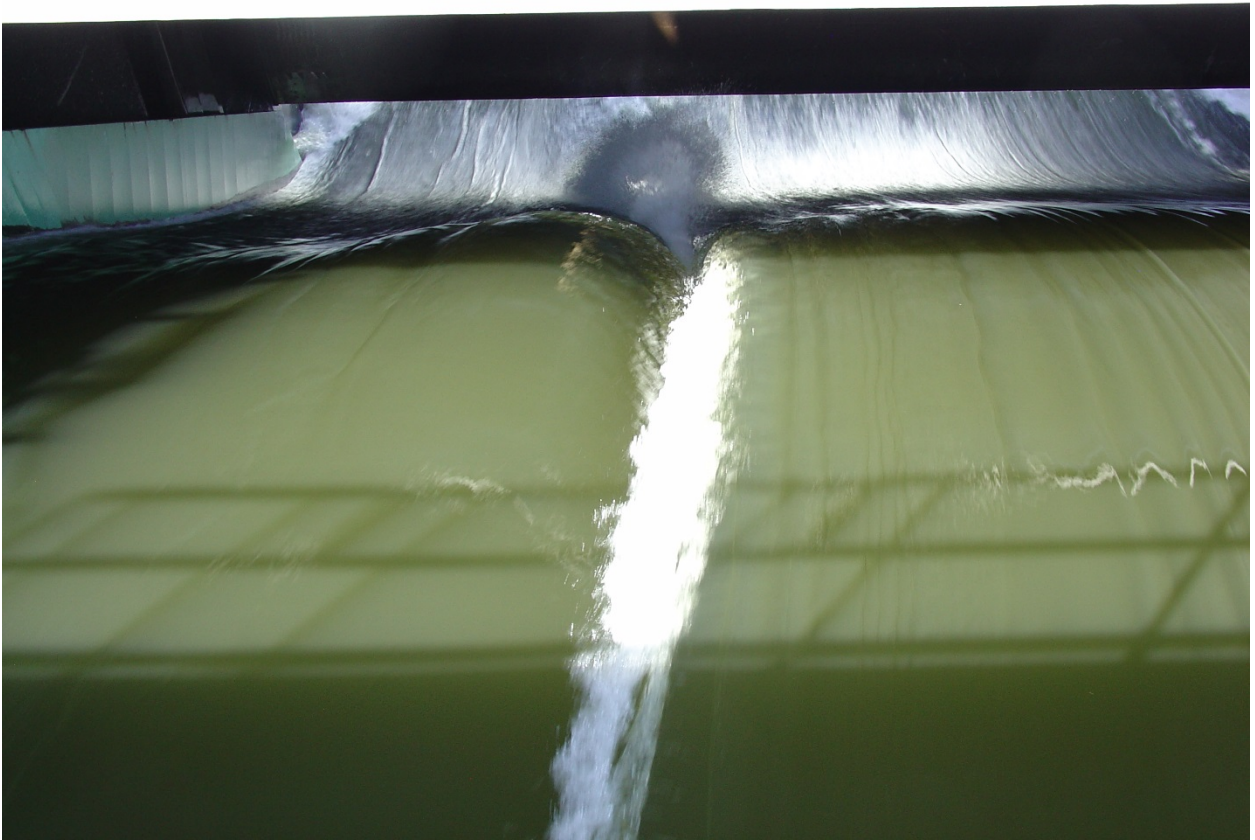
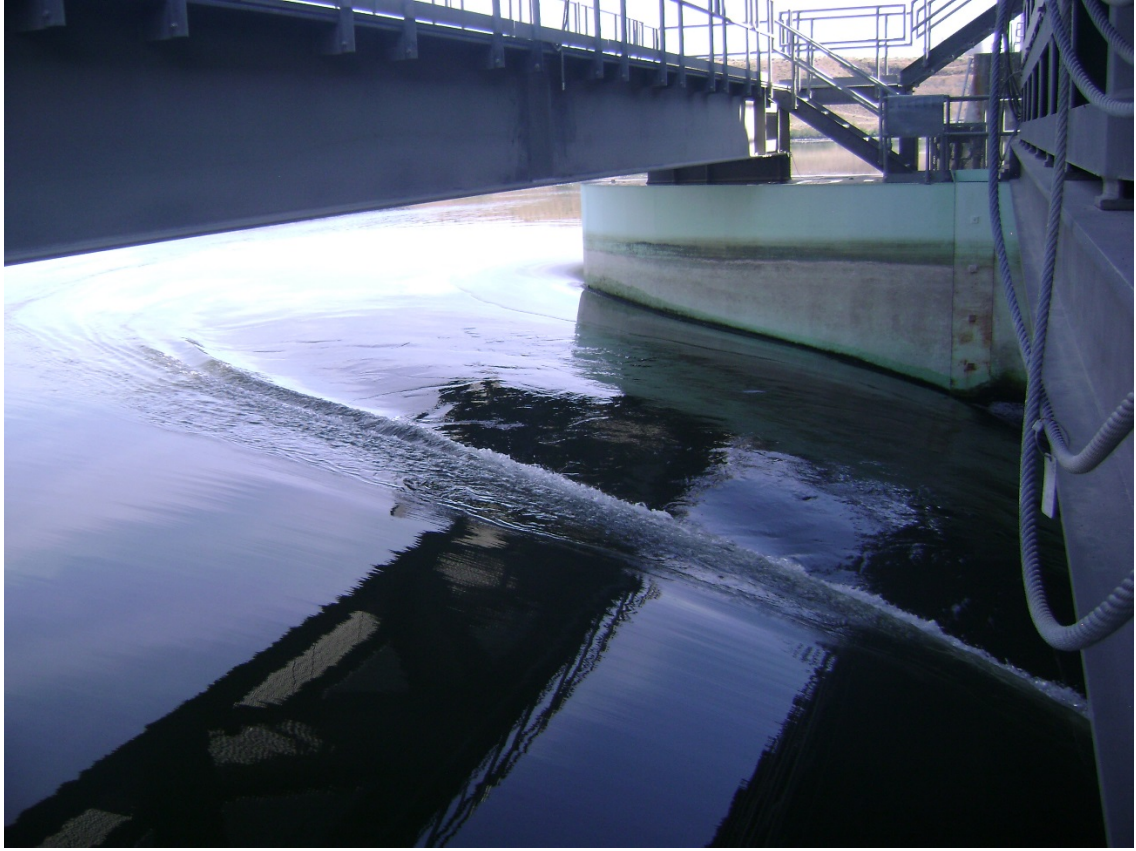
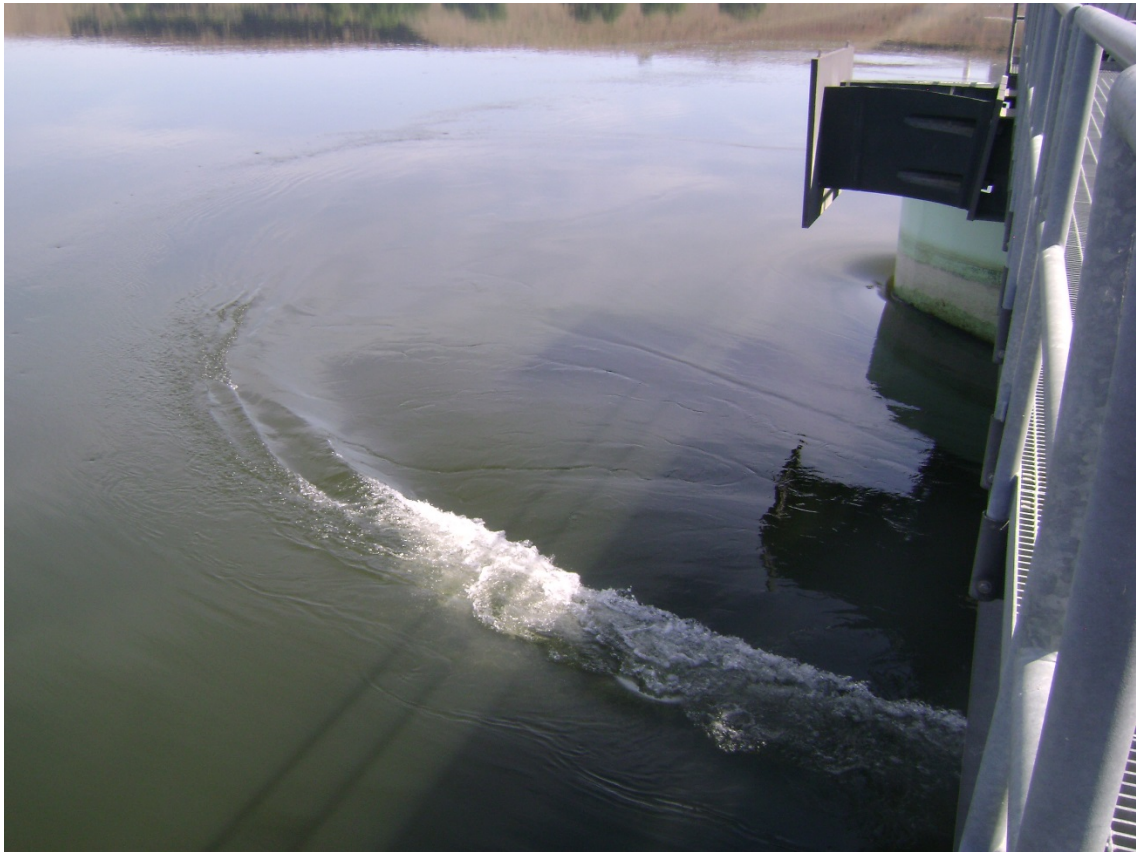
At the end of the day on May 16, 2016, project personnel observed that the river flow down the RSW chute in spill bay 2 looked turbulent and the flow profile was not smooth and even across the chute. A well-defined v-shaped furrow or “seam” was observed on the surface of the water, approximately 6-8’ out from the south wall of the RSW (see first photo below). Water was spraying 4-5’ up into the air adjacent to the lower south RSW wall. A school of fish were observed being sprayed up from the seam and striking the wall near the top. Project personnel speculated that debris may have been caught in the RSW transition plate or a loose plate may have been causing the seam to form. If debris were stuck in the plate could, it could possibly be dislodged by closing the spill bay 2 tainter gate and then re-opening. In an attempt to remove any stuck debris and maintain safe fish passage conditions, the project completely closed spill gate 2 from 1010 hours to 1014 hours on May 17. During that time, the flow going through each of the other spill bays was not altered. Upon re-opening the gate, the seam quickly re-formed (second photo below) as the gate finished opening. Upon further observation over the course of an hour on May 17, the seam repeated lessened and strengthened, with the splashing occurring when the seam was more pronounced. The seam also moved laterally along the chute, or disappeared and re-appeared in the middle or north side of the chute, or re-appeared as multiple small seams. The formation of the seam appeared to start in the forebay (third and fourth photos), appearing as a 90-foot long riffle or rip current coming in an arc from the southeast, with a vortex sometimes at the head of the rip current. These observations lead project personnel to believe that the seams were not caused by debris or a loose transition plate. River currents, wind, and project operations may have contributed to the formation of the rip currents and seams. Some project personnel recall periodically seeing seams of this magnitude in past years, while others do not. Personnel will continue to monitor the presence and severity of the rip currents and seams and make note of certain environmental conditions or project operations that may be contributing to its formation. Any further sightings of fish splashing out of the seams and hitting the walls will be noted in the weekly ESA report. Video was taken of the rip currents and seams for future reference.
