MEMORANDUM FOR THE RECORD: 17 IHR 002 – MFR UPDATED South shore AWS pumps turned off due to high tailwater. Updated March 21, 2017.

SUBJECT: Ice Harbor AWS pumps turned off to prevent flooding of the warehouse

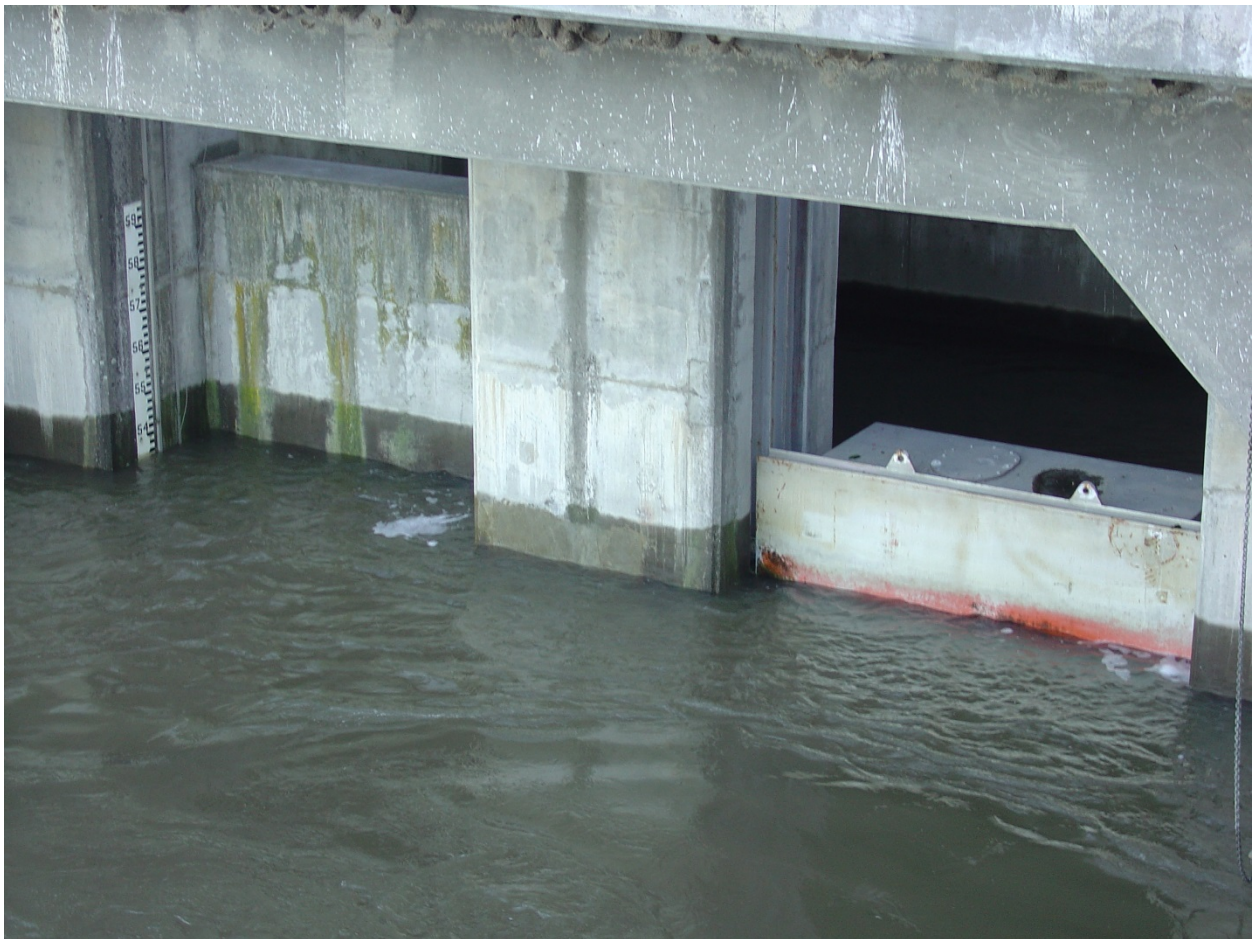
Figure 1. IHR operating floating orifice, sometimes referred to as a FOG (floating orifice gate).

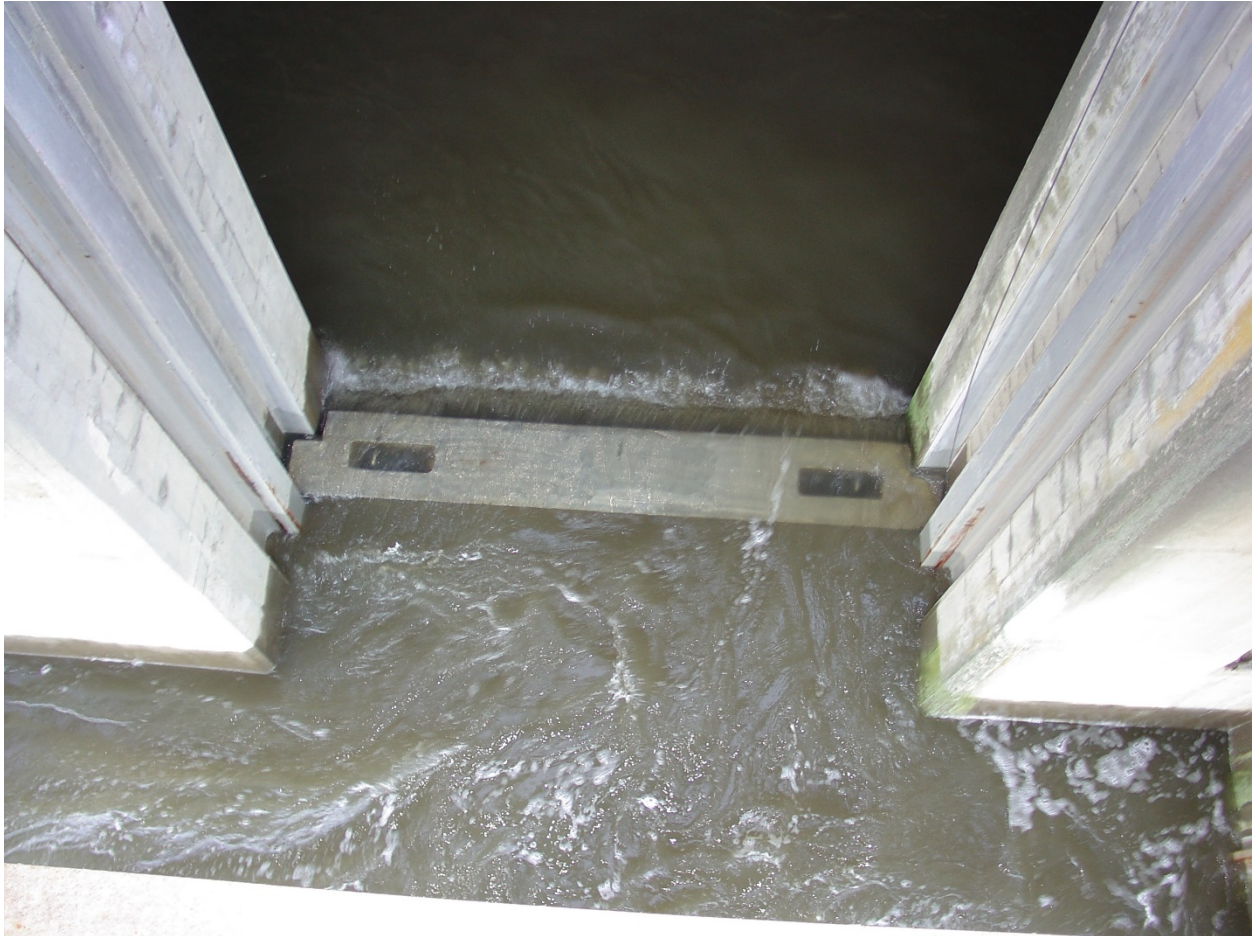
off the floating orifices with the high tailwater, project staff realized that they only have enough spare stop logs to close off one floating orifice. Also, as of this morning, tailwater elevations are about even with the top of stop logs of closed floating orifices (approximately 353.6'), as shown in the photo below. So the steps outlined in Sections 3.3.2.4.b and 3.3.2.4.c cannot be accomplished with current high tailwater conditions.

Figure 2. Tailrace overtopping closed floating orifice at Ice Harbor Dam.

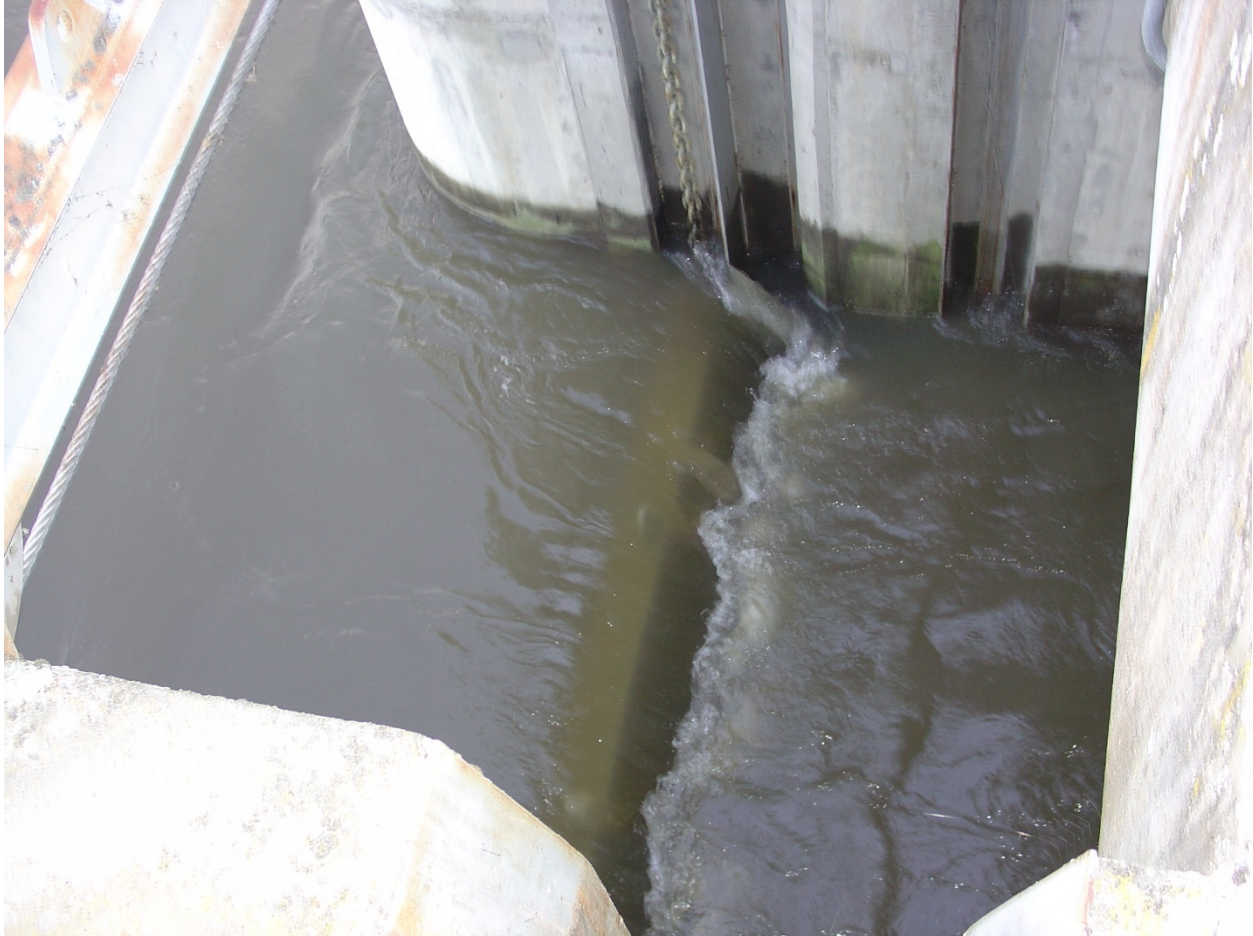
Section 3.3.2.4.d calls for the north powerhouse entrance weir gate (NFE-2) be closed and the adult fish channel be bulkheaded off at the junction pool, leaving only the south shore entrance (SSE-1) in operation. With high tailwater conditions and no south shore AWS pumps in service, the south shore tailwater level is approximately 0.5' higher than the south shore channel level, so water is flowing into SSE-1. As shown in the photo below, tailwater is also flowing into the fish ladder over the top of the adjacent closed SSE-2 weir gate, which is raised to its maximum height. Gravity flow of approximately 142 cfs is coming down the ladder from the ladder exit and upper diffuser. During normal operation, six south shore AWS pumps supply an additional 1,800 cfs to the bottom of the fish ladder to meet the channel/tailwater differential criteria of 1-2'. Walla Walla District hydrologists and the Hydrology & Hydraulics Branch Chief were consulted. Closure of the north powerhouse entrance weir gate (NFE-2) and bulkheading the

adult fish channel would not be sufficient to negate the -0.5 channel/tailwater differential nor provide sufficient flow through the entrance to bring the adult fishway entrance into criteria without the south shore auxiliary water supply pumps.

Figure 3. Tailrace overtopping closed fishway entrance SSE2 at Ice Harbor Dam.

Consequently, the project will not be carrying out the steps outlined in Section 3.3.2.4. During the period that the south shore AWS pumps are off, the south fish ladder will be out of FPP operating criteria. The north shore fish ladder is operating normally and meeting FPP criteria.
