**OFFICIAL COORDINATION REQUEST FOR
NON-ROUTINE OPERATIONS AND MAINTENANCE**

COORDINATION TITLE - 18 IHR 05 – Inspection of north fish ladder upper diffuser intake

COORDINATION DATE - July 19, 2018

PROJECT - Ice Harbor Dam

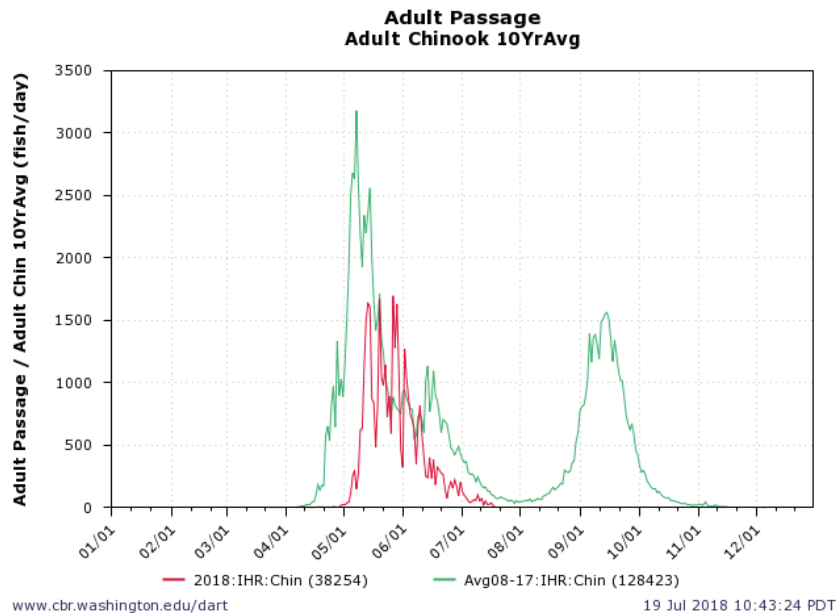
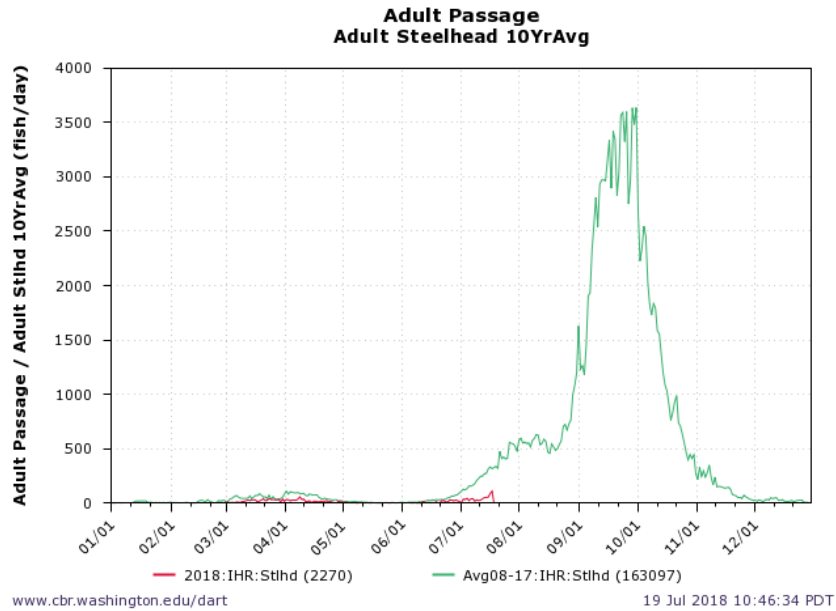
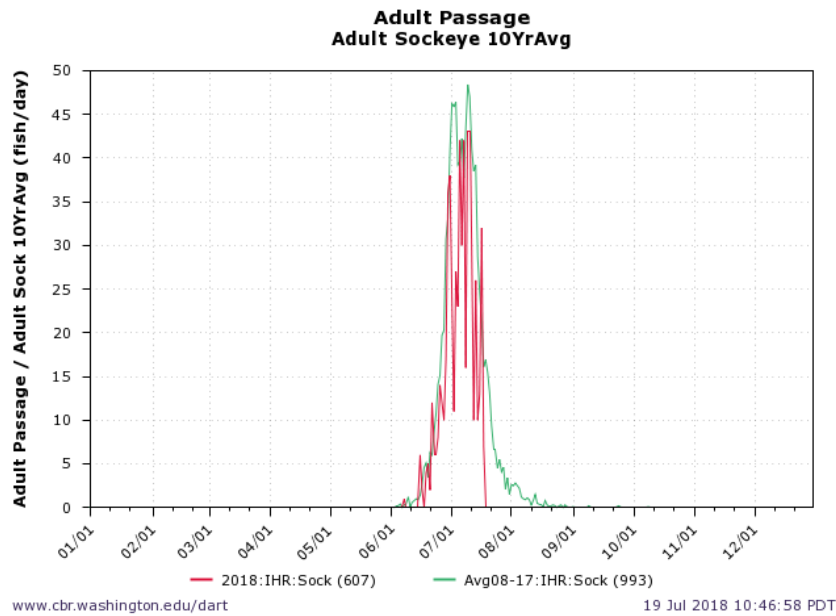
1. Number of adult Chinook salmon, steelhead and sockeye salmon expected use the north shore ladder on 30 July between 1200 and 1700 hrs is 13, 2, 0, based on the 10-year average.
2. 2018 Chinook salmon, steelhead and sockeye salmon runs are currently 45%, 26% and 69% of the 10-year average.
3. The percentage of the runs to be exposed to the outage will be less than 0.01% for Chinook salmon, steelhead and sockeye salmon, based on 10-yr averages.
4. Adult fish in the fishways at the time of outage may experience slight delay in passage times as they adjust to lower flow conditions. Few adult lamprey are actively migrating during daylight hours so no impacts are expected.
