MEMORANDUM FOR THE RECORD - 20 LGS 06 Direct Load Mortality

SUBJECT: Direct Loading Flume Mortalities

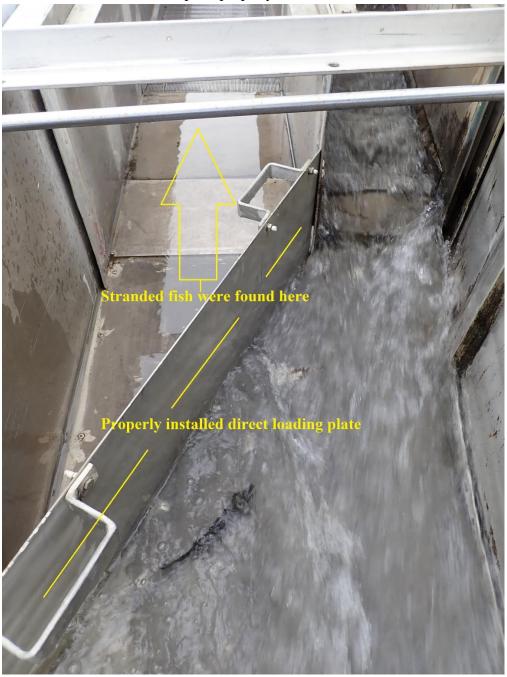
On May 17, Little Goose Juvenile Fish Facility staff found 80 juvenile salmon and steelhead mortalities in the raceway loading flume (Table 1). This particular portion of the flume only contains water while emptying raceways into a transport vessel. The plate preventing fish from swimming up the raceway loading flume while conducting direct loading operation was not properly installed after barge loading on May 16 (Picture 1).

Picture 1: Direct load flume plate properly installed.

- A. Species Chinook salmon *Oncorhynchus tshawytscha*, Steelhead *O. mykiss*, Sockeye salmon *O. nerka* and Coho salmon *O. kisutch*.
- B. Origin Hatchery and Wild
- C. Length N/A
- D. Marks and tags All fish were examined for PIT tags. Of the 80 fish, 2 were marked with PIT tags (Table 1).
- E. Marks and Injuries found on carcasses N/A
- F. Cause and Time of Death Improper installation of flume plate on May 16.
- G. Future and Preventative Measures Project staff are drafting an SOP for proper installation of the flume plate and all staff will be retrained on flume operation.
