MEMORANDUM FOR THE RECORD – 20 LGS 14-6C2 Orifice Liner

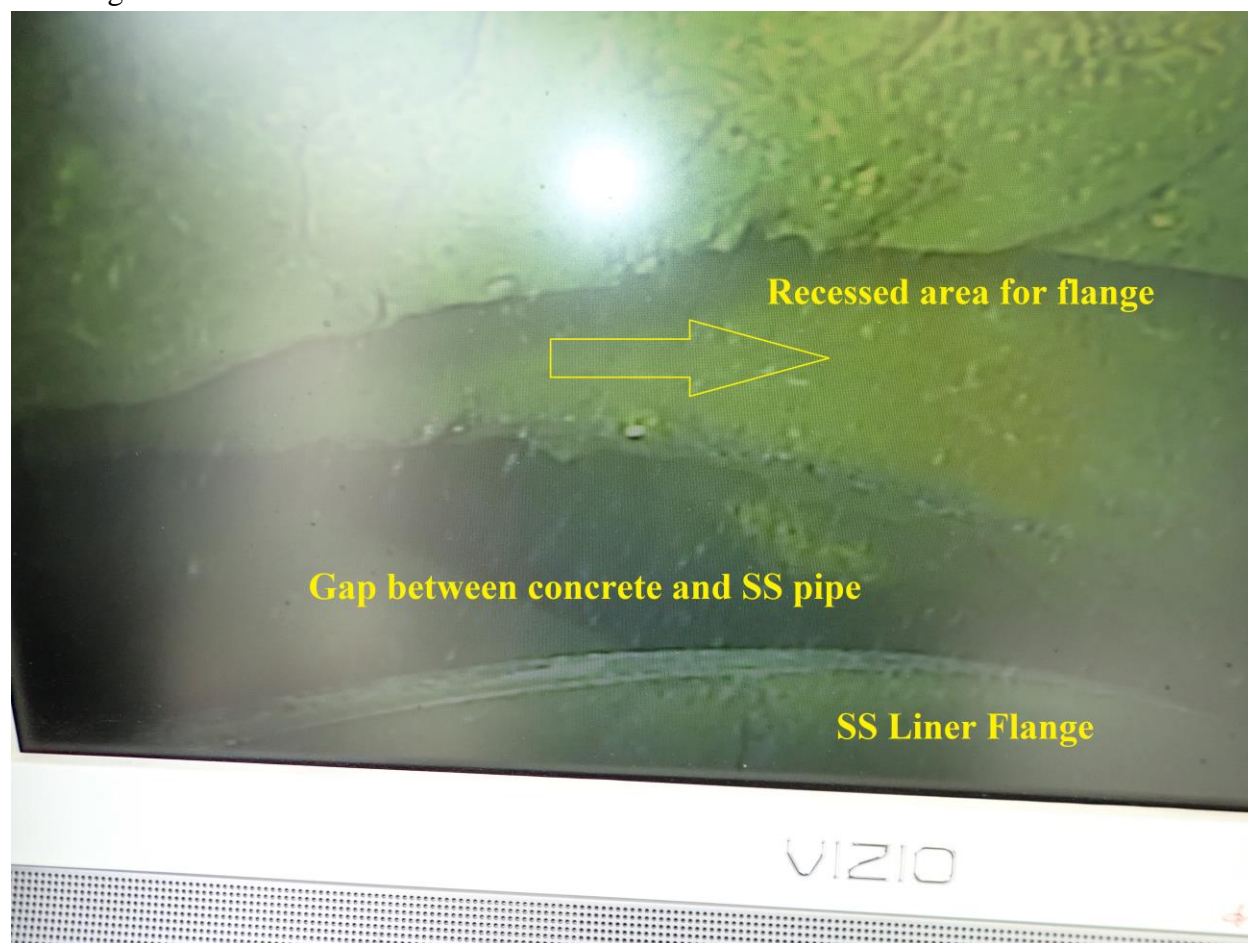
SUBJECT: During ESBS/VBS inspections on July 9, the orifice liner for 6C2 was found detached from the gatewell cement wall (Picture 1). VBS screens and orifices were last inspected via underwater camera on June 8 and no issues were observed. Each orifice at Little Goose, except 1A1, consists of an 18” diameter hole in the concrete protruding from the gatewell slot to the juvenile collection channel. A 16” diameter steel pipe is grouted inside the opening with the 12” diameter stainless steel pipe mounted inside. The 12” diameter pipe, or liner, is the pipe that fish actually pass through when moving from the gatewell into the juvenile channel (Picture 2). This pipe has a flange on the gatewell side which is bolted onto the concrete (Picture 3 & 4). This pipe is extremely smooth and when properly mounted with the flange, prevents fish from striking any portion of the gate valve when entering the juvenile collection channel.

Little Goose staff have determined that in order to properly reattach the 12” diameter pipe, both the gatewell and the juvenile channel will need to be dewatered. The work will likely take at least a full day. Since orifices in operating Units with ESBS screens installed cannot be closed for more than 5 hours, the work cannot be performed during the fish passage season (Fish Passage Plan, Chapter 8, 2.3.2.4.).

Picture 1: Photo taken from gatewell looking toward the juvenile channel. You can see the top of the 12" diameter pipe flange, the gap between the flange and 16" pipe and the recessed area the flange bolts into.

Little Goose has shut Orifice 6C2 and plans to keep it shut until repairs are made during the winter maintenance period. Orifice 6C1 remains fully operational and will be monitored and backflushed during routine inspections. This will allow Little Goose to operate the one required orifice per gatewell (Fish Passage Plan, Chapter 8, 2.3.2.4.) Additionally, Unit 6 will likely not operate very frequently as river flows are dropping and will continue to do so through late summer.

- A. Species – N/A
- B. Origin – N/A
- C. Length – N/A
- D. Marks and tags – N/A
- E. Marks and Injuries found on carcass – N/A
- F. Cause and Time of Death – N/A
- G. Future and Preventative Measures – Little Goose staff plan to leave orifice 6C2 closed for the remainder of the year. Staff will continue to monitor orifices during mandatory ESBS/VBS camera inspections. More thorough inspections may be conducted during winter maintenance.
- H. Pictures – See pictures below.

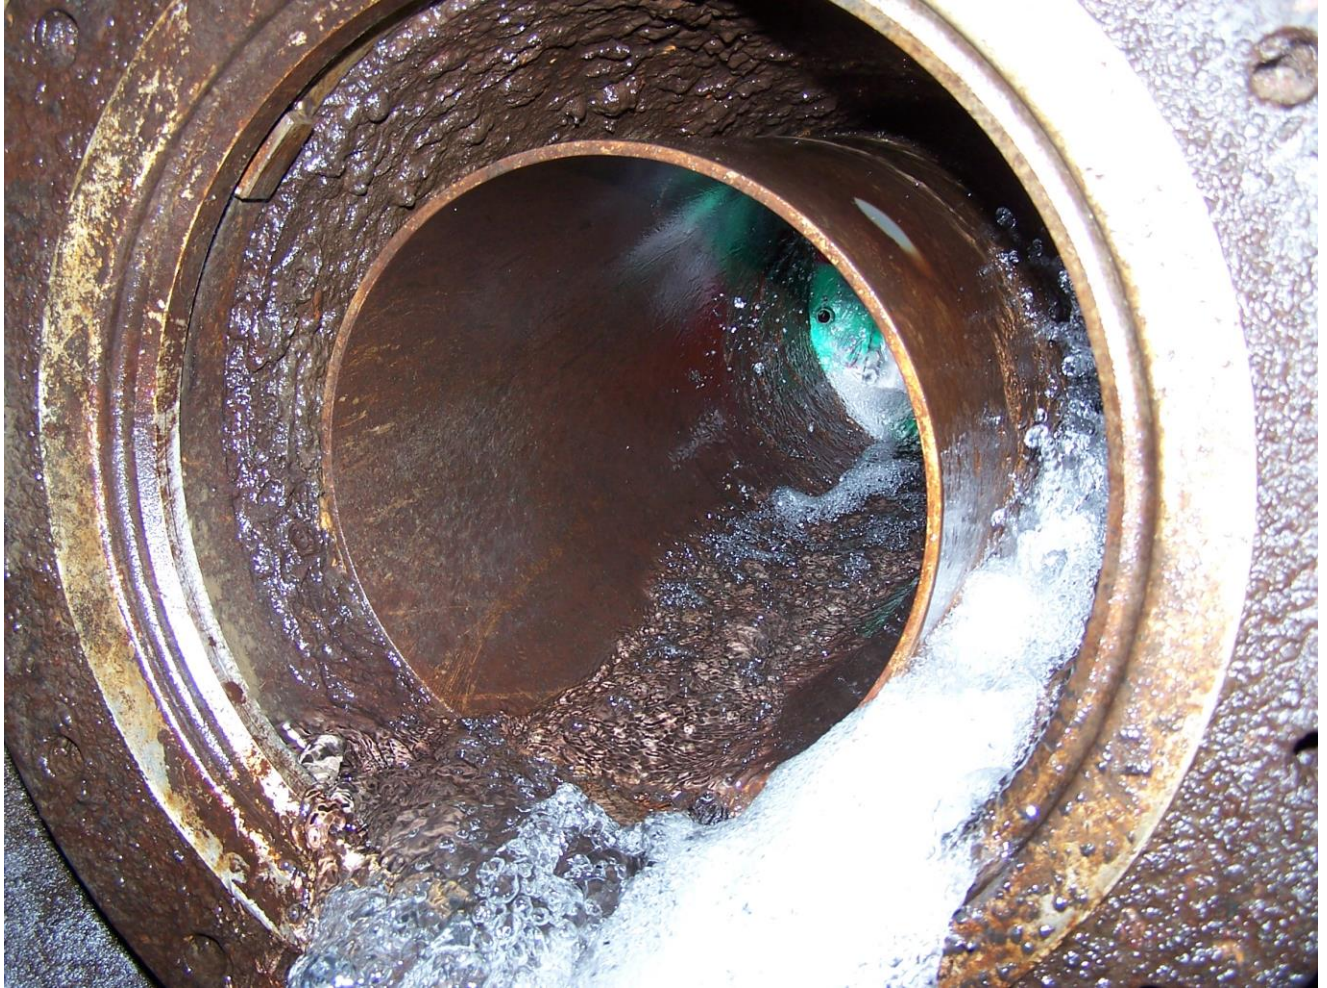
Picture 2: Photo taken looking from the juvenile channel looking toward the gatewell on an unknown orifice from a previous year inspection. You can see the 12" stainless steel liner inside the corroded 16" pipe.

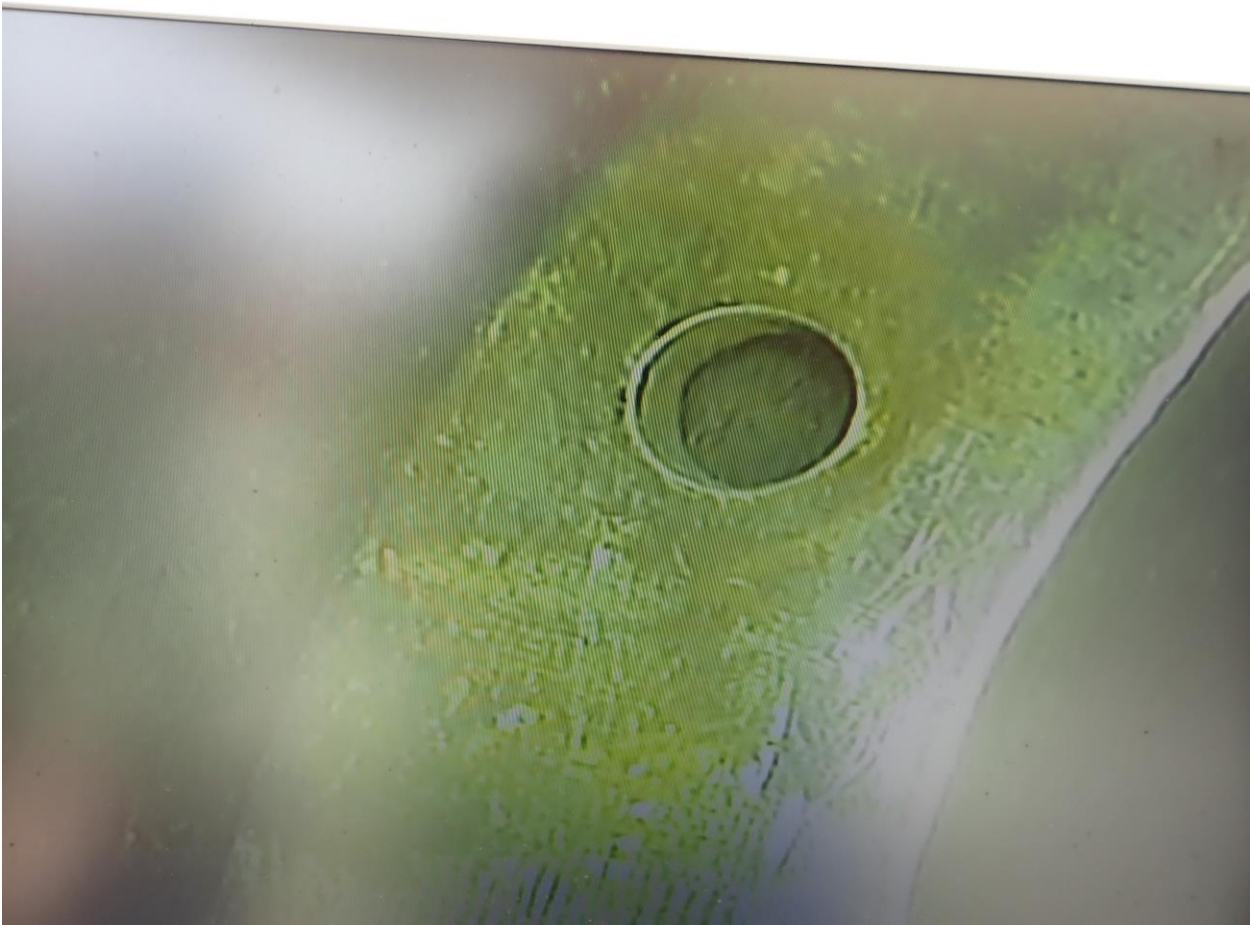
Picture 3: Stainless steel flange with missing bolt found on 6C2, July 9, 2020.

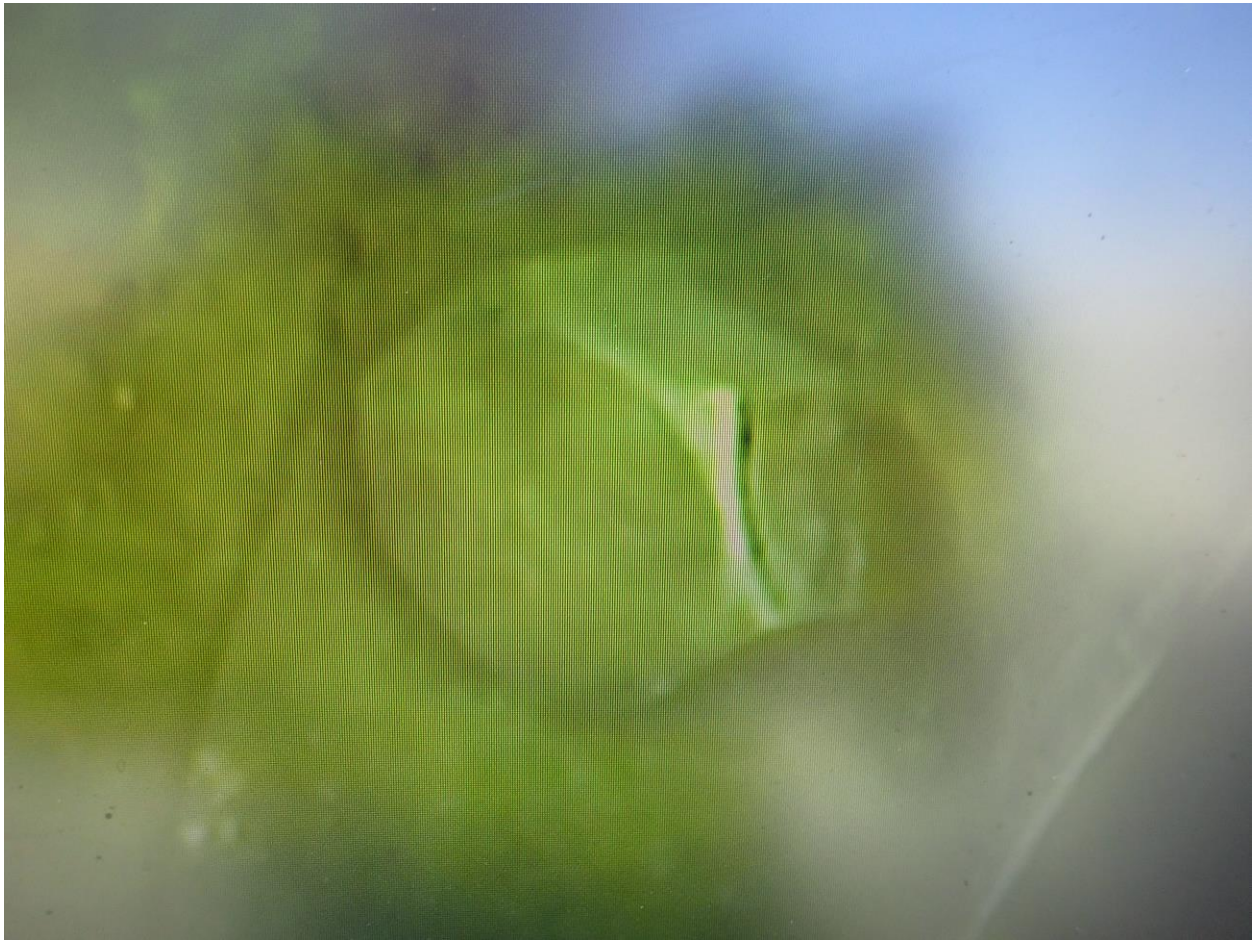
Picture 4: Stainless steel flange with bolt and proper installation found in 6A on July 9, 2020.
