CENWW-ODO

MEMORANDUM FOR THE RECORD 20 LMN 07 MFR Closing of Spillway Weir due to Findings of Dive Inspection on Floating Guide Wall Cables

SUBJECT: Closing of Spillway Weir due to Findings of Dive Inspection on Floating Guide Wall Cables

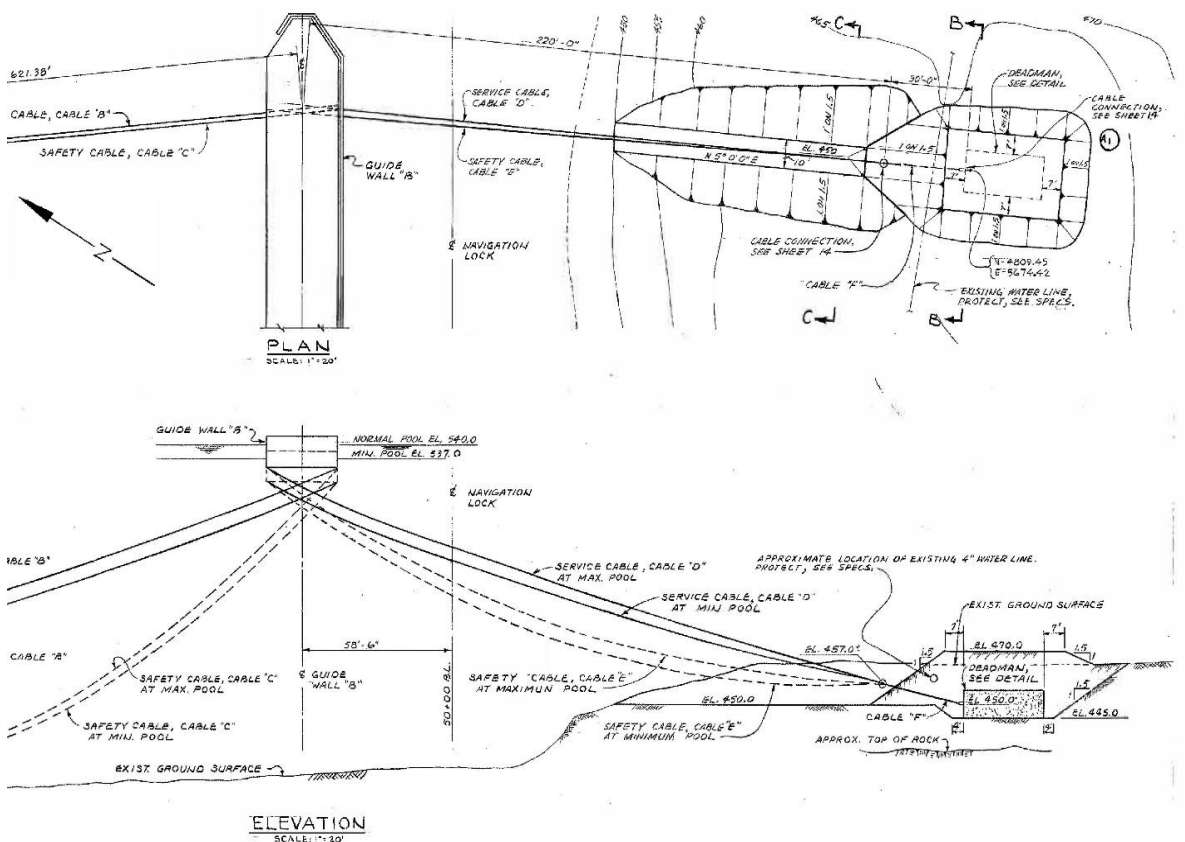
Per the drawing below, there are three cables on the south shore maintaining the guide wall in a static location. Initial ROV inspection led designers to suspect Cable D (replaced 2017) due to excessive slack at the surface. ROV inspection of that cable was inconclusive, but Cable E a cable scheduled to be replaced in March 2021 during the annual maintenance outage was discovered to be reduced from an effective diameter of 2 ½" to ½". The cable had been previously replaced in 1986. Divers on Tuesday discovered that the actual failure mechanism was cable F which attaches to the anchor block, exits the sediment and connects to cables E & F. This inspection was performed by tracking the cable from the guide wall to the bridle. Due to recent winds, it is estimated that the tip of the guide wall has shifted to the north by 45 feet. Total guide wall failure would occur should the tip move an additional 15 feet northward.

The service cable (D) is 2 1/8" in diameter, safety cable (E) is 2 1/2" in diameter, and cable F is also 2 1/2" in diameter. The project does not have the breaking strength of this size bridge strand cable.

- A. Species:** NA
- B. Origin:** NA
- C. Length:** NA
- D. Marks and Tags:** NA
- E. Marks and Injuries Found on the Carcasses:** NA
- F. Future and Preventative Measures:** There is a Project Delivery Team working on setting up a contract to permanently fix the cable system for the guide wall during the lock outage in March.
- G. Photos Taken:** None.

In close coordination with the tugboat operating to hold the floating guide wall in position, the Lower Monumental Dam RSW was reopened at 10:35 August 4, 2020. The remaining spill gates were returned to comply with the appropriate spill table in the FPP. The towboat holding the floating guide wall in position is planned as a temporary measure until the repairs to the floating guide wall anchor cable are made.
