**OFFICIAL COORDINATION REQUEST FOR
NON-ROUTINE OPERATIONS AND MAINTENANCE**

COORDINATION TITLE - 17 LWG 01 - Lower Granite Unit 2 Blade Position

COORDINATION DATE - 3 February 2017

PROJECT- Lower Granite Dam

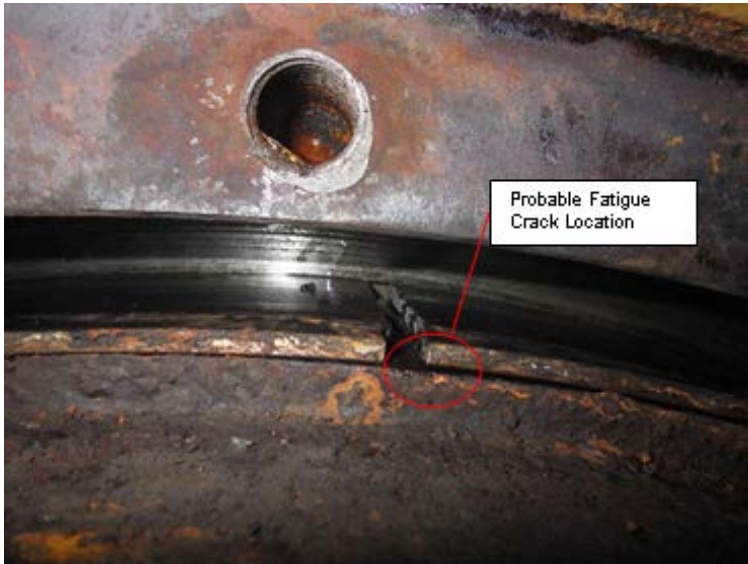
Description of the problem - Intermittent sheens of oil were observed in Lower Granite tailrace December 19-21. The source of the oil was determined to be from failed blade packing in unit 2. When the unit 2 blade seal rings were removed, project maintenance personnel found one of the blade packing sleeves had failed with cracks extending through the sleeve (see photos). This magnitude of failure requires the placement of unit 2 blades into fixed positions prior to operation. The temporary repair of unit 2 for the 2017 fish passage season will include modified blade seals in the failed blade packing box and hydraulically locking the unit at a 29 degree angle of pitch as recommended for unit 1 fixed blades (see photos below). This work is expected to take about 4-6 weeks to complete depending on parts delivery. The Project would like confirmation of 29 degrees as the angle to position the blades as was coordinated for unit 1 (12LWG 001).

Photo 1. Broken sleeve as found in the blade packing box

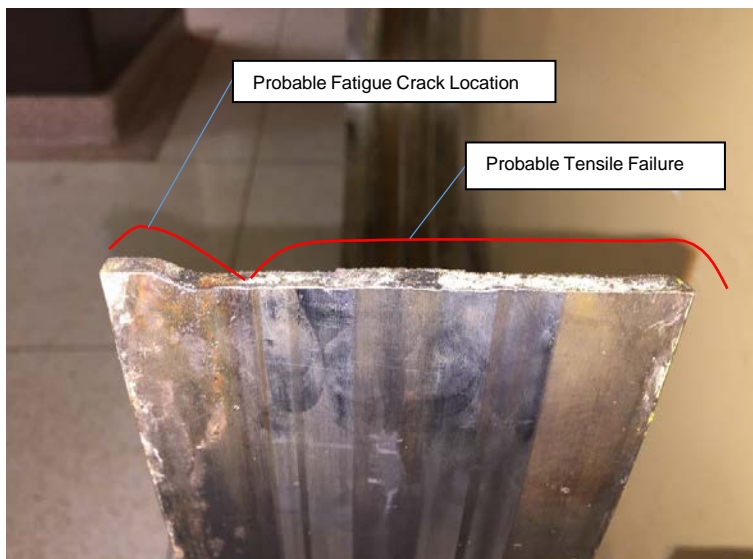
Photo 2. Fatigue on left side of sleeve after removal from unit 2.

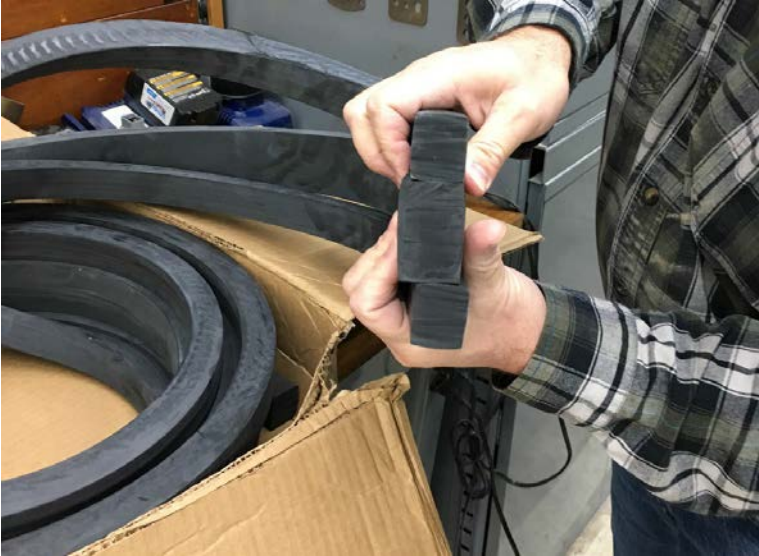
Photo 3. Example of square packing to be installed.

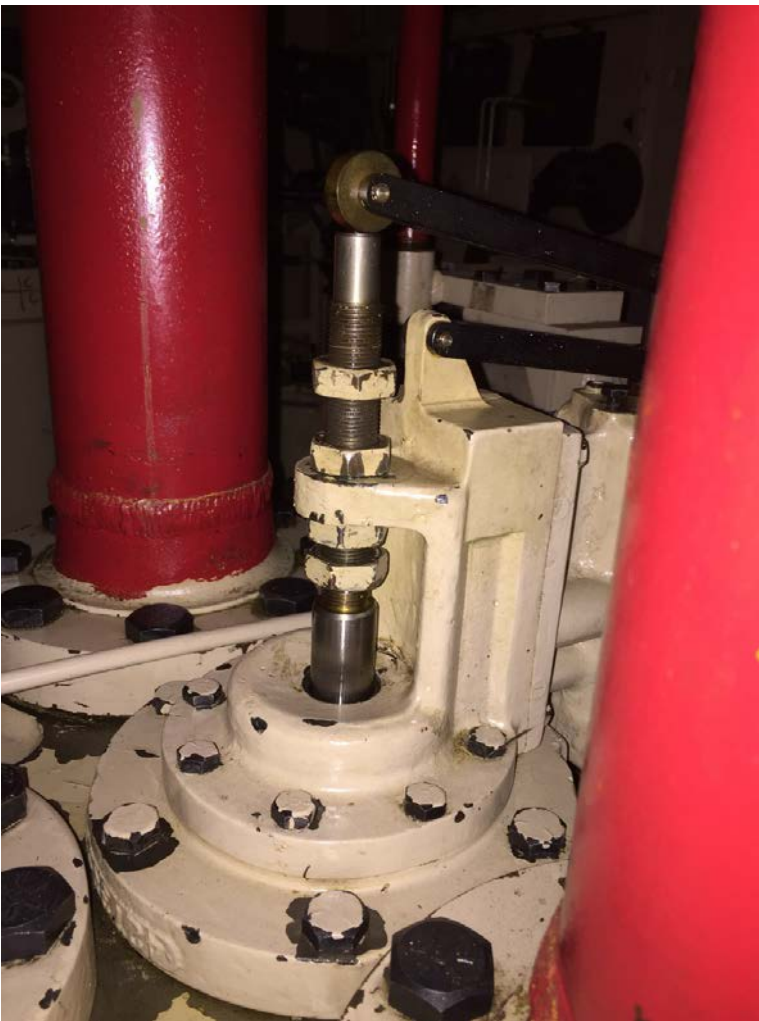
Photo 4. Centering and locking pilot valve after moving blades to final position.

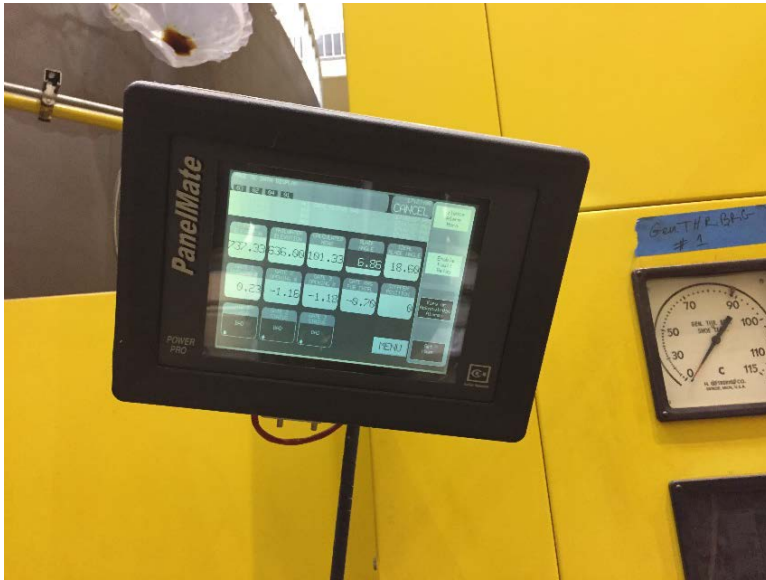
Photo 5. Monitor blade angle digital readout to verify minimal or no blade movement.

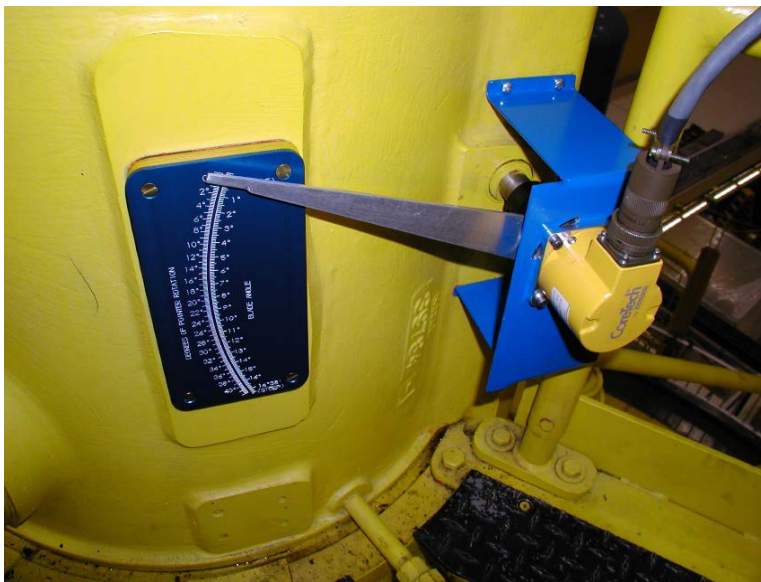
Photo 6. Monitor oil head blade indicator to verify minimal or no blade movement.
