MEMORANDUM FOR RECORD: 17 LWG 06**Subject: Emergency Spill Operation to Clear Lower Granite Forebay Debris and a Log from RSW**

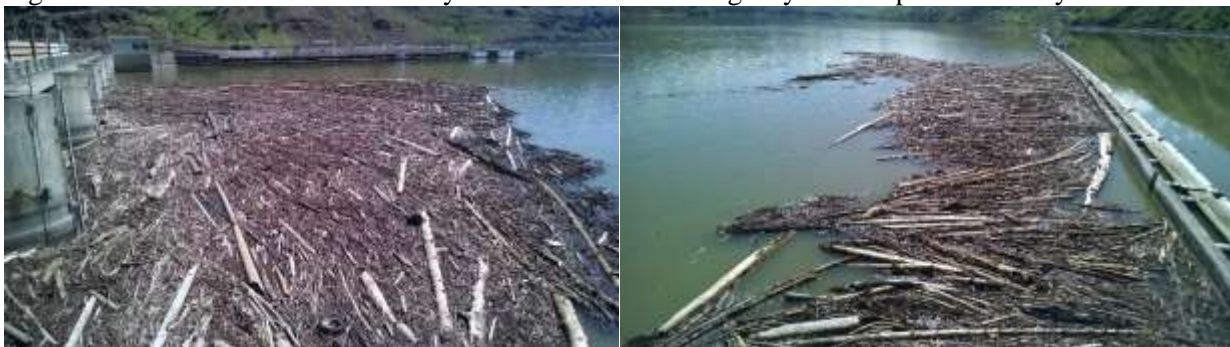
Forebay debris at Lower Granite has been increasing from an estimated 70 square yards on 5 May to about 2,700 square yards on 10 May, and over 5,000 square yards on 14 May (see Figure 1). In addition, a log became jammed between the corner of the debris boom and the Removable Spillway Weir (RSW). Additional debris accumulated behind the log on the south side of the RSW decreasing the RSW passage width to only about 15 feet of debris free water flowing over the RSW.

Figure 1. Lower Granite Dam forebay debris before the emergency debris spill on 15 May 2017.

In response to increased debris in the forebay and the wedged log in the RSW preventing debris from passing over the RSW, Lower Granite performed an emergency debris spill from 1043-1206 hours on 15 May 2017. During the debris spill the spill pattern was changed however the spill volume remained unchanged. Modification to the spill pattern included closing the RSW at 1043 hours, opening spillbay 2 to full, opening spillbay 3 to 12 stops, and reducing spillbays 4 through 8 to approximately 1 stop. The spill pattern was returned to normal operation at 1206 hours. The powerhouse mechanical crew pulled debris from the navigation lock area and released it in front of the RSW prior to the emergency debris spill to maximize the benefit.

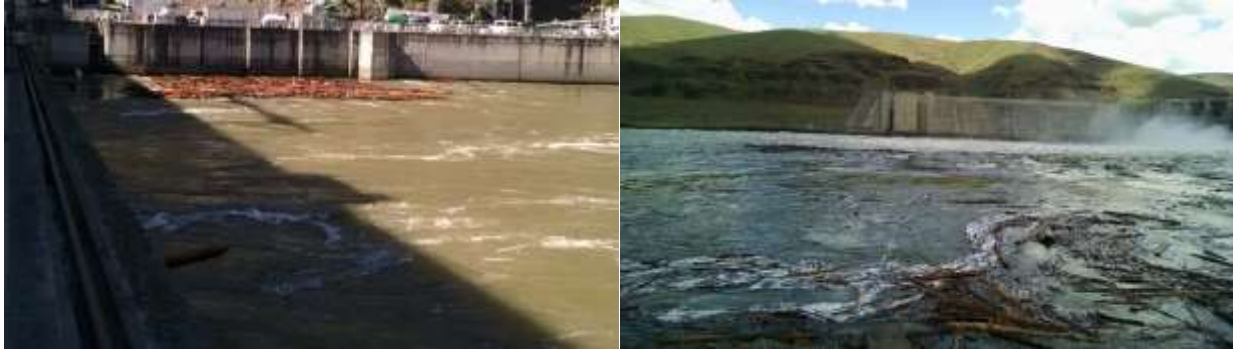
Debris loads have also been increasing in the tailrace with wood collecting in the stoplog area. A log became stuck in fish ladder collection channel (see Figure 2) on the morning of 15 May 2017 and was subsequently cleared.

Figure 2. Lower Granite Dam tailrace debris on 15 May 2017.
