CENWW-ODL

07/10/2017

MEMORANDUM FOR RECORD: 17 LWG 14 Adult Trap Chinook Mortality:

Lower Granite Adult Trap Chinook Mortality – 09 July 2017

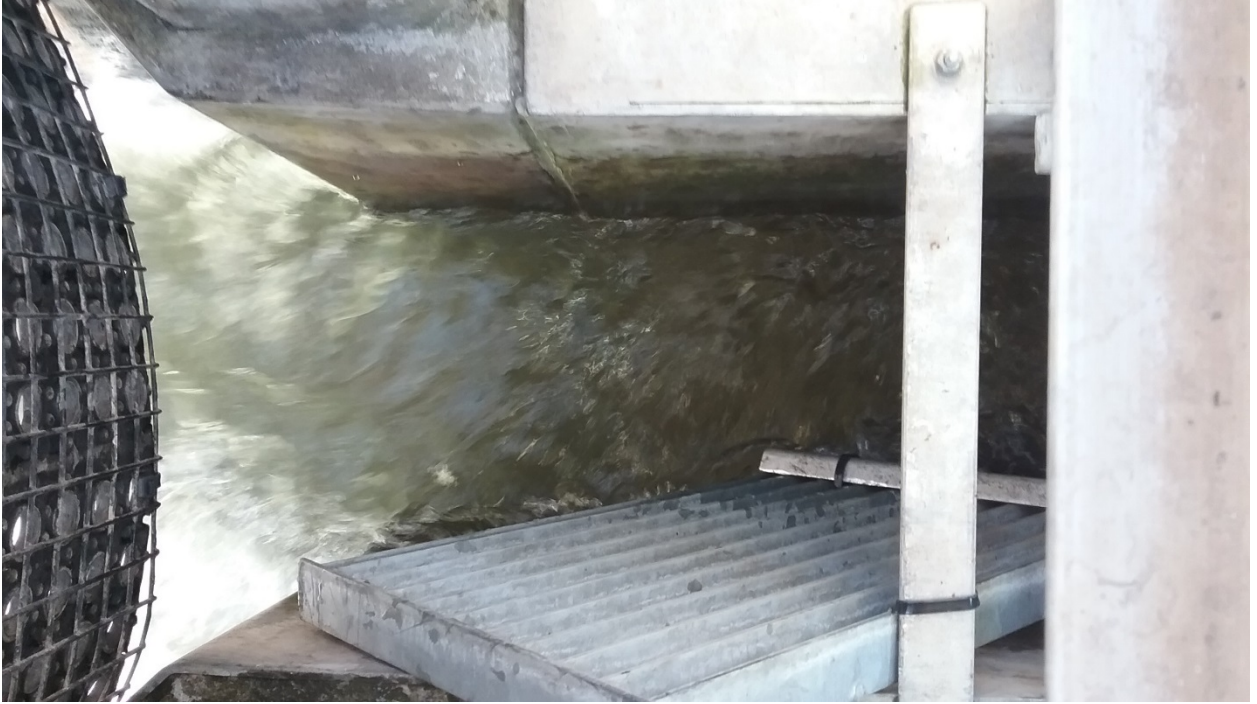
Description of the problem: Four adult Chinook salmon mortalities were discovered on top of the adult trap recovery pool grating July 9 at 0940 hours. The fish likely jumped through failed false weir seclusion bars and landed on the grating below. Friday afternoon to Sunday morning the adult trap operation is changed to non-sampling mode and NOAA personnel are not present. Mortalities occurred between 1500 hours July 7, when NOAA personnel switched out of trapping mode, and 0940 hours July 9 when the Corps biological staff noticed the fish during a fish ladder inspection. Temporary repairs to the existing false weir were made. New seclusion bars are being fabricated to replace the temporary fix and will be installed when available.

Photo 1. Looking down on failed false weir grating.

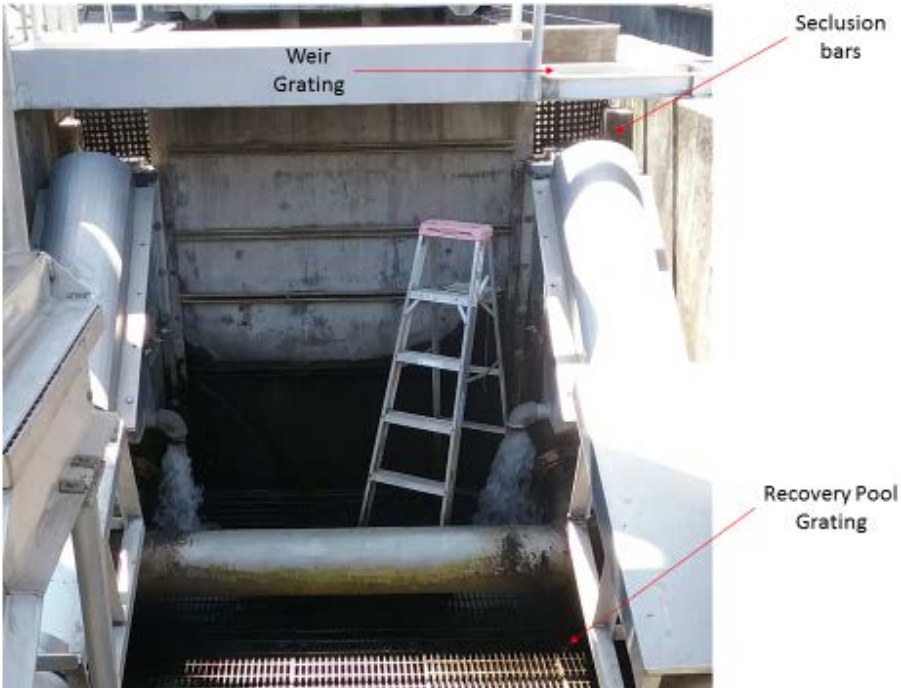
Photo 2. Looking upstream adult trap attraction pool and false weirs.
