MEMORANDUM FOR THE RECORD – 17 LWG 23 – MFR Spillway 1 Gate Seal Inspection.**SUBJECT:** Spillway 1 gate seal damage inspection.

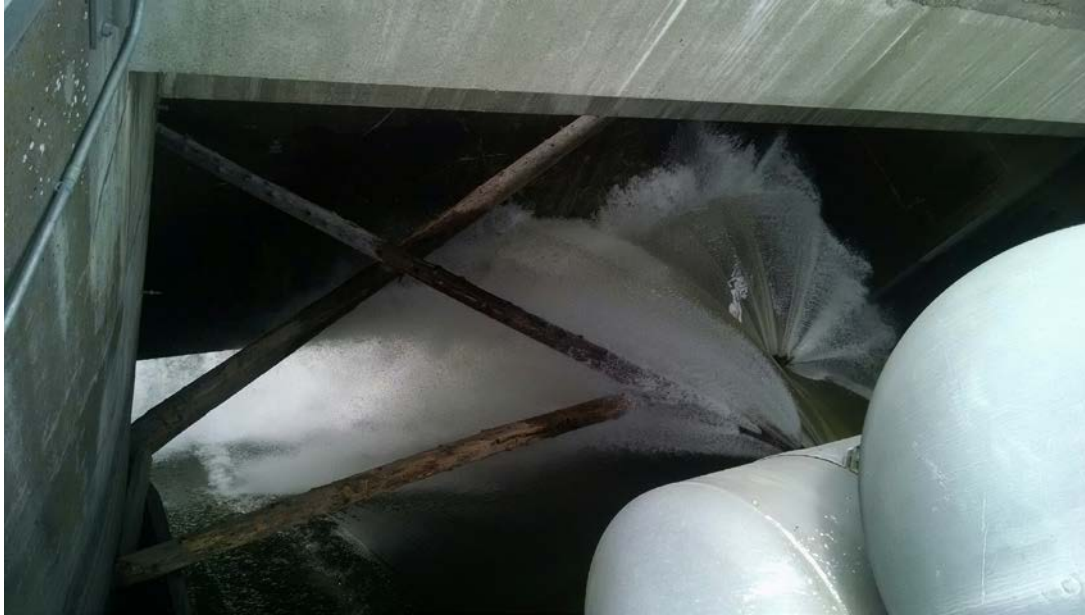
Spillway 1 gate seal was damaged June 19 during the removal of several logs wedged between the RSW and the spillway gate (photo 1&2). The RSW was closed at 1313 hours July 12 due to increased forebay water temperatures. Inspection of the seal requires the gate to be open 100% and was delayed until the RSW is re-opened for extended spill in support of Phase 1a. In the interim, as-built drawings and the tech section has been consulted by the mechanical crew to determine repairs and material needed to replace the missing section of the seal. The Project coordinated a 2-3 hour window the work week of September 18-21 to inspect the gate seal and verify the accuracy of the drawing. This information will be used to determine the materials needed to be ordered, time needed for materials to be delivered, develop a procedure and safety plan for work, and estimate of the total time needed for repairs. Spillway 1 gate seal was inspected from 1200-1352 hours September 19. During the inspection it was determined that about 20 feet of the seal is missing. To safely make seal repairs bulkheads will need to be installed in spillway 1. This will require the RSW to be tilted about 35 degrees in the upstream direction away from the spillway. Operations will need to monitor the RSW 24 hours/day to ensure damage to the RSW or spillway gate does not occur due to winds or river flows. Estimating the procurement time for materials and the time needed to perform repair work is ongoing due to the scope of the damage and unique access issues to the repair site. Following inspection the Project recommends ordering the required material/parts in preparation for repairs to begin after end of the 2018 spill season.

Photo 1. Logs wedged between RSW and spillways gate June 19, 2017.

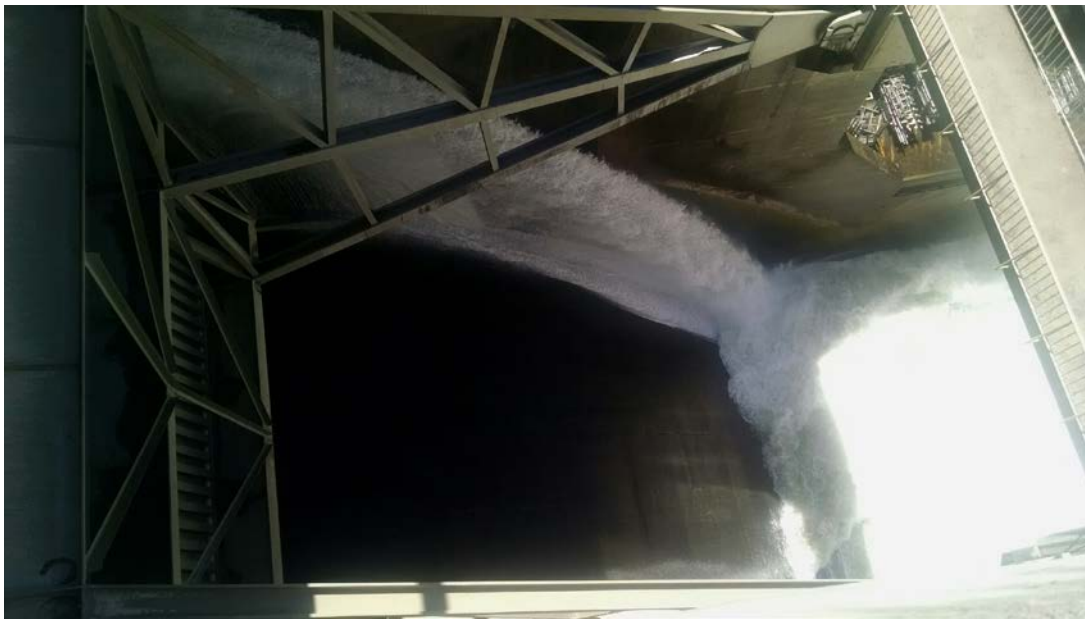
Photo 2. Spillway 1 seal leak while gate is in the closed position.

Most importantly, the RSW functions normally with the damaged gate seal and has no risk of negatively impacting fish condition, it is when RSW is out of service that the failed seal leaks. I am told that the failed seal area opening is about 1 inch by 20 ft long. Project staff are routinely monitoring to watch for any unforeseen sign of fish impact.

The project does not believe due to logistics that they will be able to complete repair this fall/winter. The seal can be purchased in relatively short order, but accessing the area to repair the seal will require procurement of some specialized equipment, in order to undertake safely.
