MEMORANDUM FOR THE RECORD: 19 LWG 05 Fish Ladder Partial Dewater

SUBJECT: Adult fish ladder partial dewatering due to fish count backboard repair.

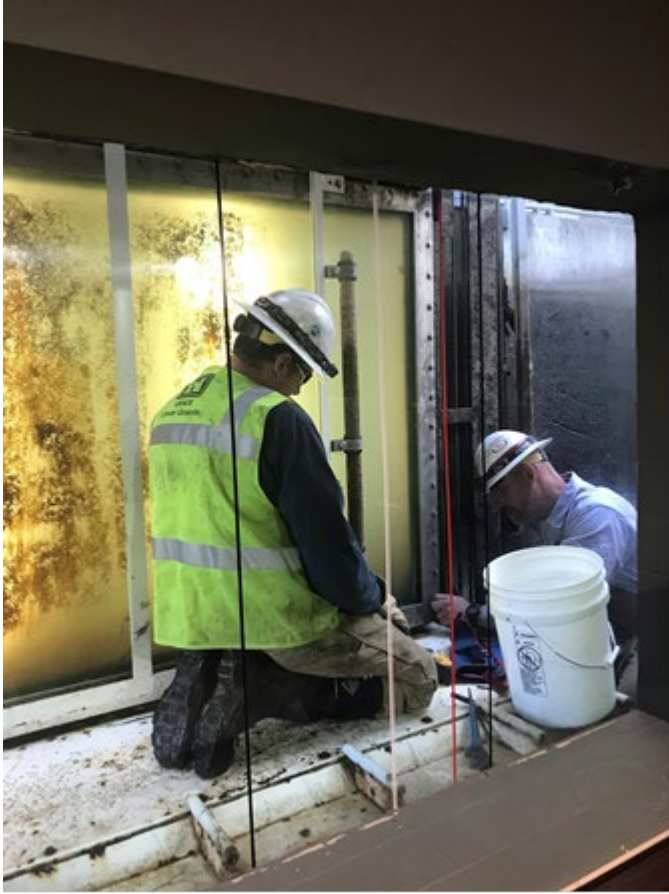
The upstream lower corner of the adult fish count backboard frame broke loose resulting in the frame and backboard moving back and forth in the fish count slot (see photos below). Ladder flow was pushing the backboard towards the counting window glass and allowing fish to go behind the backboard. Not repairing the backboard risked the entire frame breaking from the support structure. Lower Granite dewatered the upper section of the fish ladder from 1200-1615 hours May 2 to repair the fish count backboard. ASW supply pumps were removed from service from 1230 hours May 1 until 1624 hours May 2. There were no live adult fish in the ladder during dewatering. There were 12 clipped juvenile Chinook salmon removed from the fish ladder exit and released below Lower Granite. Mortalities included 1 clipped juvenile Chinook salmon and 3 decomposed clipped steelhead. Adult fish counts at LWG for the last week (April 25-May 1) totaled 11 adult Chinook salmon, 1 jack Chinook salmon, and 73 steelhead.

Photo 1. LWG fish ladder PH mechanical crew repairing the fish count window backboard frame.

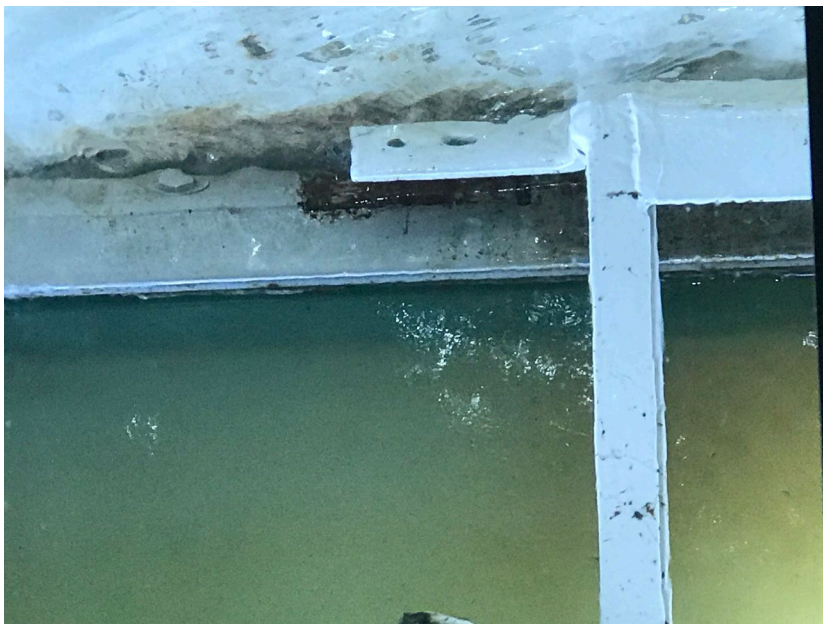
Photo 2. Close up of disconnected backboard bracket.
