MEMORANDUM FOR THE RECORD

SUBJECT: MFR 14 MCN 25 Adult steelhead mortality

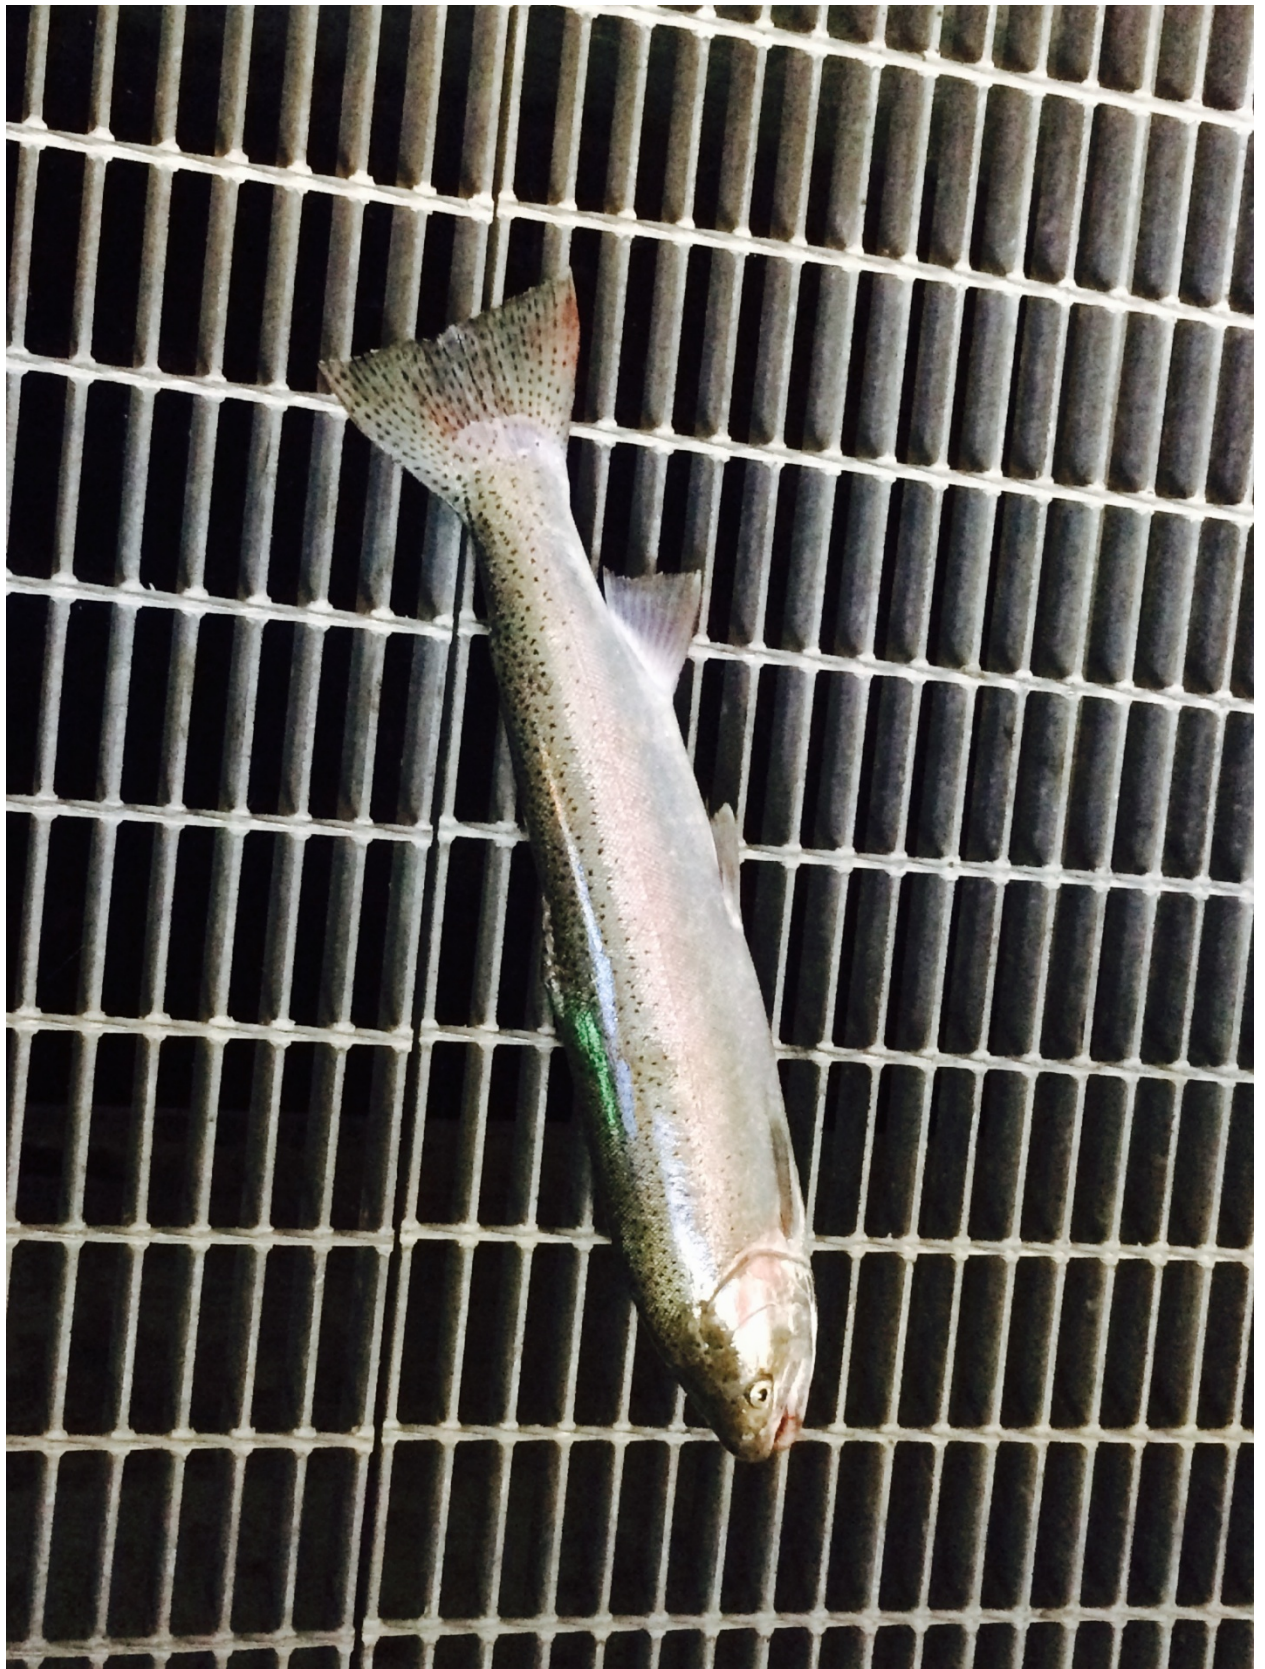
Narrative: Yesterday a bio tech reported that she observed a dead steelhead on the walkway grating near orifice 14C North. It had been dead for less than an hour before she found it while going down to reset the orifices after a VBS inspection. All of the netting was in place. The netting is lower at this location, because the north orifices are not normally in use. However, this orifice was opened as a reliever orifice for about an hour when other nearby orifices were closed during VBS inspection and cleaning operations.

E. Marks and Injuries Found on the Carcasses: Injury on the nose and on the lower caudal fin, probably due to landing on the steel grating.

F. Future and Preventative Measures: About the only way you could prevent this type of rare incident would be to raise the netting to 12' around all north end orifices. Currently the netting is raised that high only over the south orifices at the north end of the juvenile collection channel, where fish have an infrequent history of jumping over the railings onto the grated deck. It happens there about once every two years. Covering all the orifices with netting that extends 8' above the walkway and 12' above the channel would be a major commitment of time and money, for the few times that the north orifices are actually in operation.
