MEMORANDUM FOR THE RECORD - 16 MCN 015 MFR Oregon Ladder Picketed Lead Debris Blockage and Weir 338 Failure.

SUBJECT: Oregon ladder exit picketed lead debris blockage and weir 338 failure. Adult sockeye, steelhead and Chinook passage affected. No fish mortality.

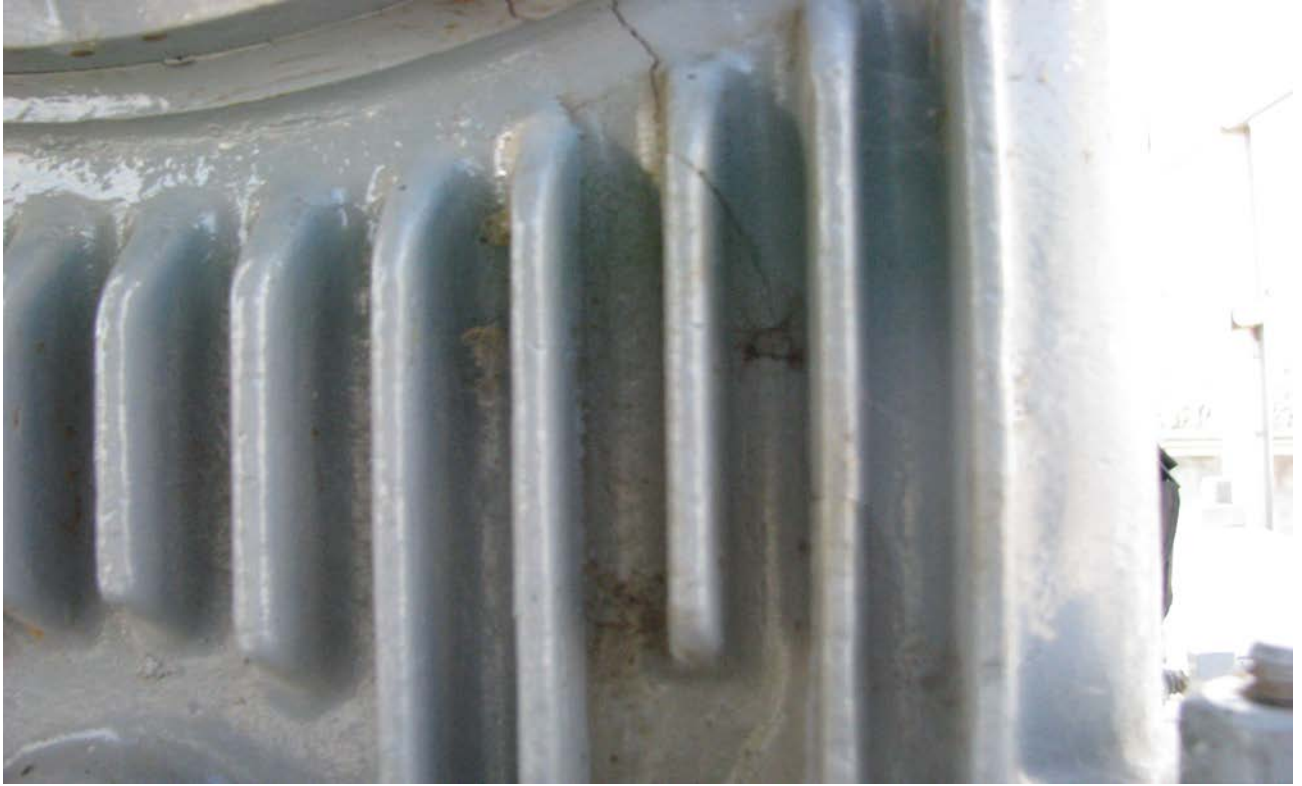
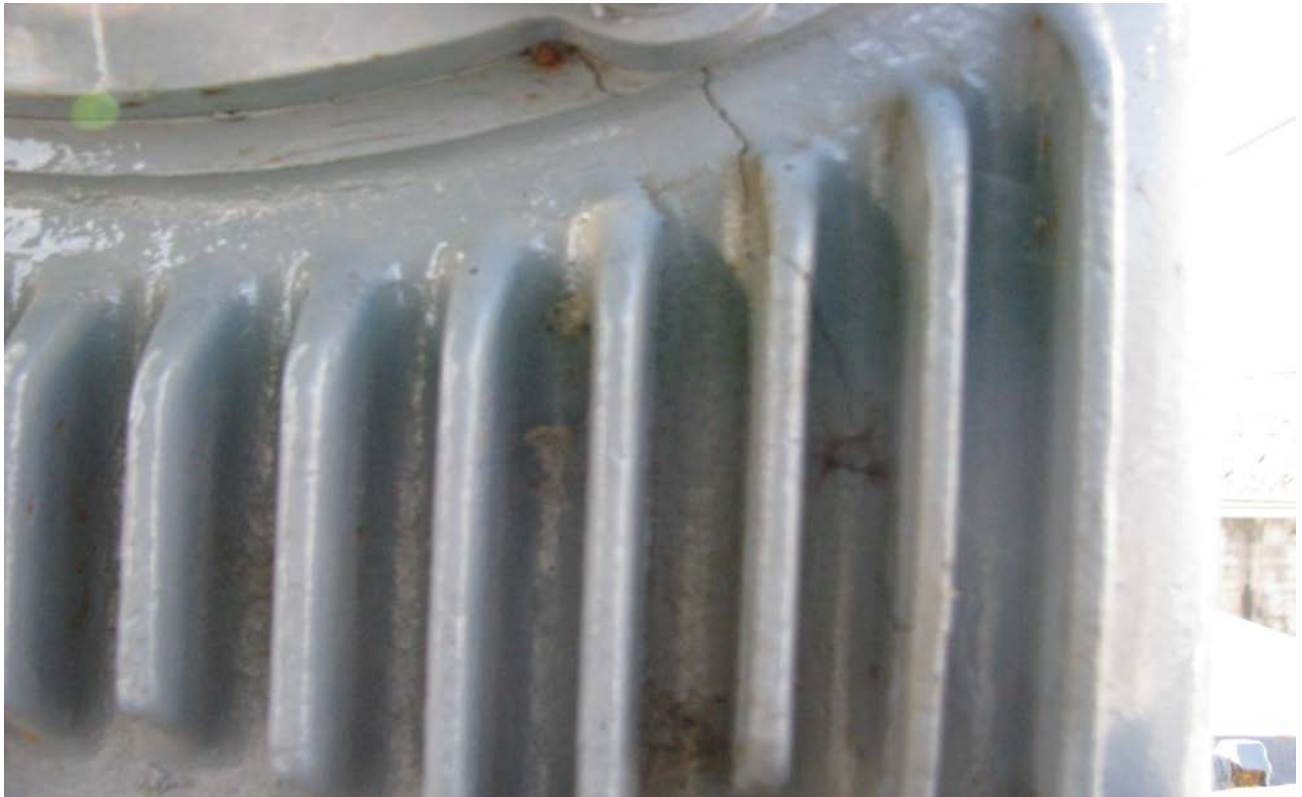
Weir 338 remains out of service as one of the two associated gear boxes was found cracked (see figures 1 & 2 below). The weir shafts may also be bent, but this cannot be determined for certain until the weir drive is removed at a future date. As a preventative measure, mechanics removed all oil from the gear box to ensure oil would not seep into the ladder or river.

Gear box replacement necessitates the removal of the entire drive assembly which would require a 2 to 3 day ladder outage. The drive assembly from weir 340 (which does not move under the current forebay elevation restraints) would have to be used as a replacement.

Due to high water temperatures (refer to Figures 3 & 4 below) and increasing adult fish counts (refer to Figures 5 & 6 and Tables 1 & 2 below), project staff have deemed it prudent to defer repairs to the February ladder outage period. An emergency ladder outage could lead to delay of adult fish passage and the need to conduct an extensive fish recovery operation. The ladder exit
