MEMORANDUM FOR THE RECORD - 16 MCN 12 MFR McNary Side Brush

SUBJECT: Failure of the side screen brush in the McNary Juvenile Channel, entering emergency bypass operations and subyearling Chinook smolt mortalities noted in the juvenile collection channel when returning to primary bypass mode.

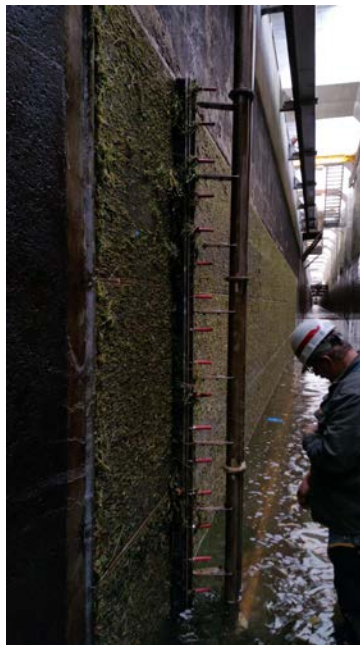
At 0730 hours, June 14, the side brush was run manually twice. From 0800 to 1015 hours, the orifices were closed and the system was switched to emergency bypass. The mechanics found that the brush bar drive gear was not making full contact on the drive rail gear teeth. The rail had a spot where the brush had been stalling out. The mechanics added shims to the drive rail, which resolved the problem. However, the biologist noted the side screen was covered in aquatic vegetation and requested that the brush be examined more thoroughly.

The next day, June 15, powerhouse mechanics determined that the brush was only contacting about 50 percent of the screen. They made adjustments to the brush strips until 100 percent screen contact was assured. The fisheries mechanics then cleaned the screen with wire brushes.

Failed Brush and Uncleaned Screen

- F. Cause and Time of Death – impingement in and around the emergency bypass bulkheads. Occurred while the system was in emergency bypass.
- G. Future and Preventative Measures – For the brush: continue to perform inspections and maintenance as proficiently as possible until the brush is replaced during the winter outage of 2017-2018. For the fish: The emergency bulkheads already are difficult to install. Adding gaskets to them might be feasible but would require discussion with engineers and the general maintenance staff. The best prevention is to avoid emergency bypass.

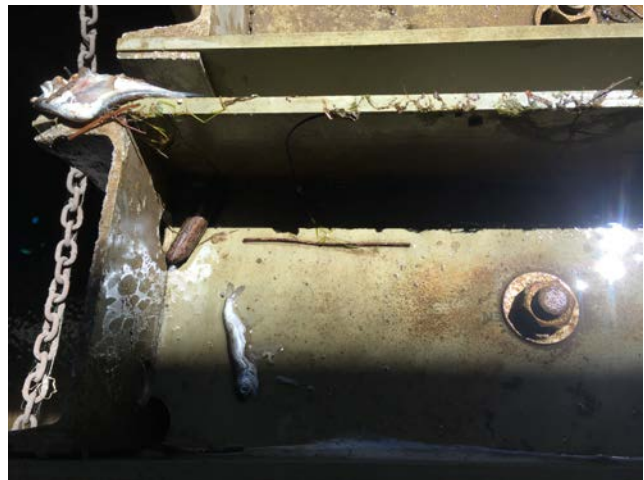
At 1045 hours, the orifices were closed and preparations were made to switch the system to primary bypass. When the emergency bulkheads were removed, 26 subyearling Chinook mortalities were noted. The fish appeared to have wedged themselves between the channel structure and the fiberglass bulkheads. By 1324 hours, the channel system was back in automatic mode. After checking all facility systems, the facility was switched to secondary bypass at 1415 hours. A partial sample was collected for the day.

- D. Marks and tags – none noted, fish could not be retrieved safely.
- E. Marks and Injuries found on carcass – fish bodies were crushed and/or bent. All mortalities looked fresh.

Emergency Bypass Bulkhead Fish Mortalities

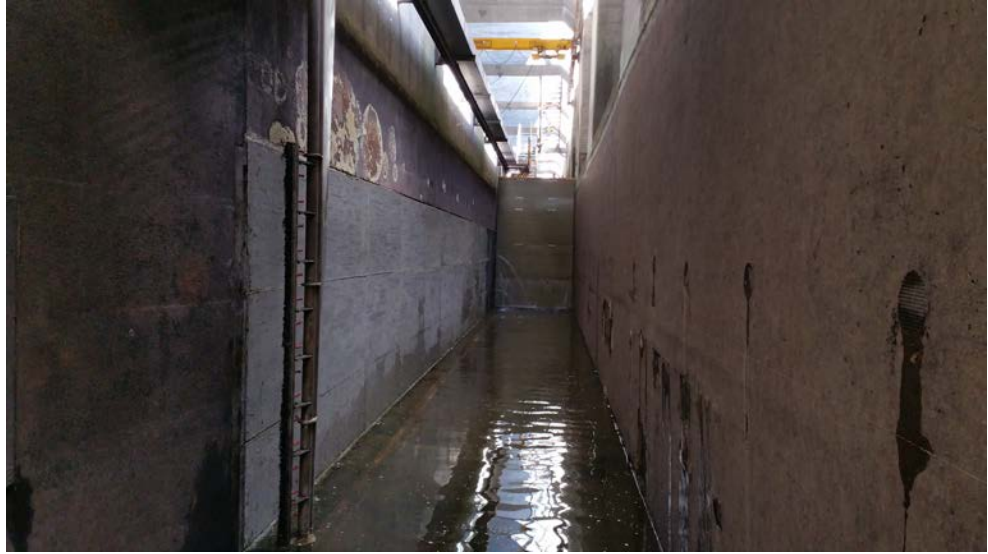
Cleaned Side Dewatering Screen
