OFFICIAL COORDINATION REQUEST FOR NON-ROUTINE OPERATIONS AND MAINTENANCE

COORDINATION TITLE - 17 MCN 04 Oregon Ladder Lamprey Plating Removal

COORDINATION DATE – 06 February 2017

PROJECT- McNary

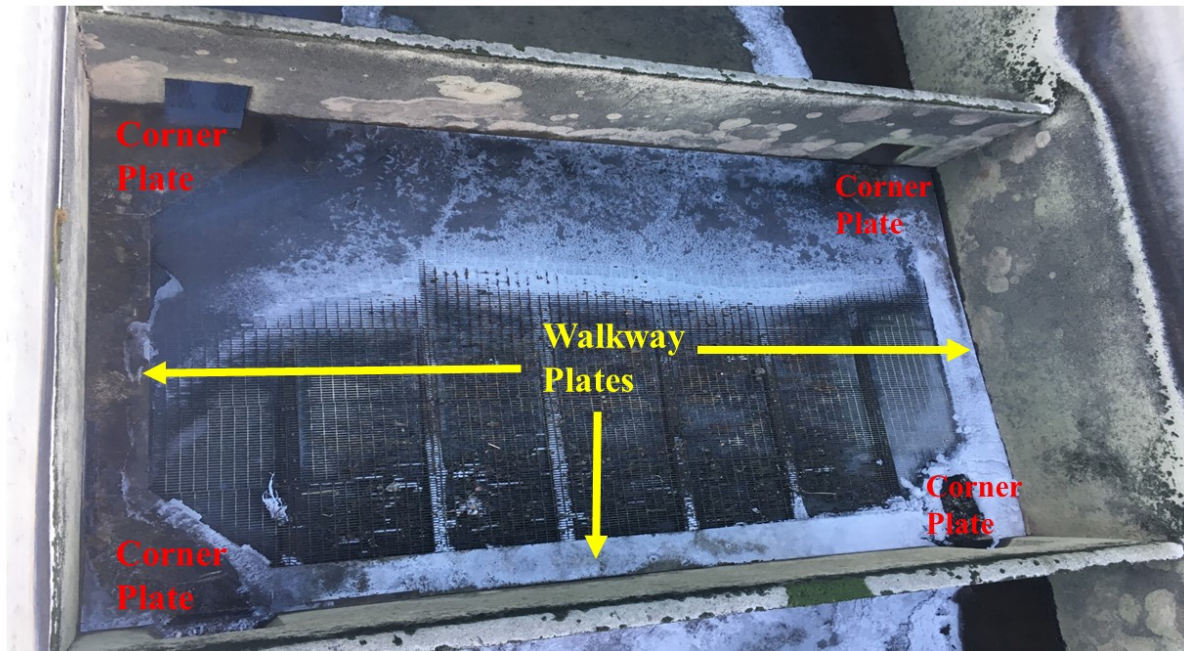
Description of the problem: The McNary Project is seeking approval to remove plating over diffusers 12 and 14 grating in the Oregon shore ladder that was originally installed to serve as passage aides for adult Pacific lamprey (Figure 1). Lamprey plates decrease flow area at diffusers and increase pressure on grates and increase the likelihood of grating failure.

Figure 1. Arial Photo of Diffuser in OR Ladder

Yearend reports, show Oregon shore diffuser 11 supports failed in 2005 and 2010. Though the diffuser was not covered with plating, this reflects the amount of force along the west ladder wall. After installations in 2010, diffuser 14 walkways were repaired in 2011, diffuser 11 supports were repaired in 2013 and diffuser 13 supports along with

plating was repaired in 2014. For 2017, one corner plate at diffuser 14 needs to be reattached.

This winter, the intake valve was closed to dewater the ladder, so District engineers could examine the discharge valves and develop a path forward for rehabilitation. At this time, it is very uncertain how often the project will dewater the Oregon ladder in this section in the future. Remove the plating during the current outage will hopefully reduce the risk of future grating failures and the number of times the project has to risk dewatering the ladder.

Plates were removed.
