MEMORANDUM FOR THE RECORD**SUBJECT: 18 MCN 07 MFR Outfall Avian Sprinklers and Walkway Out of Service**

Location: Juvenile outfall walkway and avian hazing water sprinklers at the end of outfall pipe.

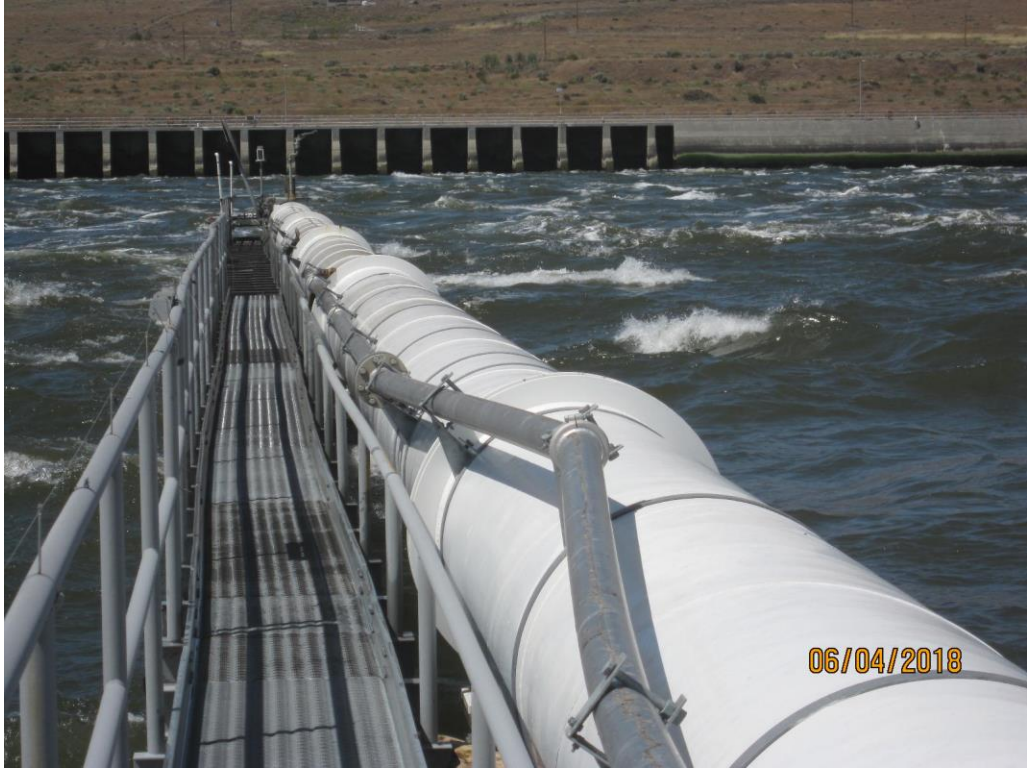
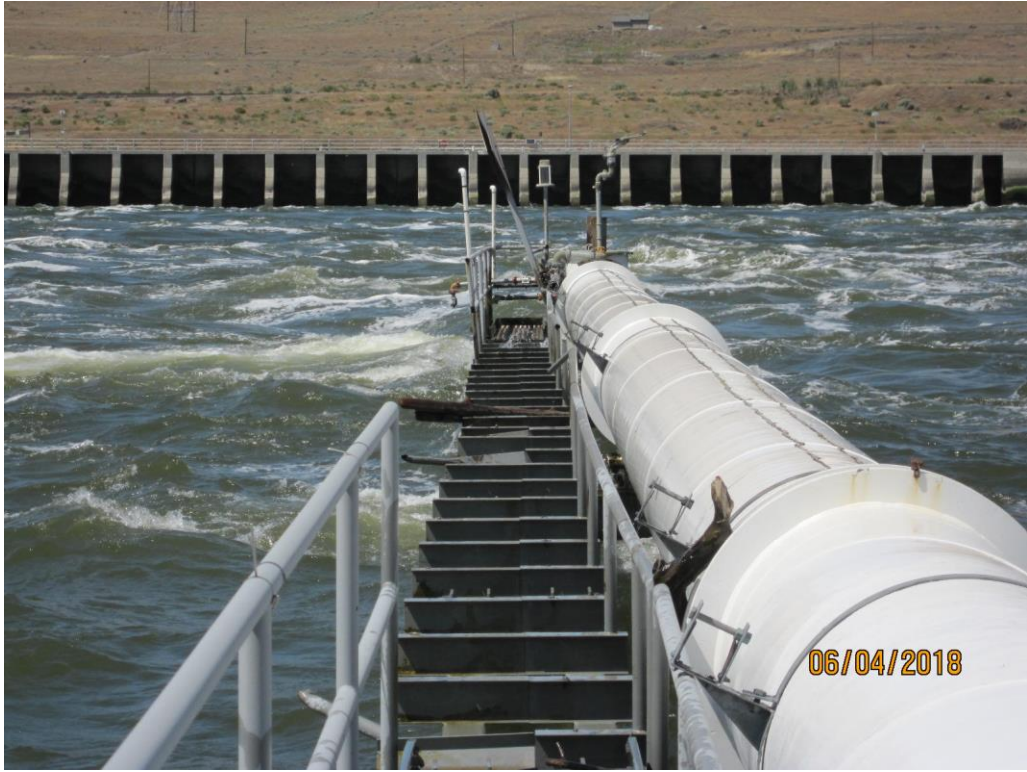
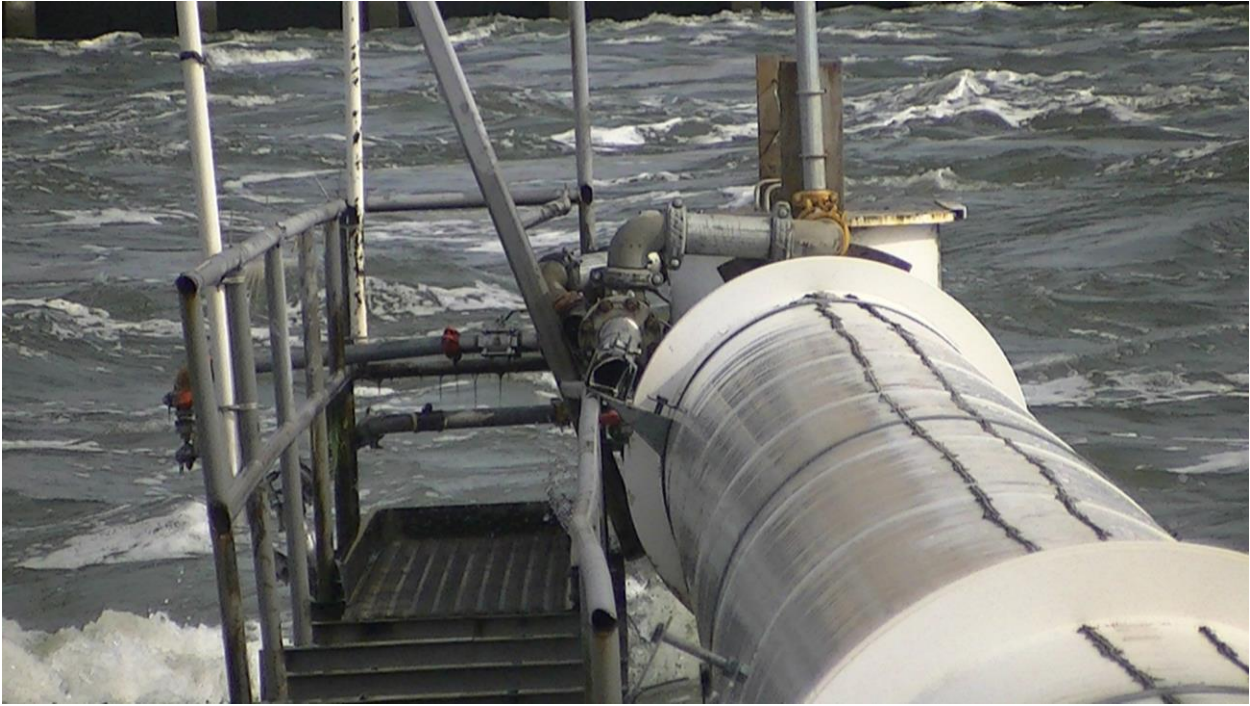
Narrative: On June 1, while doing an avian count, the assistant biologist noted handrail missing from the outfall pipe walkway. Due to high flows cresting over the outfall pipe, we have been very concerned about the condition of the outfall pipe, access walkway and avian hazing sprinkler system. On June 3, the project biologist turned in a trouble report and requested the control room not allow anyone on the walkway until it could be inspected. On June 4, when using a spotting scope, we estimated about 100 feet of handrail missing. Later, that day, the Chief of Operations, the Project Manager and a project engineer accessed the outfall walkway. They estimated the last fifth of the walkway was not safe to use. The walkway and avian sprinkler system had both been damaged with sections of each missing. Finally, that day, the project biologist told the avian deterrent team that he had strong reservations about the life span of the new proposed sprinkler system. On June 6, project and district engineers used a boat to examine the outfall walkway and sprinkler system further. They found the walkway had structural support damage, the sprinkler system was missing two of five sprinklers, and the sprinkler supply line was damaged. Repairing the damage will require a contract, which will take time to fund and put in place.

Method: Observe the outfall area and report the damage due to high flows and large woody debris.

Time Line - Duration: The sprinklers had been off since May 8, at 1600 hours, due to high flows cresting over the outfall. If serviceable, the system would have been returned to service on June 4. With the walkway missing, repairs to the sprinkler system cannot occur within the near future. Installation of a new sprinkler system was scheduled for 2019. However, walkway repairs and design changes to the walkway and/or sprinkler system will now need to be considered. A return to service date has not been determined.

F. Future and Preventative Measures: high flow years are unpredictable. Engineers will have to examine the damage and determine a course forward that can help to strengthen the walkway and sprinkler system.
