MEMORANDUM FOR THE RECORD 18 MCN 001 Lamprey Mortality in Oregon ladder

SUBJECT: Adult lamprey mortality from the Oregon ladder exit.

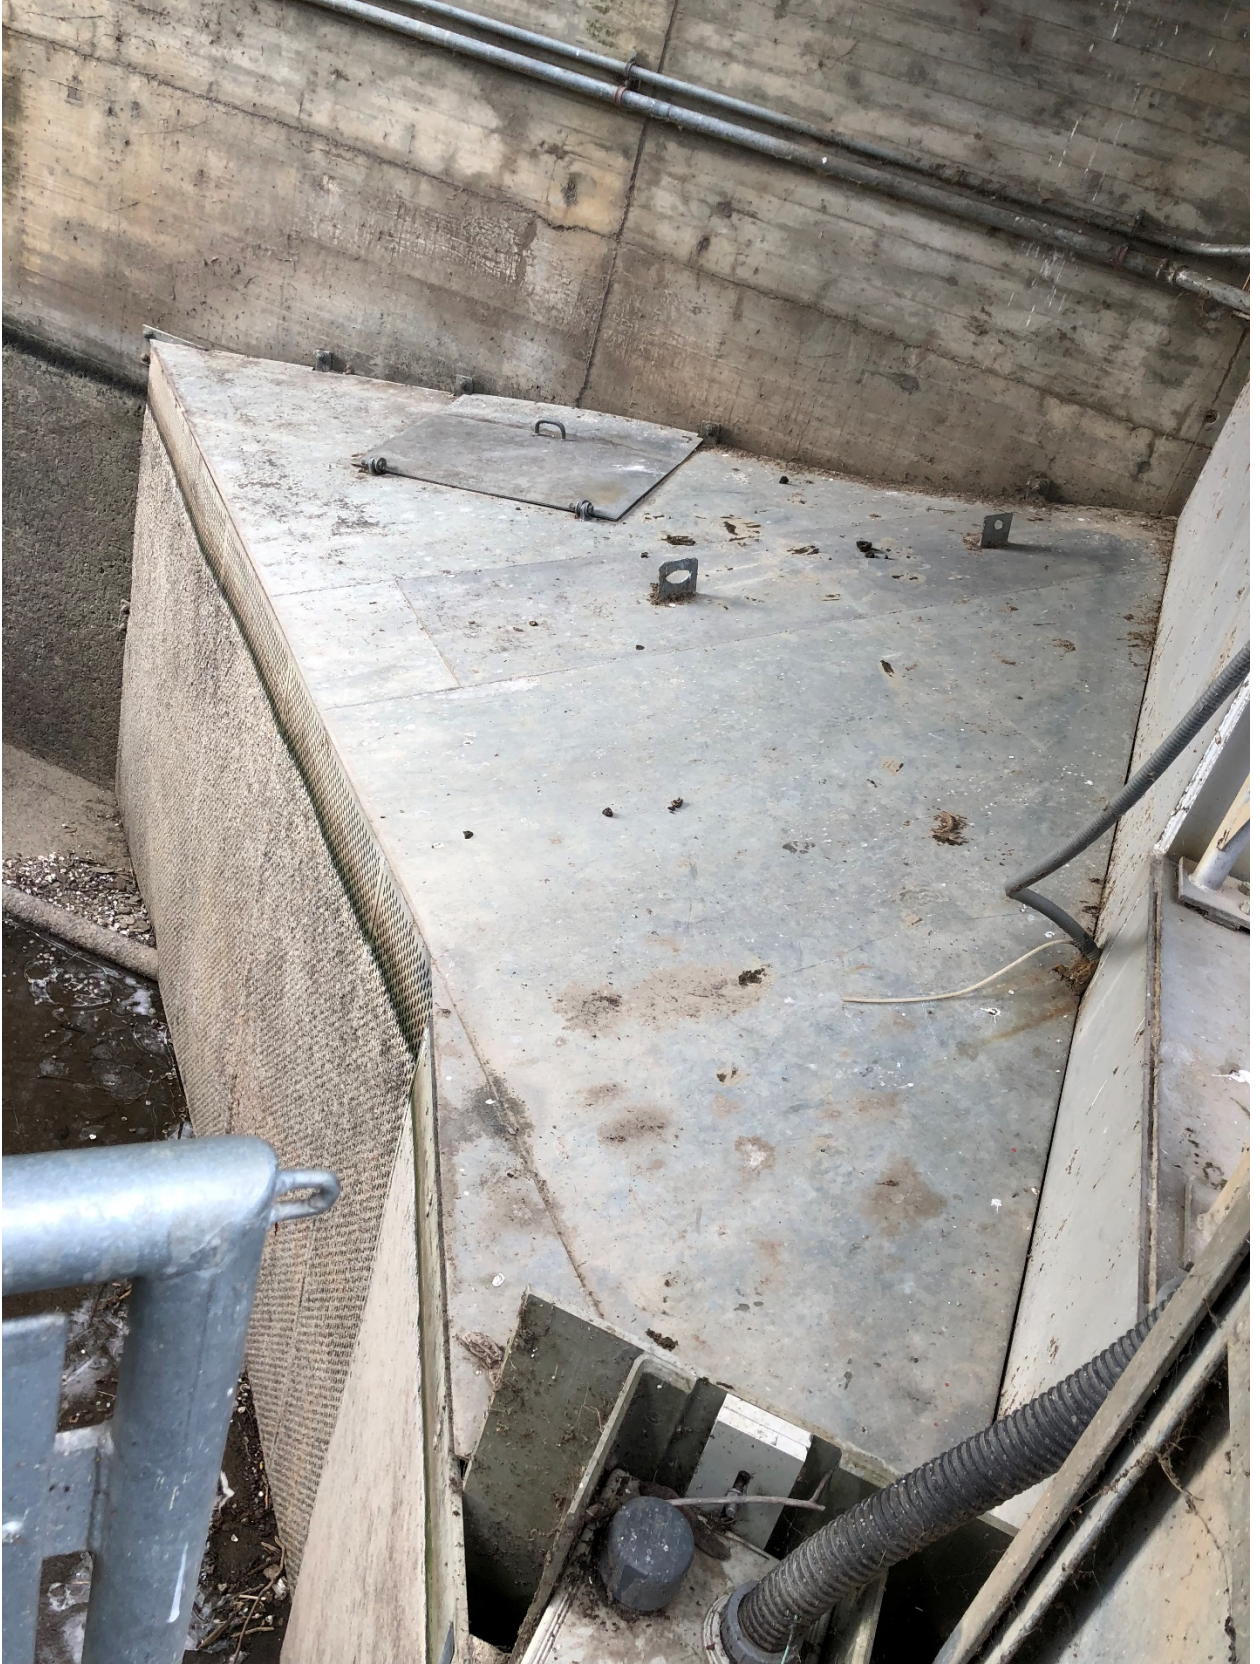
Narrative: The McNary south (Oregon) ladder has been dewatered since February 1, 2018. Today, February 22, the electrician, who is working on the count station back board repairs, noted a strong odor in the ladder. The upstream and downstream corners between the count station and the ladder wall were filled in with “spacers” when the count station was installed. These “spacers” eliminated the eddy each corner would have had and help to direct the fish into and out of the counting slot. The downstream “spacer” is covered and has an access hatch. The odor was coming from inside this “spacer”. When opening this hatch, the electrician found adult lamprey mortalities and immediately call the biologist, who sent a fisheries maintenance worker to investigate. The maintenance worker confirmed the electrician’s findings. The biologist assembled the fisheries staff to retrieve the mortalities, determine the cause and a solution.

F. Future and Preventative Measures: We found a 1 inch gap between the ladder wall and the downstream “spacer” wall. Though no lamprey were found there, the upstream “spacer” has a 1 inch gap along the ladder floor. The fisheries staff will fill in both gaps to insure lamprey cannot be stranded behind either “spacer”. During past ladder dewaterings, the fisheries staff has examined the area behind the upstream “spacer”. Only one adult lamprey had been noted there, which was two years ago and it swam back out. During future dewaterings, the staff will included examining the downstream “spacer”.

G. Photos Taken: First photo is the downstream “spacer” where the mortalities were found inside. The second photo is the upstream “spacer”.
