**MEMORANDUM FOR THE RECORD**

**SUBJECT: Failure of Spillway Crane 6 on Bay 20, the removal of Spillway Crane 7 from GDACS auto control on Bay 2 and failure of Spillway Gate Hoist drum bearing on Bay 15.**

**Location:** McNary spillway.

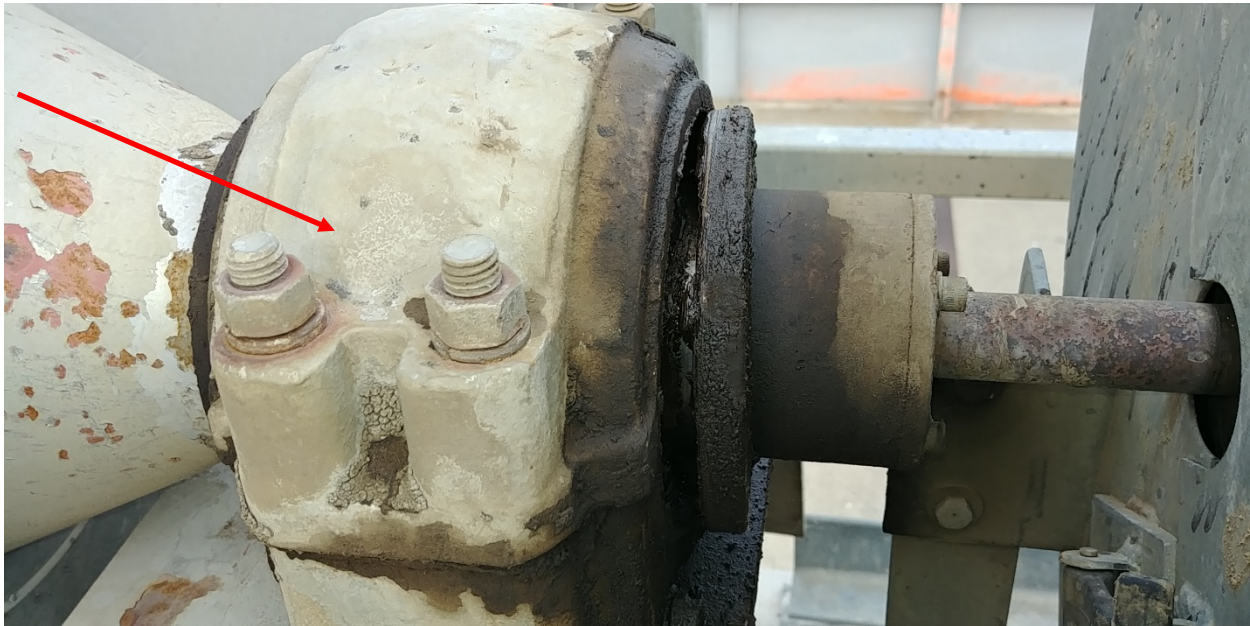
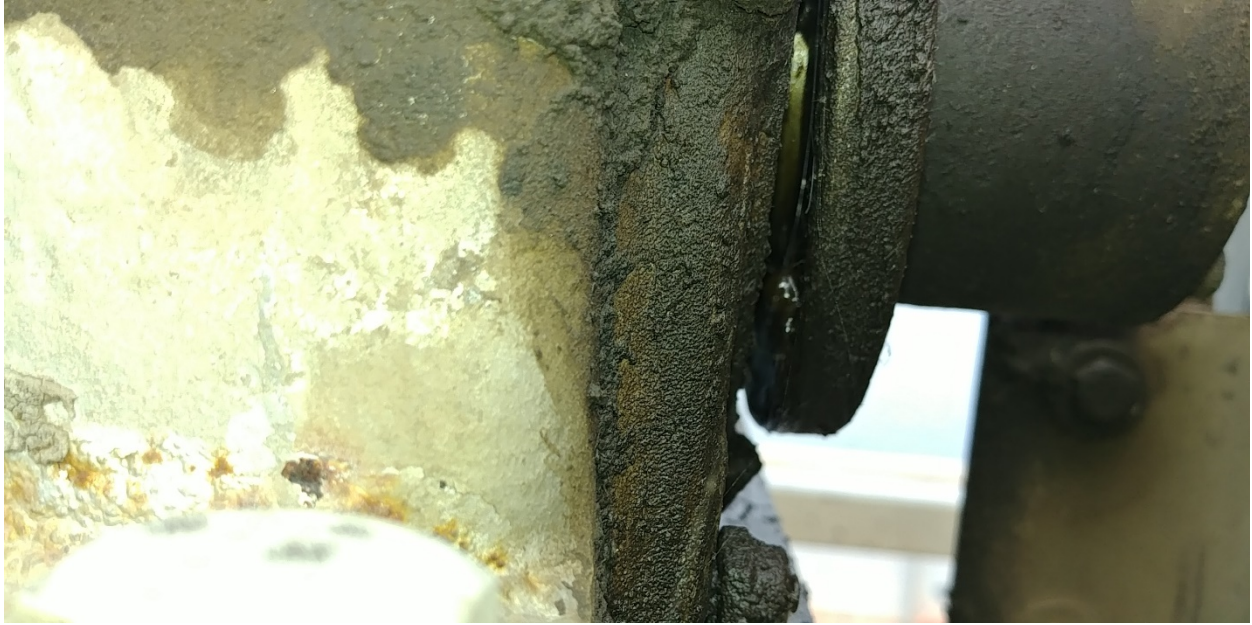
**3.** Initially, the hoist failure on the spillway gate in bay 15 was going to be a separate MFR. However, at this time it seems appropriate to include this issue due to the overall effect on the spill pattern. The hoist issue is a failing drum bearing and has been communicated to District biologists via ESA Weekly Reports number 19 and 20. While preparing for installation of test equipment per MOC 20 MCN 02, the General Maintenance staff found an issue with the pillow block mount for the hoist's north drum bearing in Spillway Bay 15 and requested the bay be closed on July 9 at about 0900 hours. Spillway Bay 15's gate will remain lowered onto seal until the bearing's pillow block is replaced or repaired. The gate cannot be dogged, raised or lowered until the repairs are completed. The flow that would have gone out of bay 15 is being redistributed evenly throughout the remaining bays. The repair parts for the Hoist's north drum pillow block are special order items with an unknown delivery date. To insure the maintenance crews could work safely on Spillway Bay 15 while investigating and removing parts from the hoist, Spillway Bays 14 and 16 were closed IAW HECP procedures on July 13 thru 15 from approximately 0700 to 1800 hours each day.

**Bay 15 hoist issue.**

**F. Future and Preventative Measures:** To reduce risk to Crane 7, a critical EAP response asset, Spillway Bay 2 will be adjusted once a day, or as needed, by the control room operator for spill pattern alterations. Spillway Crane #6 once repaired will be adjusted similarly and both Cranes will be manually adjusted once per day during future spill seasons. Spillway 15 gate hoist repair will occur as soon as parts are available.

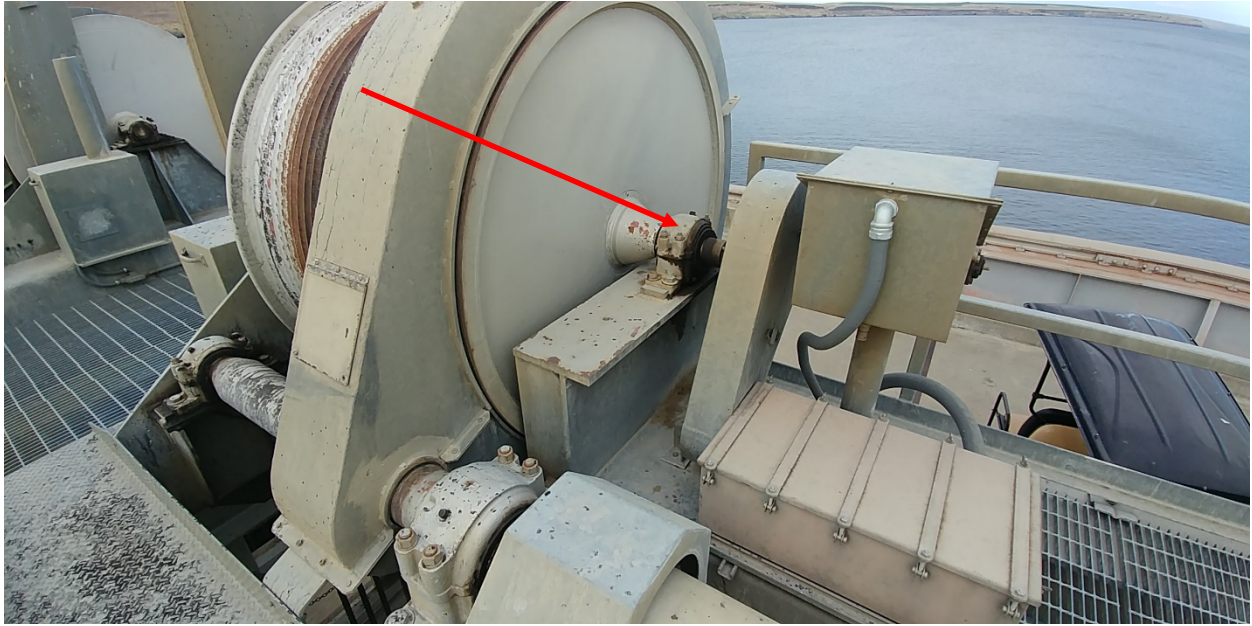
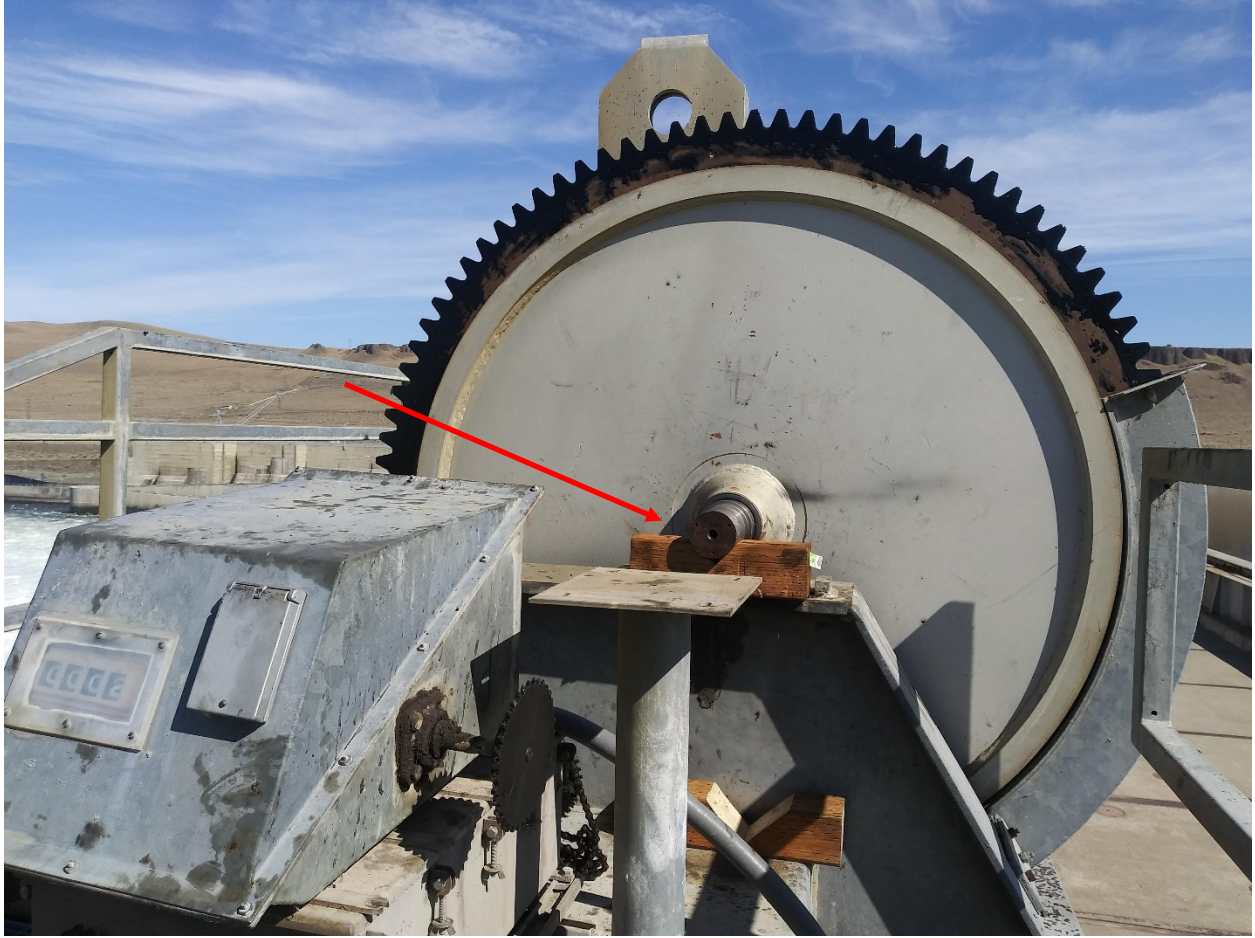
**Hoist before and after parts removed.**

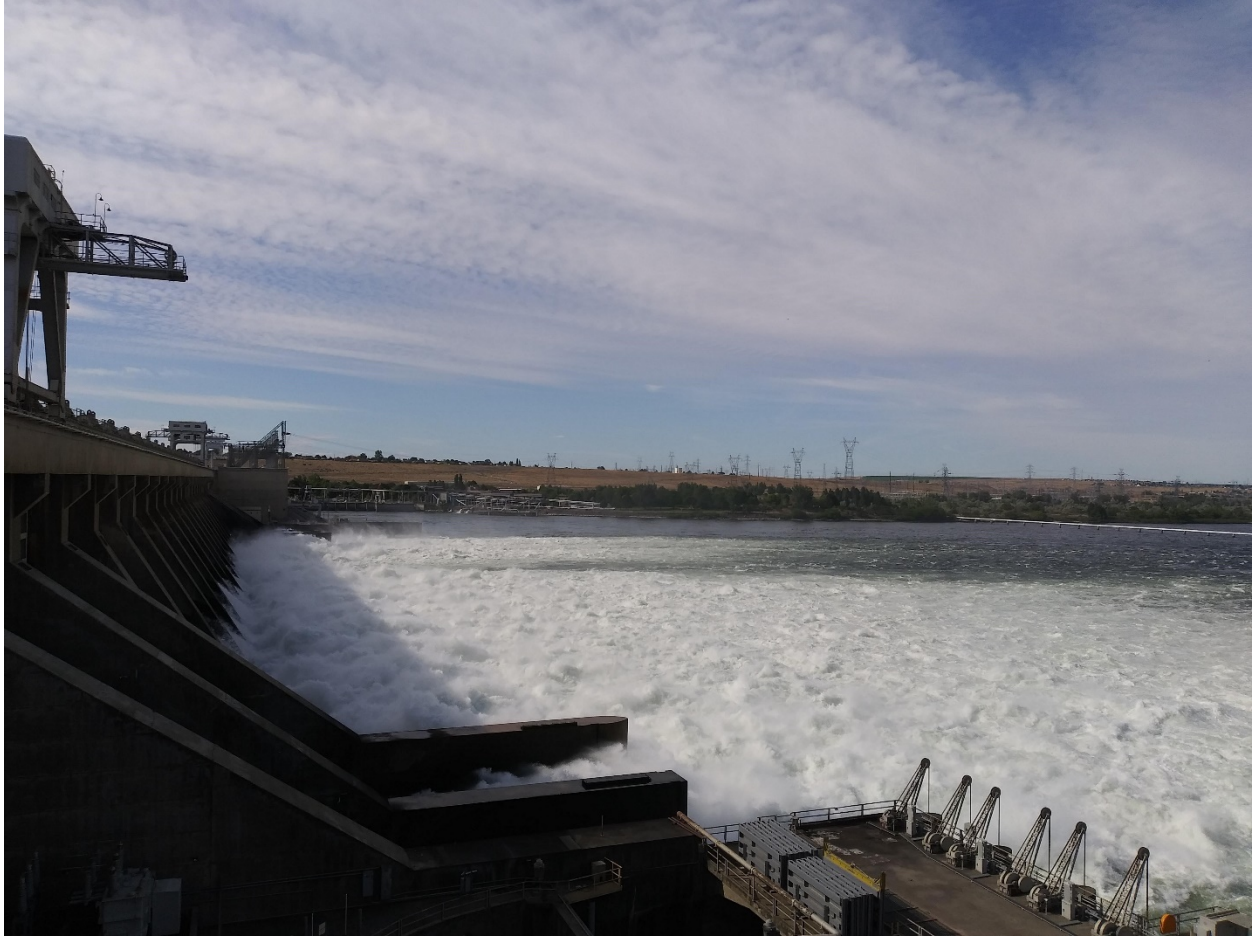
**Spill pattern bay 15 closed.**

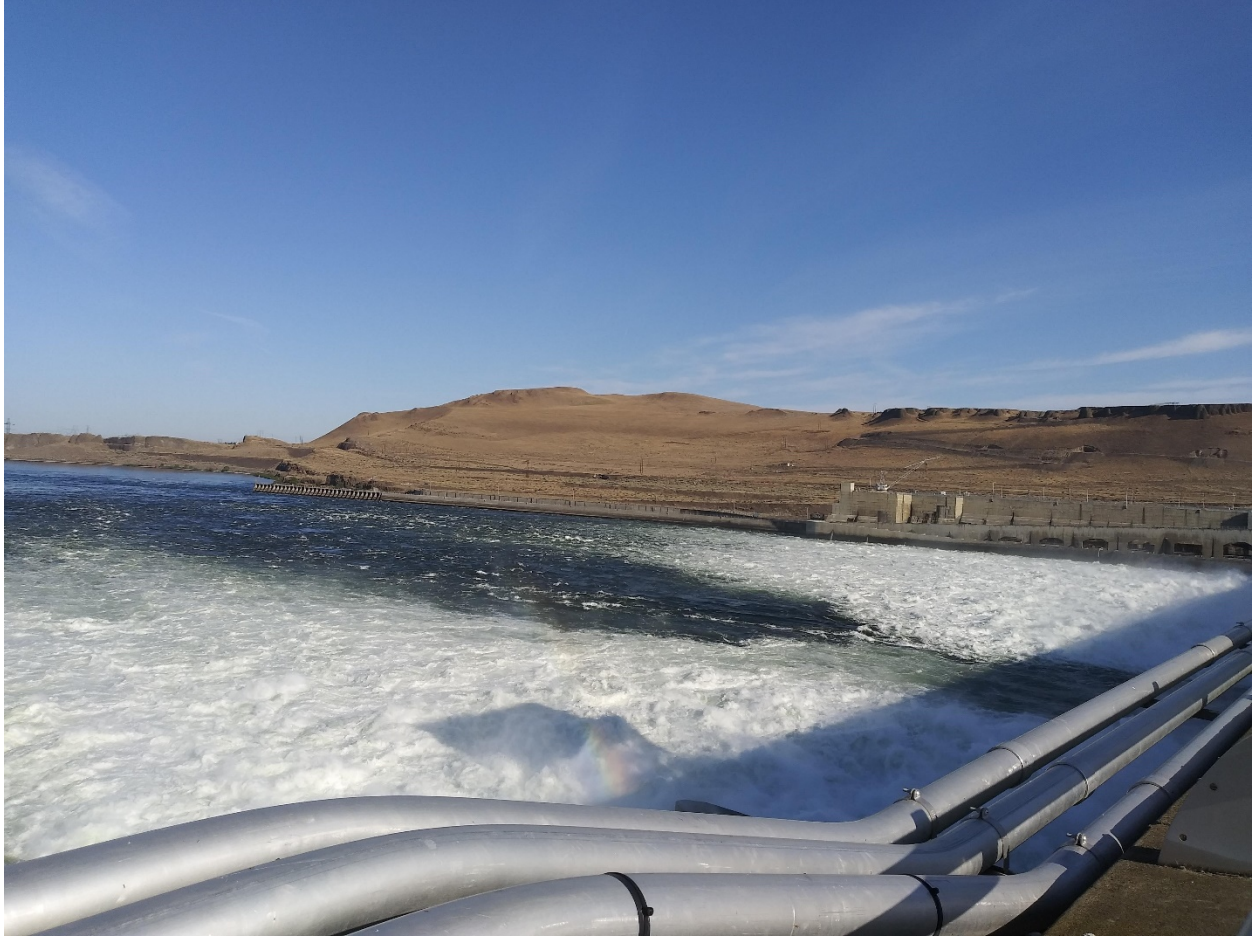
**Spill pattern when removing hoist parts.**

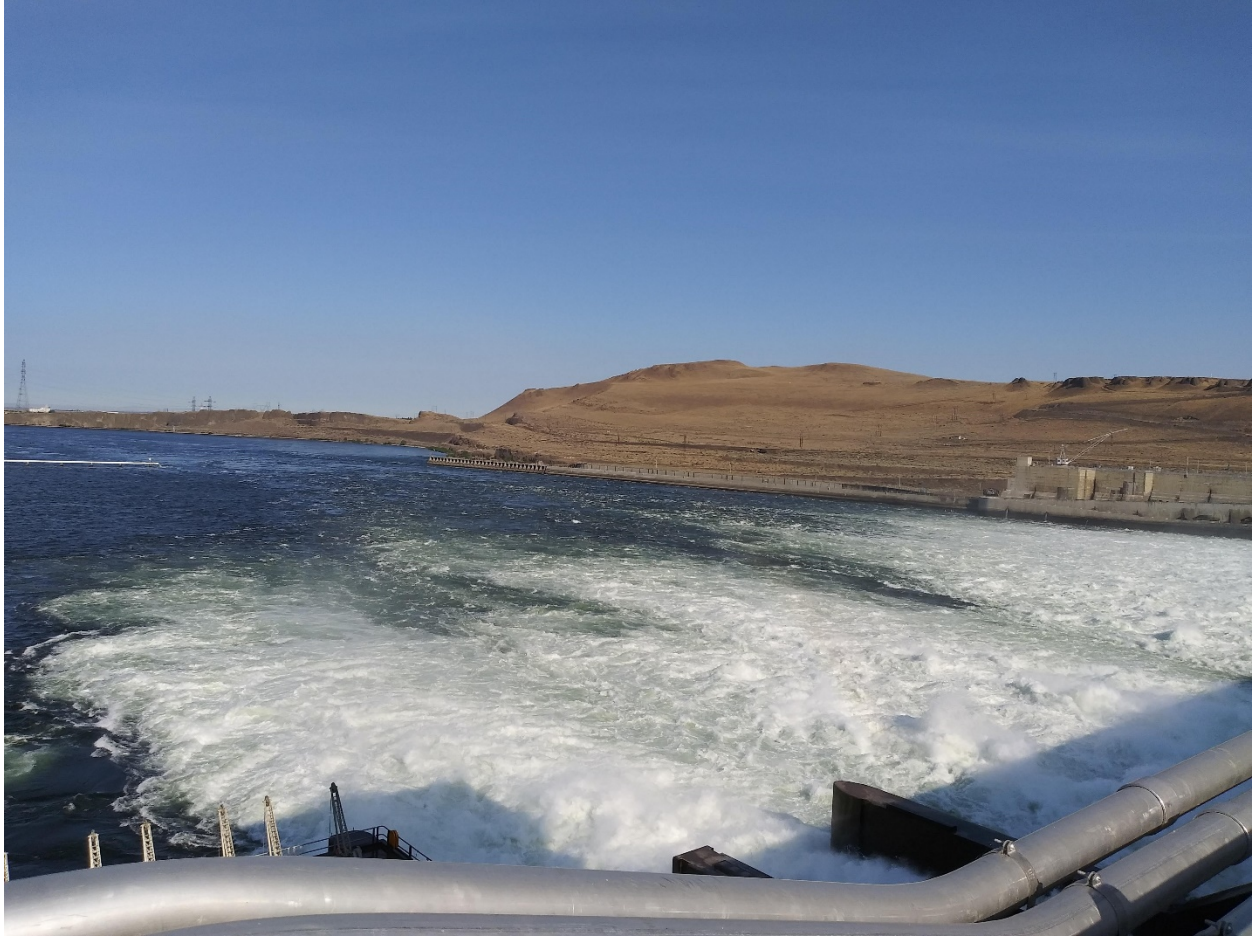
**Spill pattern with bays 15 and 20 closed.**
