**MEMORANDUM FOR THE RECORD**

**SUBJECT:** Update spillbay 15.

**Location:** McNary spillway.

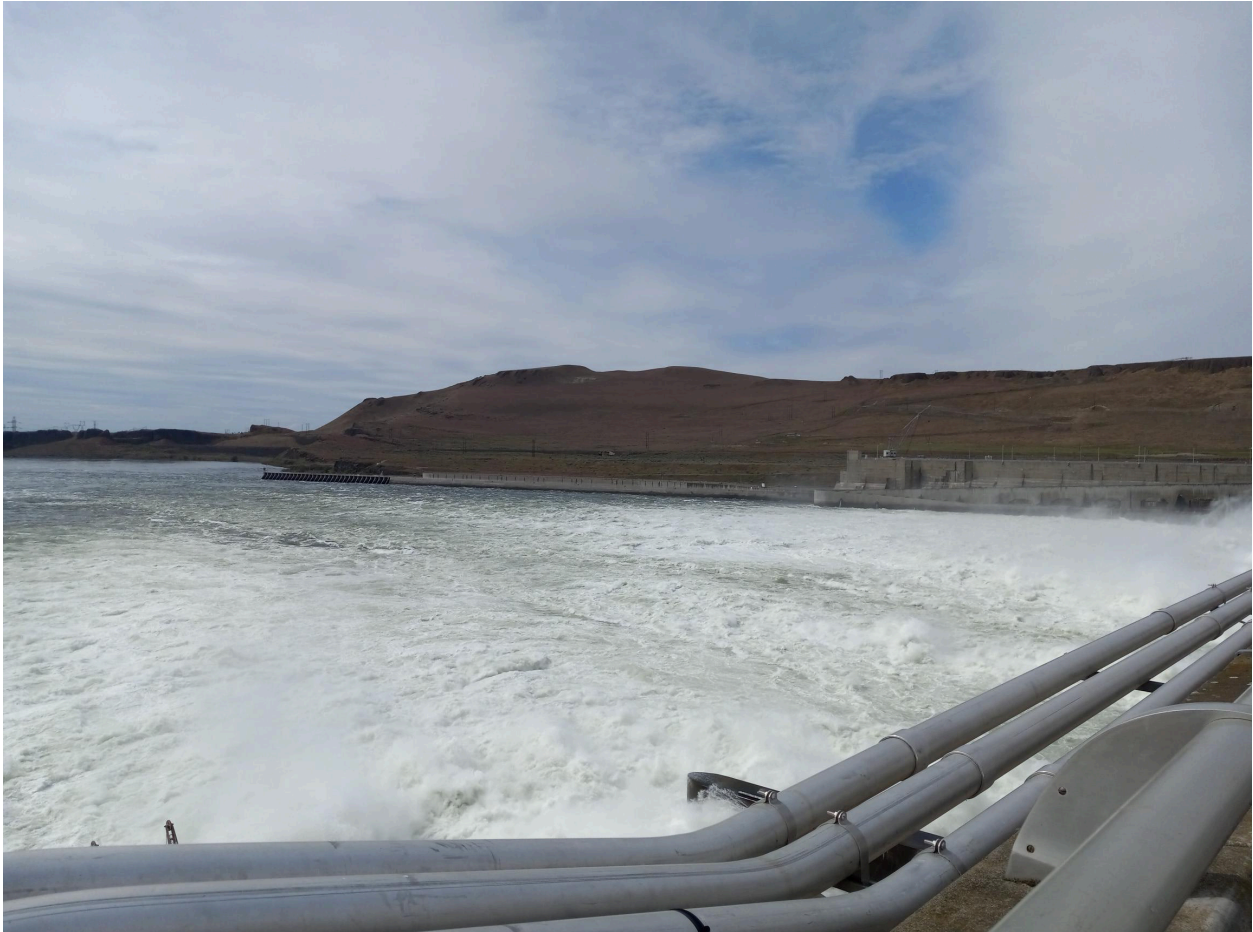
Spill with bays 14, 15, 17 and 18 on sill.
