MEMORANDUM FOR THE RECORD: 22 MCN 15 Unit 1 ESBS and VBS Differential Issues**SUBJECT:** Unit 1 ESBS and VBS Differential Issues

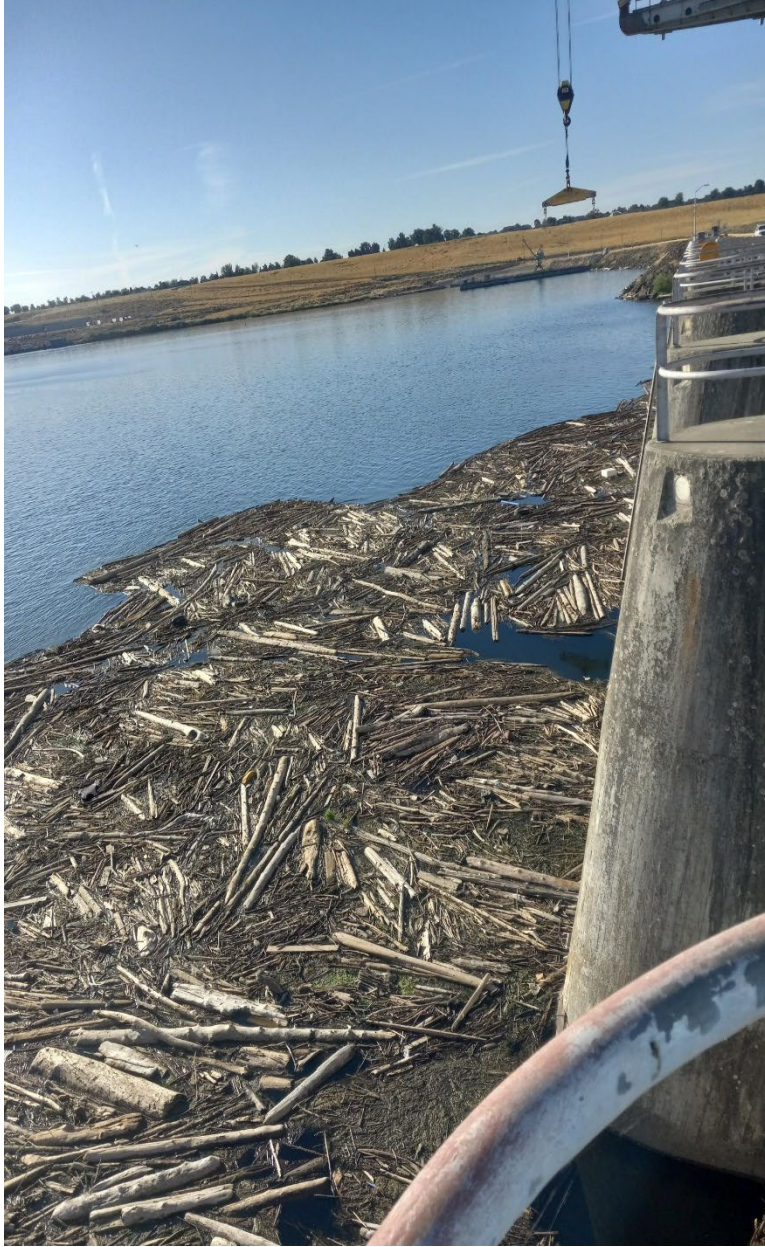
Narrative: The ESBS brush cycling in Unit 1A, and 1B slots were short and multiple cycling, respectively, from August 23 to 25 (FPP, Chapter 5, 2.3.2.2.vi.). The electrical staff found no issues with the wiring or control system. During the same time frame, VBS differentials in 1A and 1B slots measured 1.2 to 1.8 feet with the VBS's requiring cleaning three days in a row, which is very unusual. Trash rack differentials for both slots measured from 1.0 to 1.9 feet over those three days. Project staff determined debris inside and outside Unit 1 was contributing to the ESBS and VBS issues (Photos 1 & 2).

Photo 1: Forebay debris that had been in front of Unit 1 for a week to ten days.

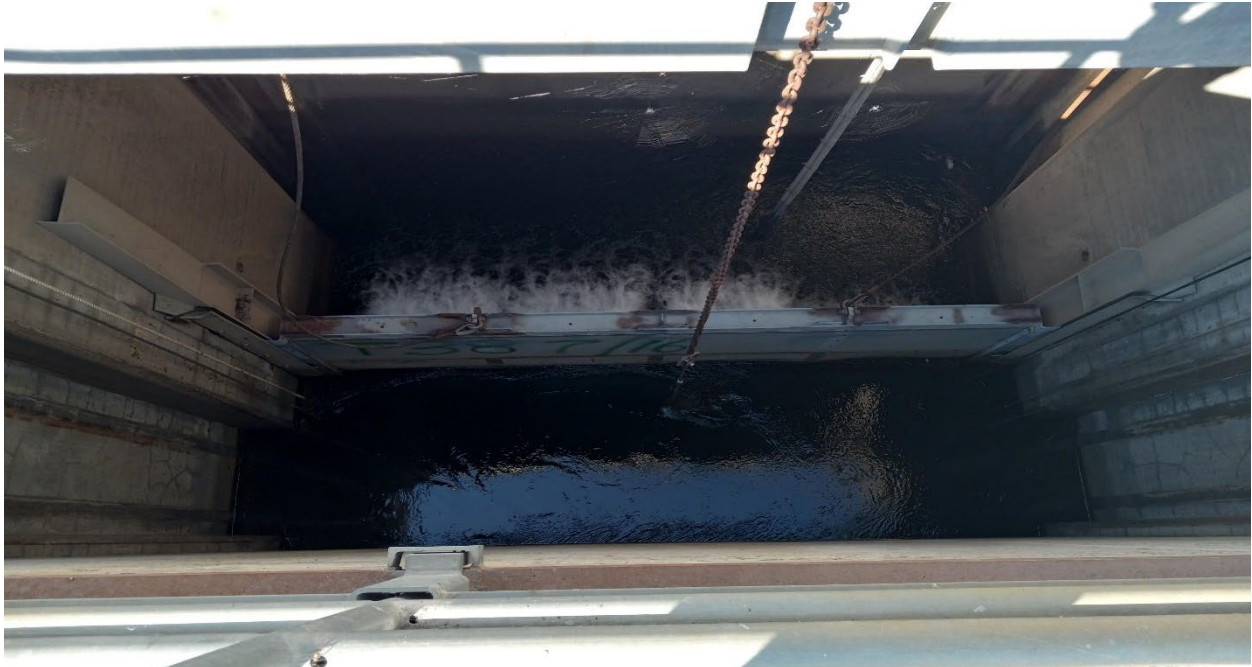
Photo 2: VBS differential caused by debris.

Trash rack and VBS differentials are back to normal ranges.

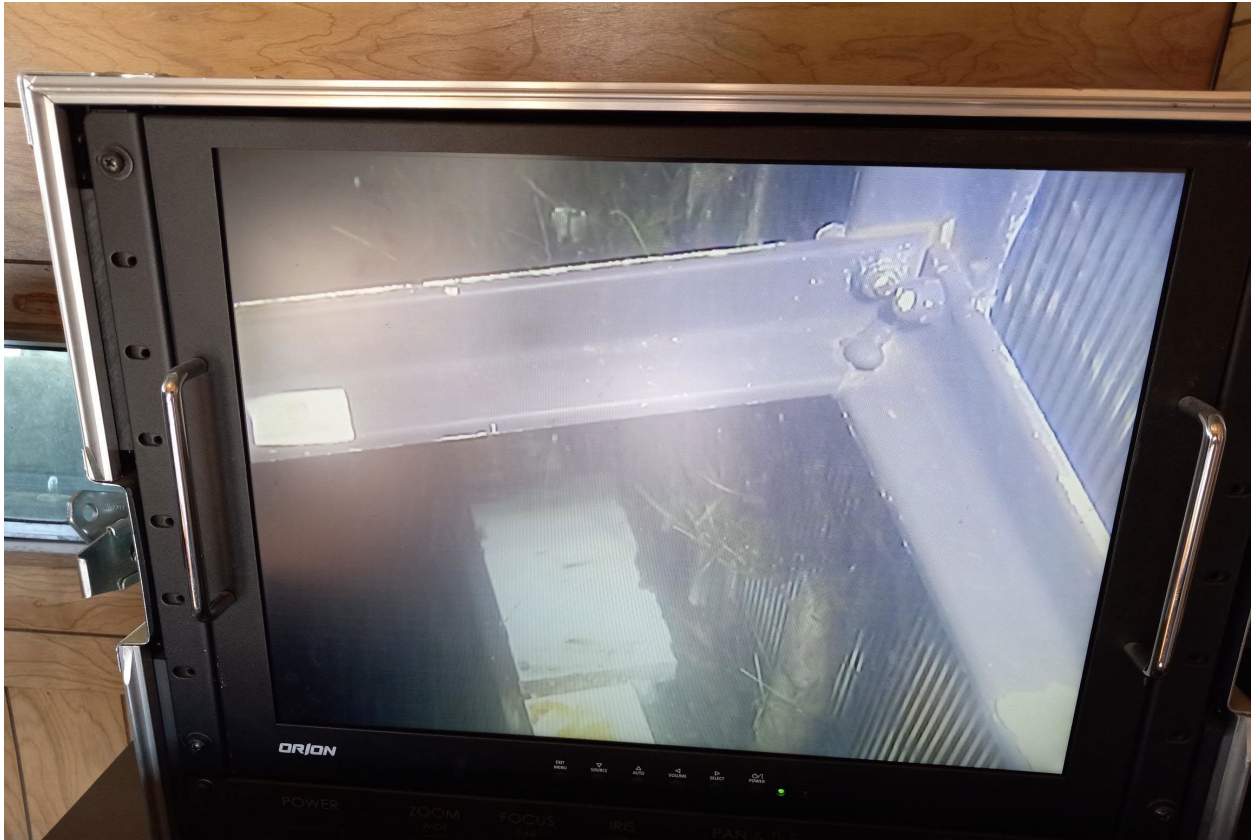
Unit 1 was removed from service at 1105 hours on August 25. A camera inspection of Unit 1's ESBS's occurred from 1110 to 1210 hours. Debris in the slots was more than usual, which could have affected the ESBS's (Photos 3 & 4). Trash racks in all three slots were cleaned from 1210 to 1330 hours. Twenty yards of debris was removed, mostly woody material and Eurasian milfoil, which could have affected VBS differential readings. ESBS's and VBS's were raised from 1330 to 1630 hours. Debris was removed from the ESBS's and the VBS's were cleaned (Photo 7).

Photo 3: Debris on the brush bar and chain on ESBS in 1A slot.

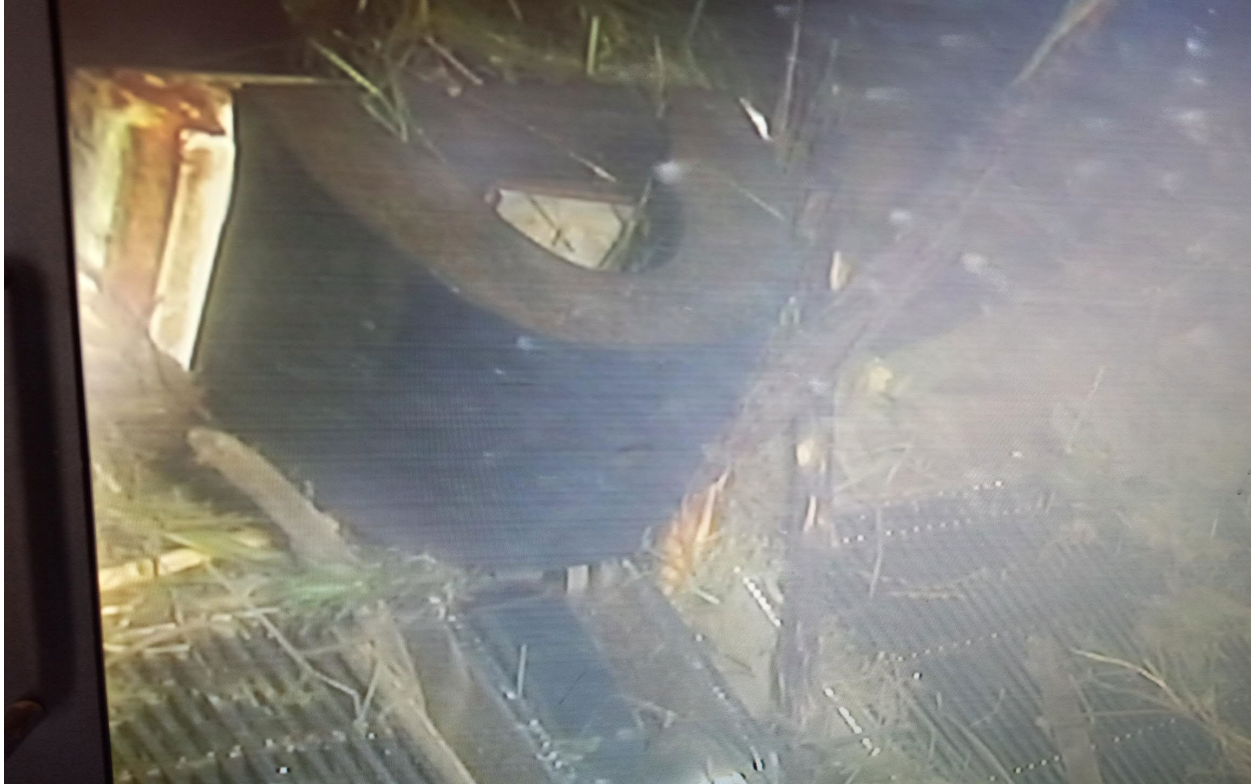
Photo 4: Debris on the top bumper on the ESBS in 1A slot.

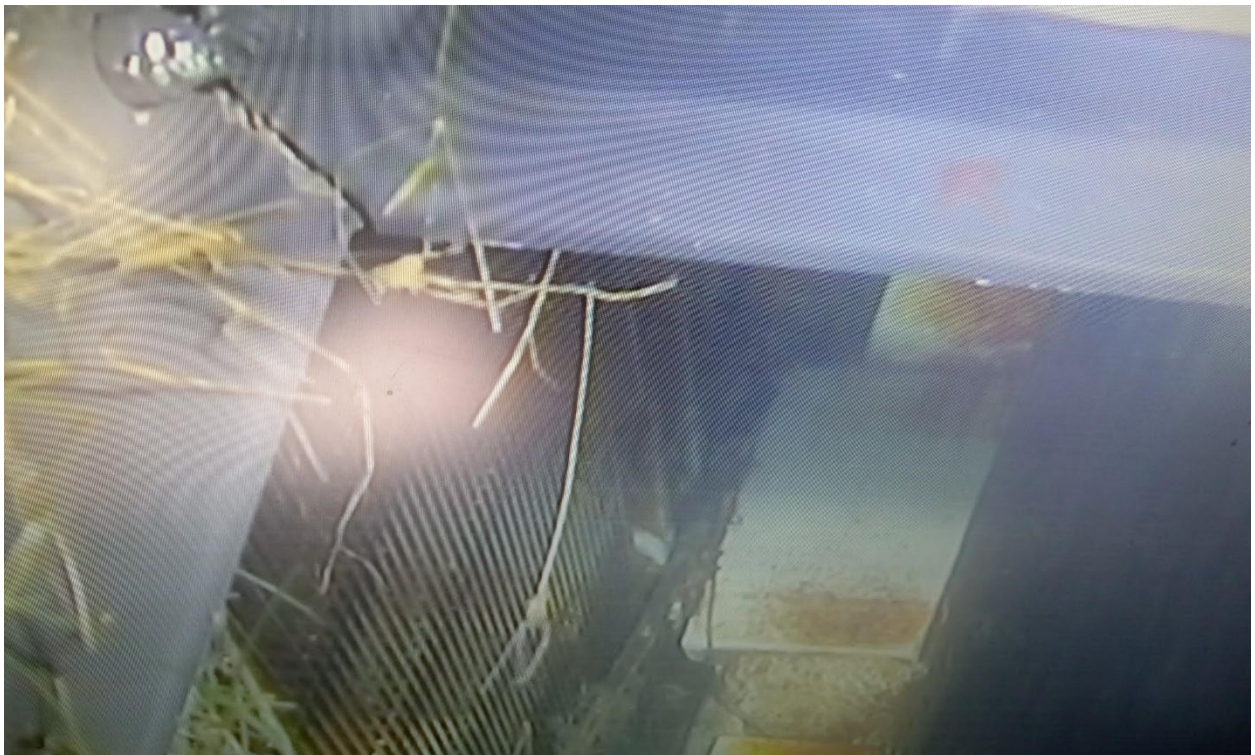
Photo 5: Debris on the brush bar and chain on the ESBS in 1B slot.

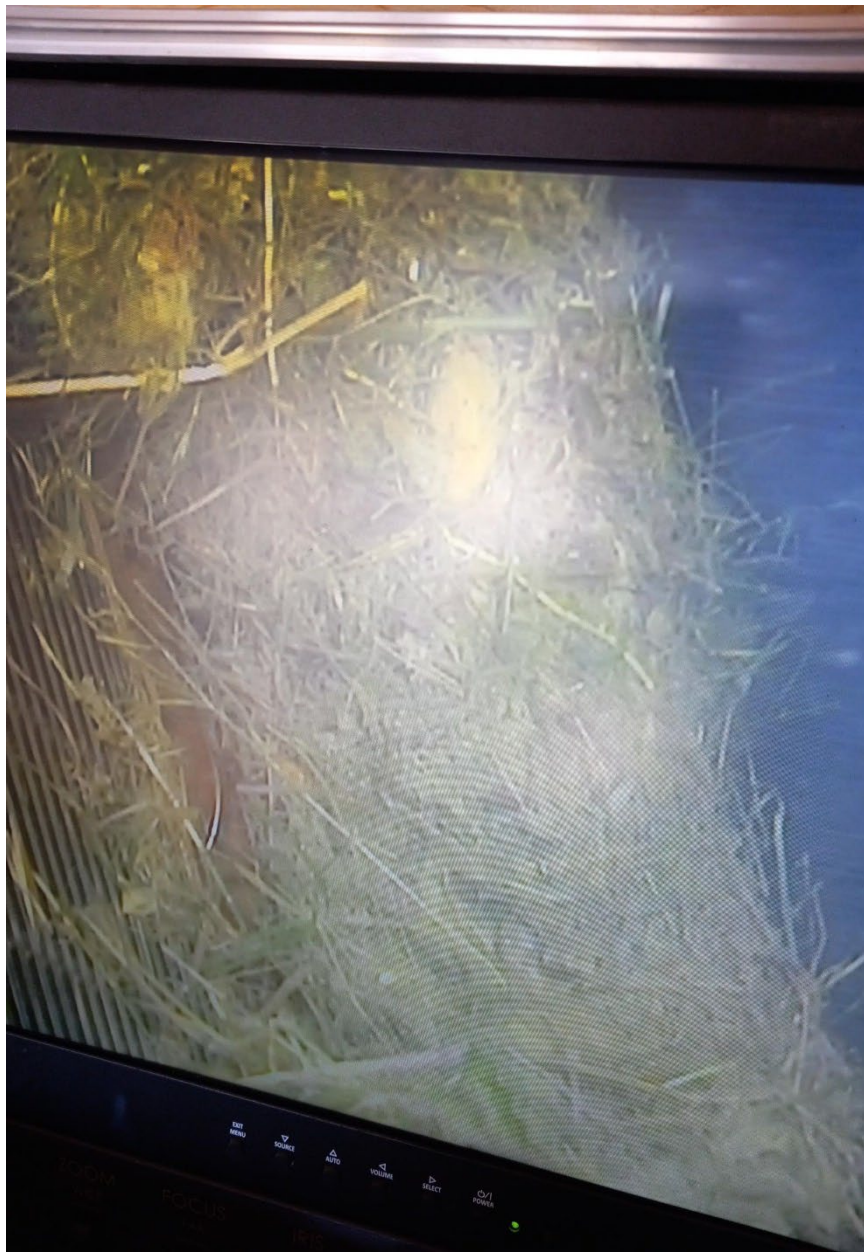
Photo 6: Debris wad on the ESBS in 1B slot.

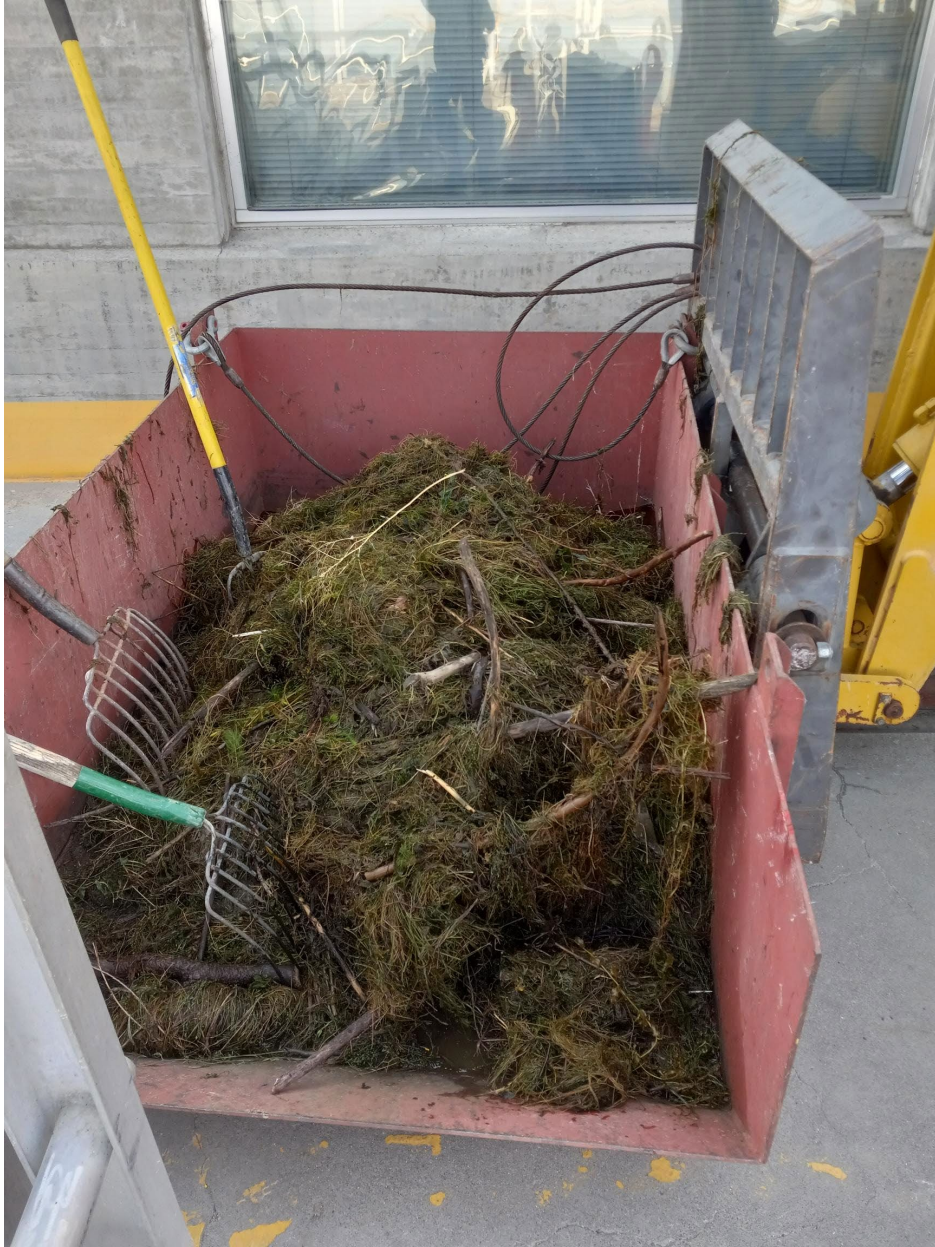
Photo 7: Debris removed from the two ESBS's (mostly the screen in 1A slot).
