COLE M. RIVERS FISH HATCHERY MODIFIED OPERATIONAL CONDITION ASSESSMENT

6-8 February, 2019

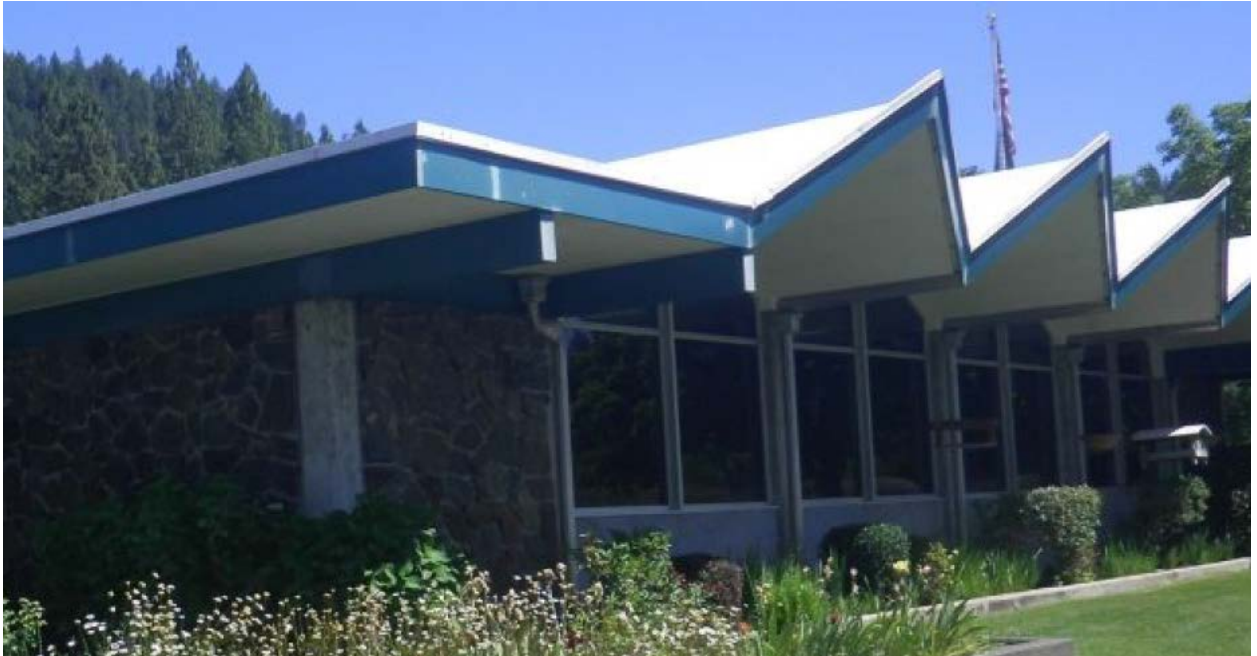
a. Hatchery Building/Hatch House

The Hatch House is in generally good condition, represented by the “B” ratings applied to most assets. The building is original and showing expected signs of aging, including a roof with minor leaking, insufficient electrical receptacles for modern equipment needs, and outdated/hard to source HVAC components.

The egg incubation area is a major feature of this building, and has a compromised water supply evidenced by several water quality tests that have detected the presence of pathogens and other contaminants (e.g. diatoms). These concerns are further detailed in the Electrical and Mechanical Building (Water Treatment Area) section of this report.

The interior lighting in the egg incubation area has negative impacts due to color temperature, placement, and a lack of on/off ramping controls. These deficiencies are added stressors to the fish.

System	Asset	Maintenance/Testing Activity Description	Notes
Water Supply	12" Supply Pipe	Confirm the source of the bacterial and other (e.g. diatoms) contamination by sampling and testing. If contamination source is confirmed to be in the 12" steel water supply pipe, a new design project should be initiated to replace this with new pipe.	ODFW has performed testing to narrow down the location of the contamination to this general location.
Building Structure	Roof	Fix existing leaks	ODFW already addresses this as the need arises.

System	Asset	Maintenance/Testing Activity Description	Frequency
Building Structure	Roof	Roof Replacement	20 Years
Lighting	-	Redesign and replacement of lighting system in egg incubation room	n/a

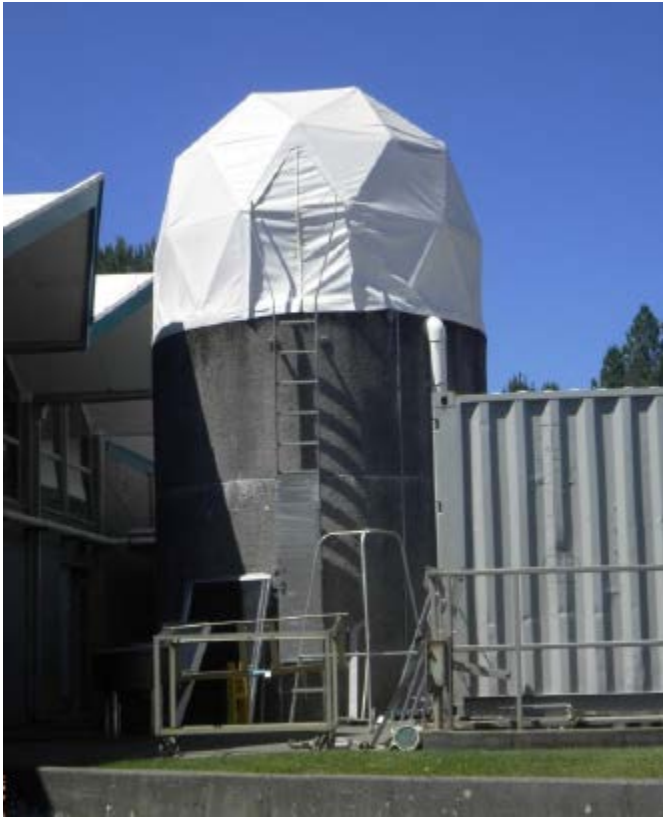
c. Electrical and Mechanical Building (Water Treatment Area)

These systems have been heavily modified since original construction. The reuse/recycling water feature has been abandoned. Three UV sterilizer units, the sand filtration system, and the micro-screen filtration system have all been added after original construction. The aeration tower is not currently in use due to concerns with bacterial and diatom contamination observed in December of 2018. In March of 2019, diatom contamination into incubation building was observed.

The assessment team had significant concerns with this area of the project. The water treatment system has been modified in several different evolutions since initial design and construction. The resultant system is overly complicated and has observable deficiencies. The primary concern is that the UV water treatment system does not occur in the final phase of water distribution to ensure clean water to the hatch house. The current configuration does not allow for this. Additionally, the sand filters have a backwash only. There is no

wash feature after the backwash process. Thus, filtered debris may enter the lines when switching from backwash to filter if there is no wash feature. Especially, if the time of backwash is too short.

As the above is only a temporary solution, the assessment team recommends a redesign of the water treatment system to include: better screening prior to the pumps, sand filters with wash feature, new pumps, boiler/chiller, UV system, sampling ports, and temperature monitoring.

System	Asset	Maintenance/Testing Activity Description	Notes
Water supply/treatment	Aeration Tower	Bypass piping around tower, and mitigate lost use of tower (used for head and degassing)	ODFW has performed testing to narrow down the location of the contamination to this general location. This is a critical area that needs addressing for the facility to meet mission requirements.
Water supply/treatment	12" Steel Supply Pipe (from Aeration Tower to Egg Incubation Area)	Immediately evaluate and implement ODFW's recommended temporary solution (in progress as of 18 March 2019)	ODFW has provided a piping design that needs evaluation for feasibility and constructability (in progress as of 18 March 2019).

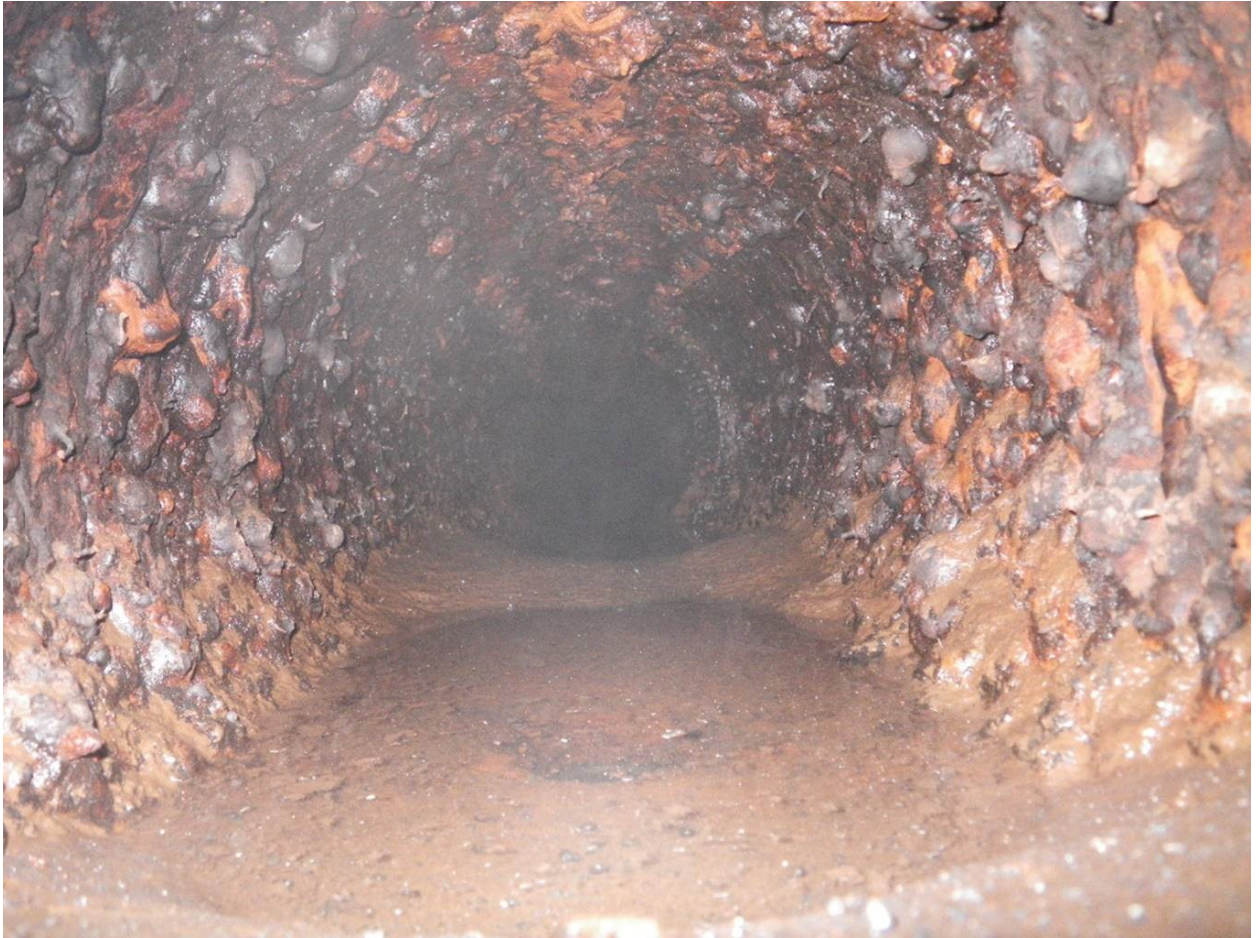
The main steel 12" water supply header that provides distribution water throughout the facility is a, likely, main contributor to the bacteria and diatoms in the water. Sections of the steel pipe have been replaced in the past. Interior photos of the replaced pipe section shows a rough pipe with significant corrosion. A rough, corroded pipe provides pockets that can trap bacteria. ODFW has tried several times to disinfect this pipe, but efforts have been unsuccessful to date.

ODFW has provided a sketch recommendation for piping that could be implemented to bypass areas of likely contamination. The sketched recommendation is an interim solution to fix the immediate problem, not a permanent one. The sketch appears to utilize easily acquired materials and simplified assembly to provide an interim fix to the problem. This should be evaluated by the OCA Technical team and immediately implemented if it appears to solve the problem (evaluated and is in progress as of 18 March 2019).

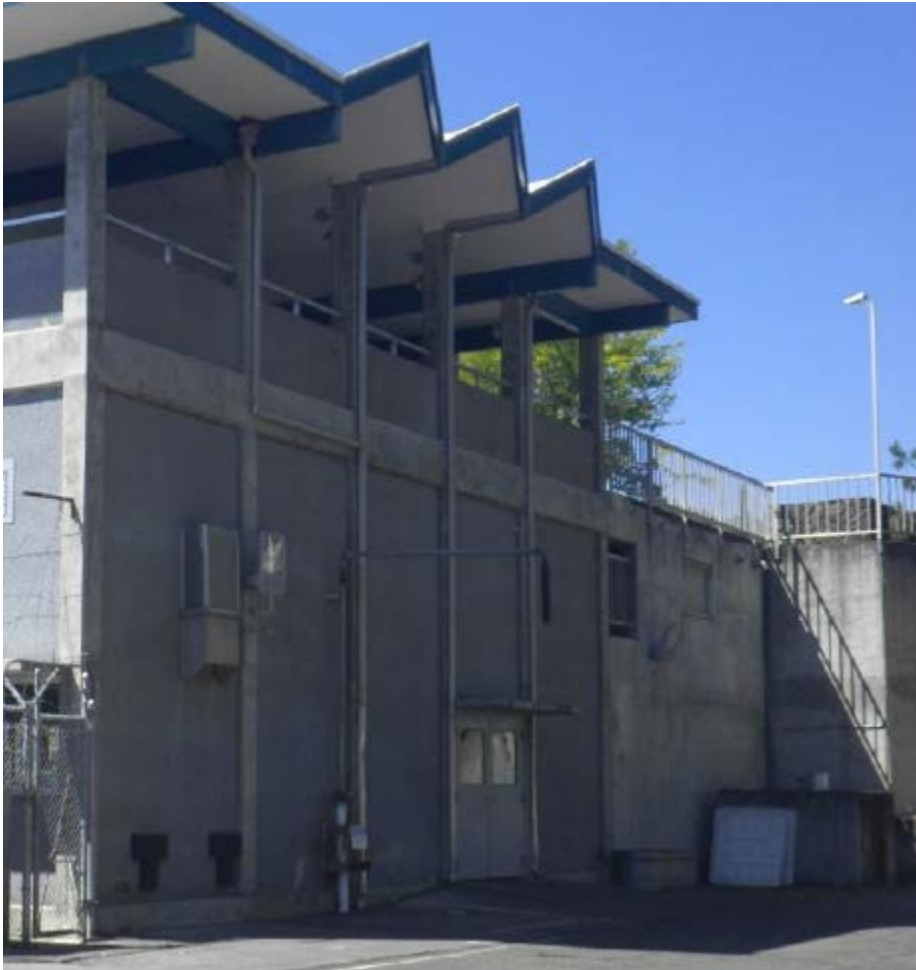
d. Spawning Building

The Spawning Building is in generally good condition, represented by the “B” rating applied to most criteria. The building is original and showing expected signs of aging, including a leaky roof.

The evolution of work performed in this building has outgrown the original configuration/design. The working area is not conducive to the spawning operations (space limitations, work flow issues, etc). Effluent from the fish handling procedures can no longer be returned to the river, but must now enter the sanitary sewer system.

System	Asset	Maintenance/Testing Activity Description	Notes
Spawning Building Brail (Redesign)	Hoist Controls	Analyze and modify limit switch/sensor devices to increase the robustness of the hoist control system and to protect against equipment damage due to misoperation.	Current operators have to carefully monitor hoist during operation to prevent two-blocking and damage to the system as the current limit switches are not reliable. Current configuration has resulted in failures and associated fish kill events.
Spawning Building Brail (Redesign)	Hoist Sizing	Increase capacity of hoist, or limit number of fish being hoisted.	Hoist can be easily overloaded. No simple way to remove fish once loaded.
<u>Low Criticality Recommendations</u>			
Spawning Building Brail (Redesign)	Equipment Layout/Geometry	Redesign hoisting system and brail basket. Efficient/effective maintenance cannot be performed on the hoist in its current configuration due to limited access to critical hoists and motors that require maintenance and testing.	Hoist motors/drums are not easily accessible.

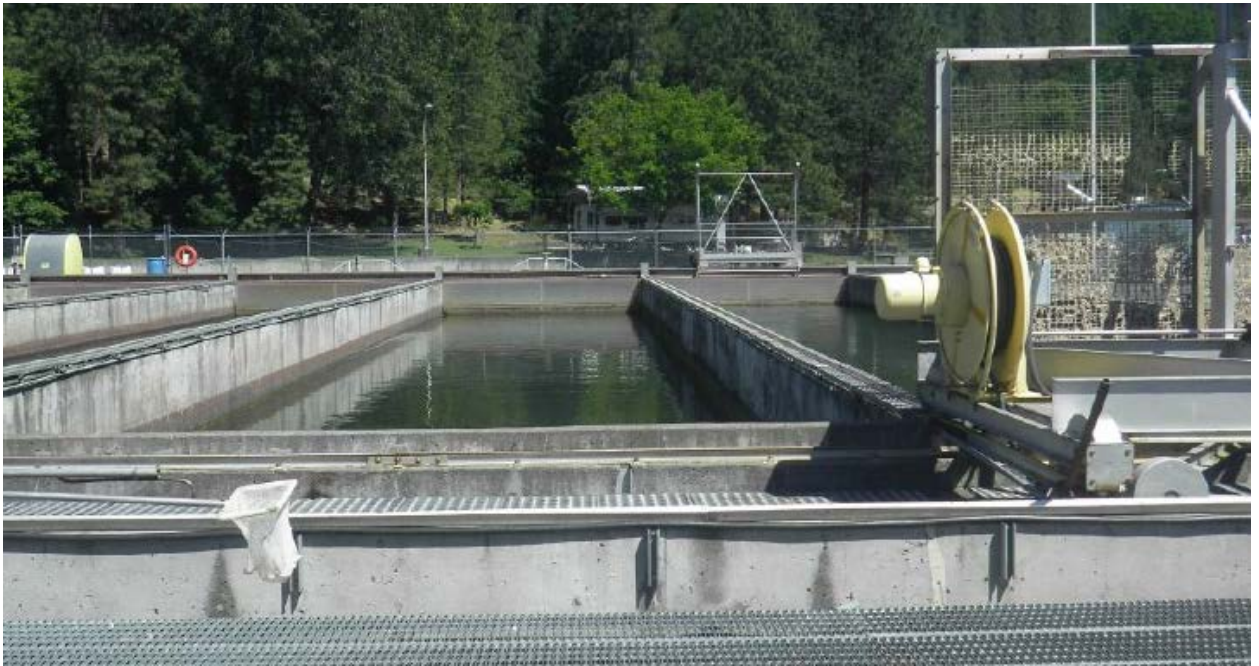
f. Brood Collection Holding Ponds

The holding ponds are in generally good condition. The crowder/sweeps are aging and have reliability issues associated with limit switches, cable reels, and cable seals. These issues can and have been mitigated by the operating staff through ongoing maintenance, and do not present an immediate concern to fish or personnel safety. However, all crowdors are closely monitored during any operational activity due to these known deficiencies.

Handrails and fall protection do not meet current safety standards as installed. Refer to existing safety audit (Safety and Occupational Health Assessment – May 2018) for additional information.

ODFW indicates the post-sort holding ponds have never been dewatered. An outage should be planned an effort should be made to see if this area can be easily dewatered. Upon dewatering, the ponds should be cleaned and inspected and the sweeps should be thoroughly inspected and maintained (cleaning and re-greasing bushings, wire rope inspections, electrical cable evaluation, electrical maintenance, and water supply and drain evaluation).

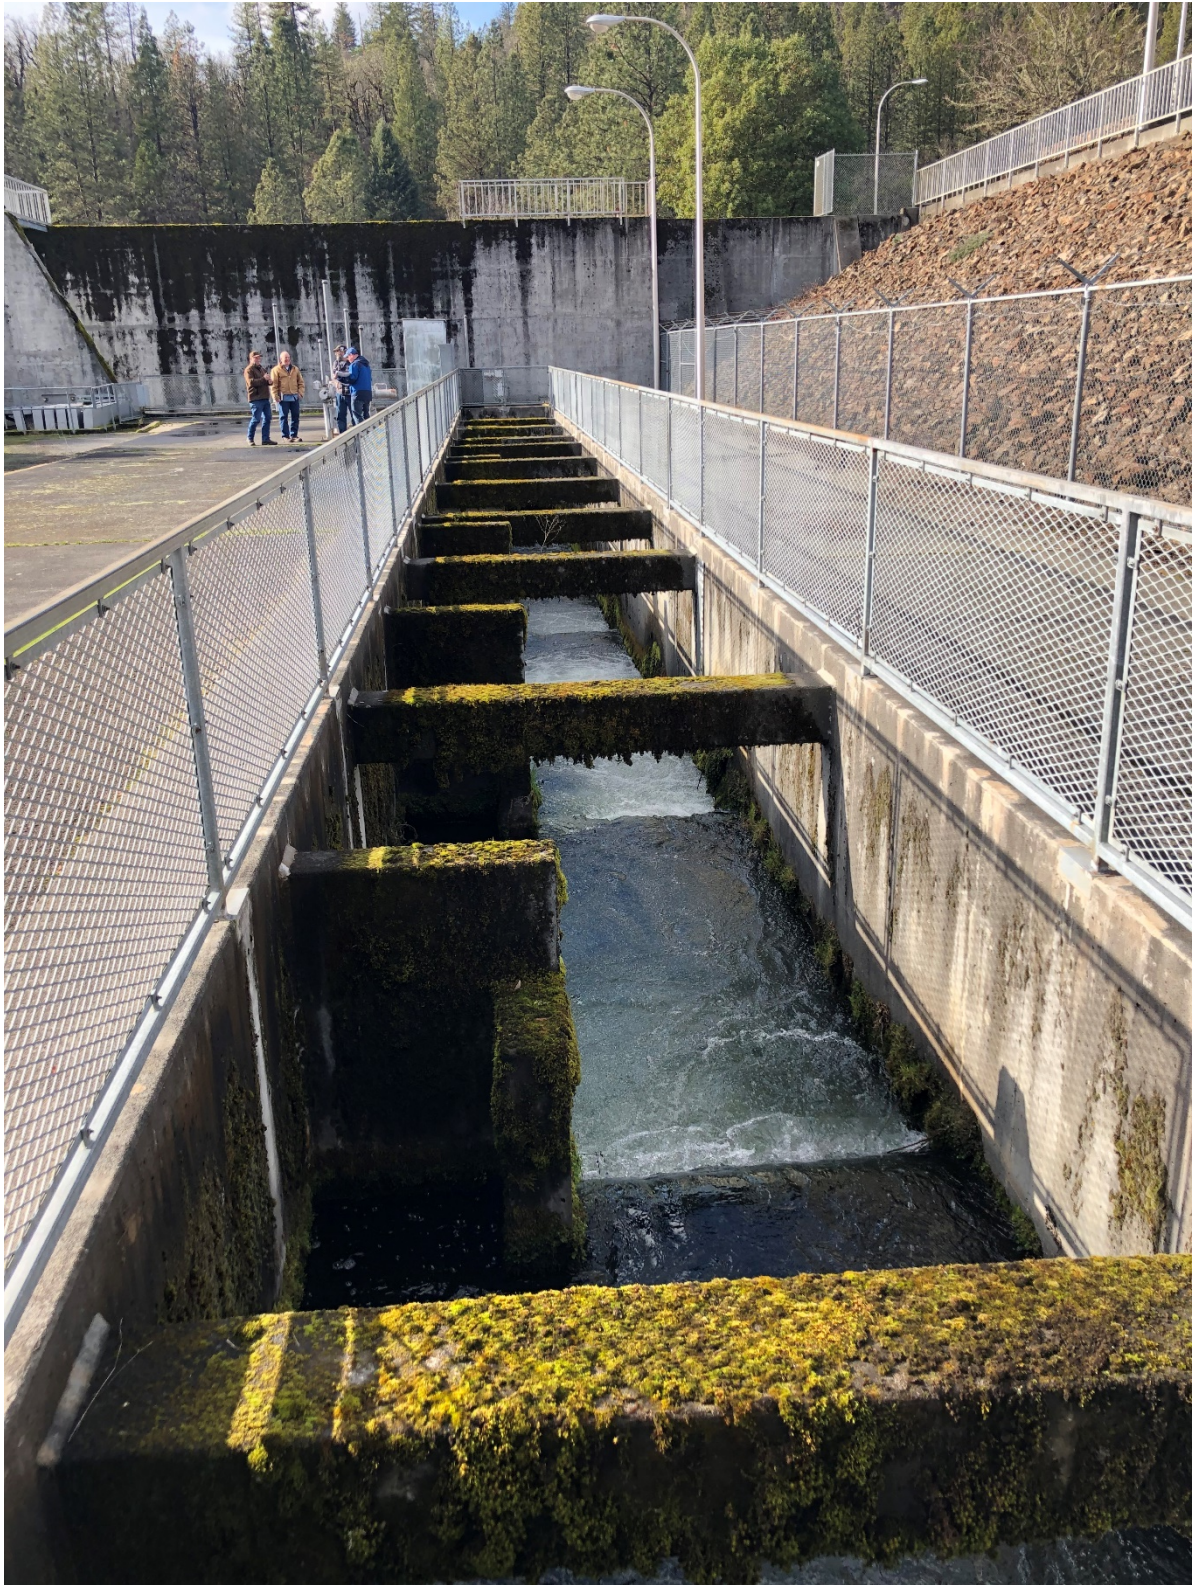
g. Fish Ladder

The fish ladder has been continually functioning since the original construction of the facility. The watered up portions of the ladder have therefore never been inspected, cleaned, or maintained in any way. To dewater, various slide gates would need to be closed and entrance bulkheads would need to be placed. The bulkheads have never been deployed and the slide gates haven't been moved in approximately 30 years. It is unlikely that these would operate if required

There are no signs of deteriorating conditions in the ladder, but the lack of inspections are a concern.

ODFW indicates the ladder and pre-sort pond has never been dewatered. As discussed above, an effort should be made to see if the slide gates can move whereby this area can be dewatered. Upon dewatering, the fish ladder should be cleaned and inspected and the sweep should be thoroughly inspected and maintained (cleaning and re-greasing bushings, wire rope inspections, electrical cable evaluation, electrical maintenance, and water supply and drain evaluation). Many of the motor mounts from on the slide gate actuators appear to be cracked or broken, it is unclear if these would operate to facilitate dewatering. Once dewatered, all slide gates should be evaluated and maintained (re-grease gear boxes, replace packing, fix motor mounts, replace gate guides, etc.).

System	Asset	Maintenance/Testing Activity Description	Frequency
Fish Ladder	Concrete Structure	Develop and implement a plan to dewater and visually inspect the ladder. This will require a mobile crane to place bulkheads.	Every 2 years
Pre-Sort Pool	Crowder	While dewatered, perform overhaul maintenance on sweeps, slide gates, and other operational equipment within the pre-sort and post-sort holding ponds.	Every 2 years

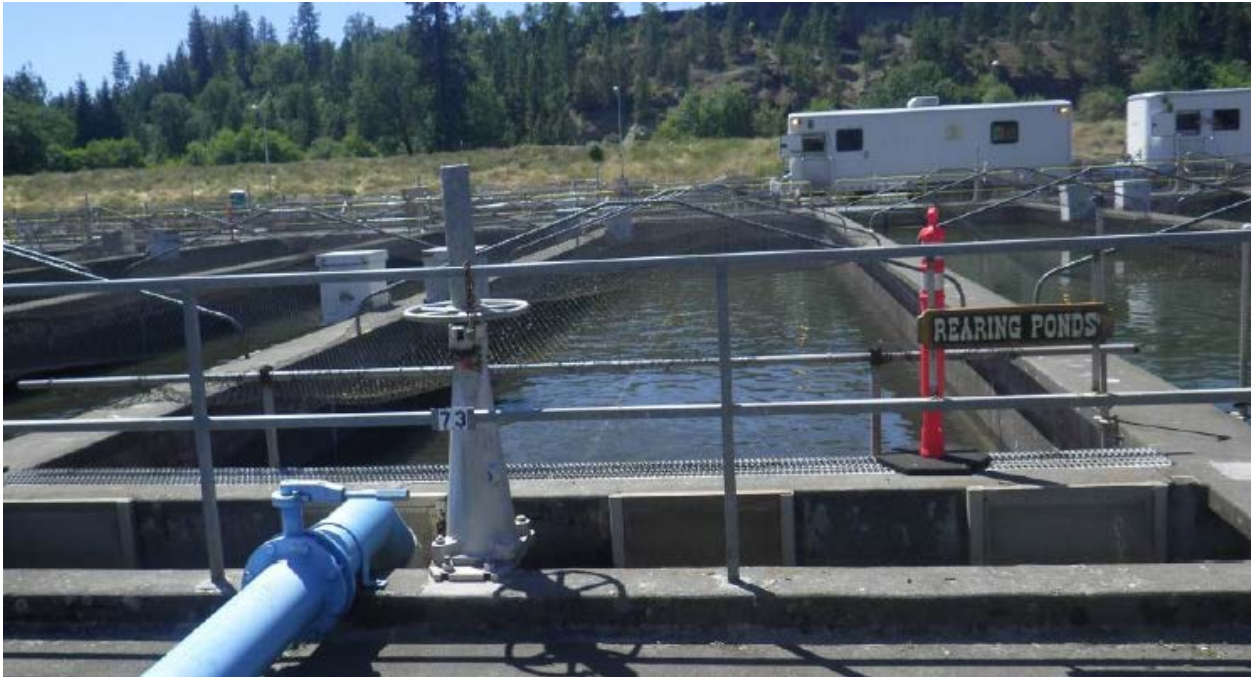
h. Rearing Ponds/Raceways

The rearing ponds/raceways are in generally marginal/fair condition. The surface layer concrete has worn/chipped away, exposing the rough aggregate beneath. This surface can collect/harbor waste products, pathogens, and algae, potentially impacting fish health.

Joint failure and concrete cracking of the raceways has resulted in settlement of the ponds, sinkholes in the adjacent roadways, and cross contamination potential between ponds.

Handrails and fall protection do not meet current safety standards as installed. Refer to existing safety audit (Safety and Occupational Health Assessment – May 2018) for additional information.

System	Asset	Maintenance/Testing Activity Description	Notes
Rearing Ponds	Structural Concrete	Perform a geotechnical inspection to evaluate potential damage due to settlement. Establish a plan repair rearing pond structural concrete.	Prioritized list of rearing ponds should be created to ensure only the ponds in the best conditions are utilized for rearing fish.
Rearing Ponds	Structural Concrete	Perform a civil inspection to evaluate potential repairs to surface concrete/coating.	ODFW has done preliminary research on coating solutions, but does not have a budget to act upon research

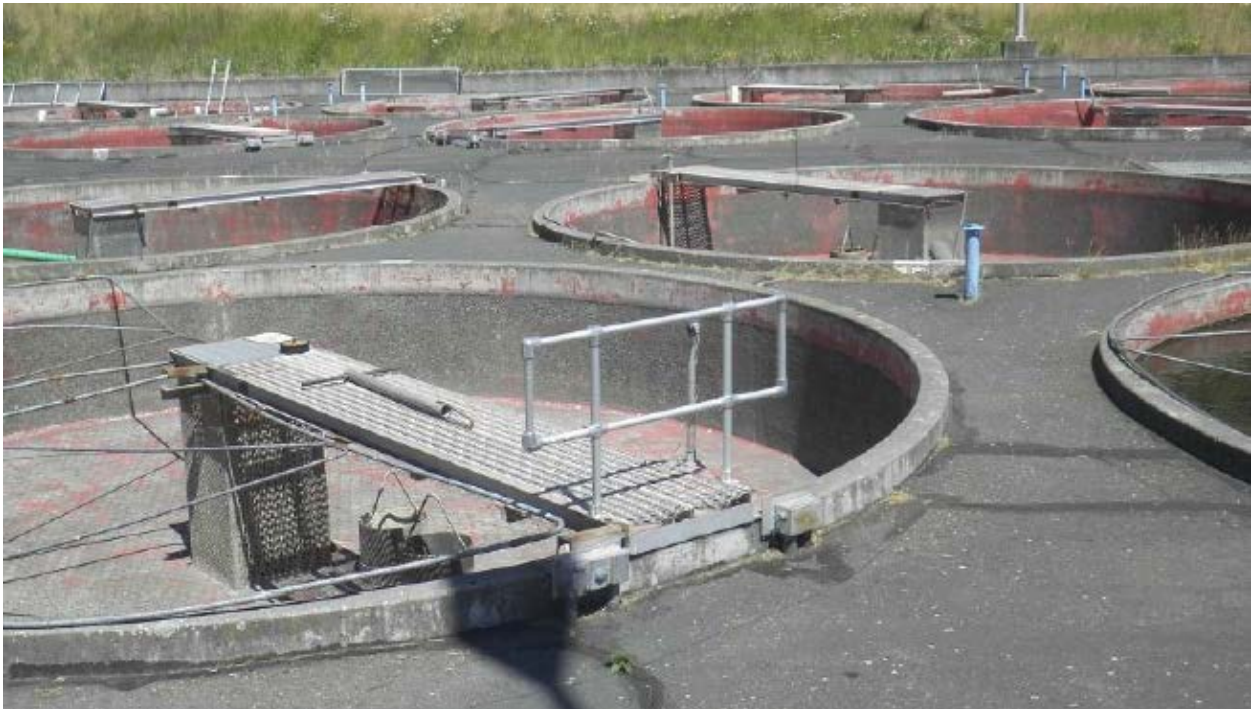
i. Circular (outside) Starter Ponds

The circular ponds are in marginal/fair condition. The surface layer concrete has worn/chipped away, exposing the rough aggregate beneath.

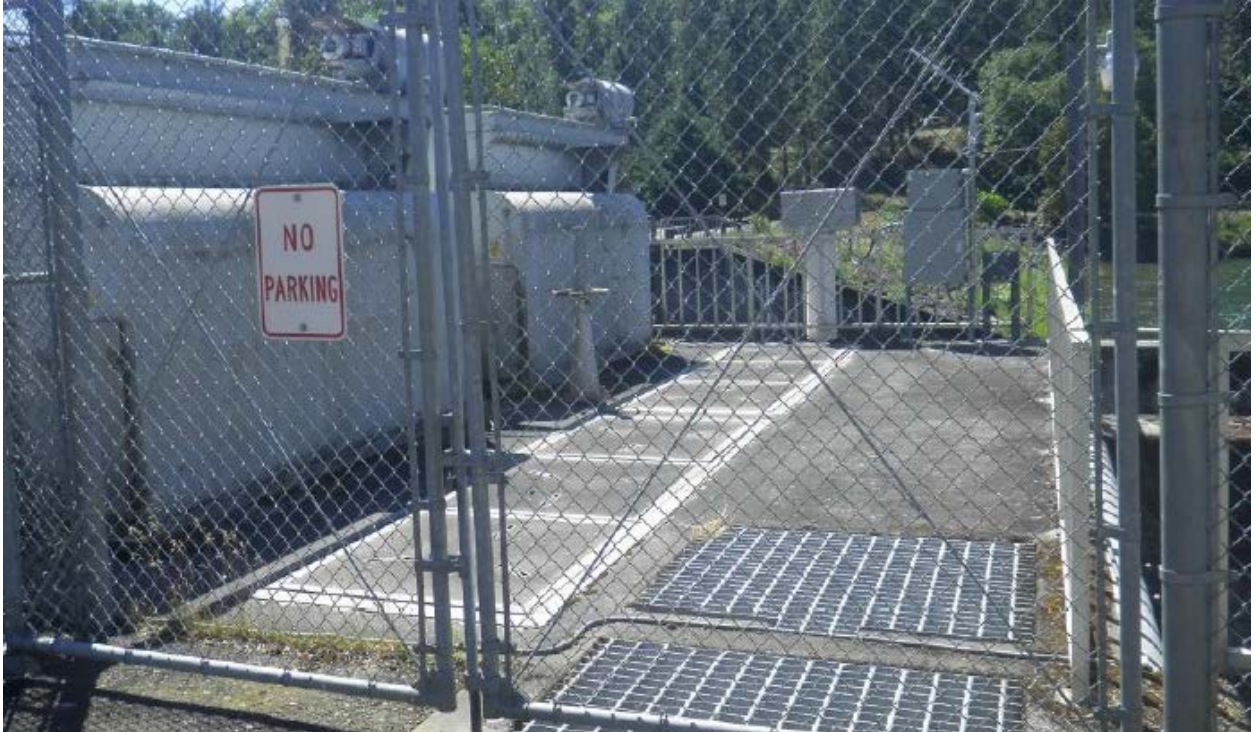
j. Water Supply Intake/Structure

The river water supply intake is in generally good condition. The only concerns with this area of the facility do not affect fish production goals, and are not considered major at this time.

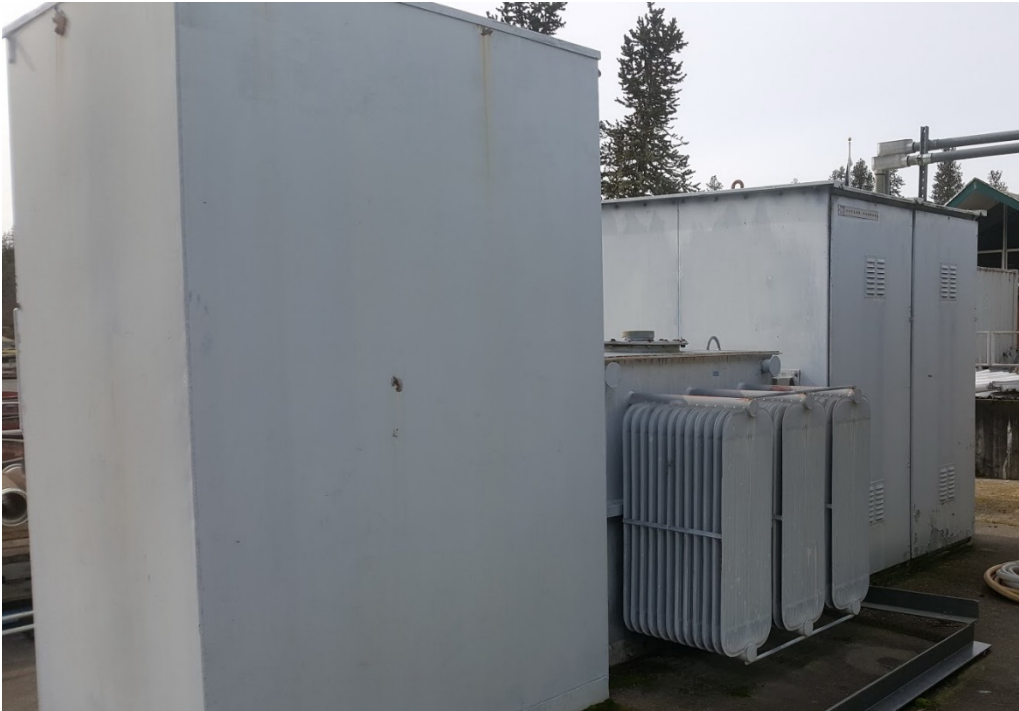
k. Electrical Power System

All power related components are in relatively good operating condition considering their age. Electricians from CENWP-ODR perform annual breaker maintenance on the main supply breakers.

- Lack of spill containment for oil-filled substation transformer; transformer oil could potentially make it into the river.
- Lack of spare draw-out circuit breakers for 480V metal-enclosed switchgear (failure of a breaker would severely impact hatchery operations until a replacement could be installed); some of the existing draw-out breakers do not operate as designed (electric closing coils won't charge, breakers must be operated manually).

- As a minimum, one spare draw-out circuit breaker for each frame size (800A and 1000A) should be purchased. This would be suitable as long as rating plugs from the existing breakers are interchangeable. The purchase of spares would also allow existing malfunctioning breakers to be temporarily replaced with a spare so existing breakers could be repaired.
