## 2017 BON Spillway Apron ROV Inspection Report

**Inspection date:** 11/8/2017;

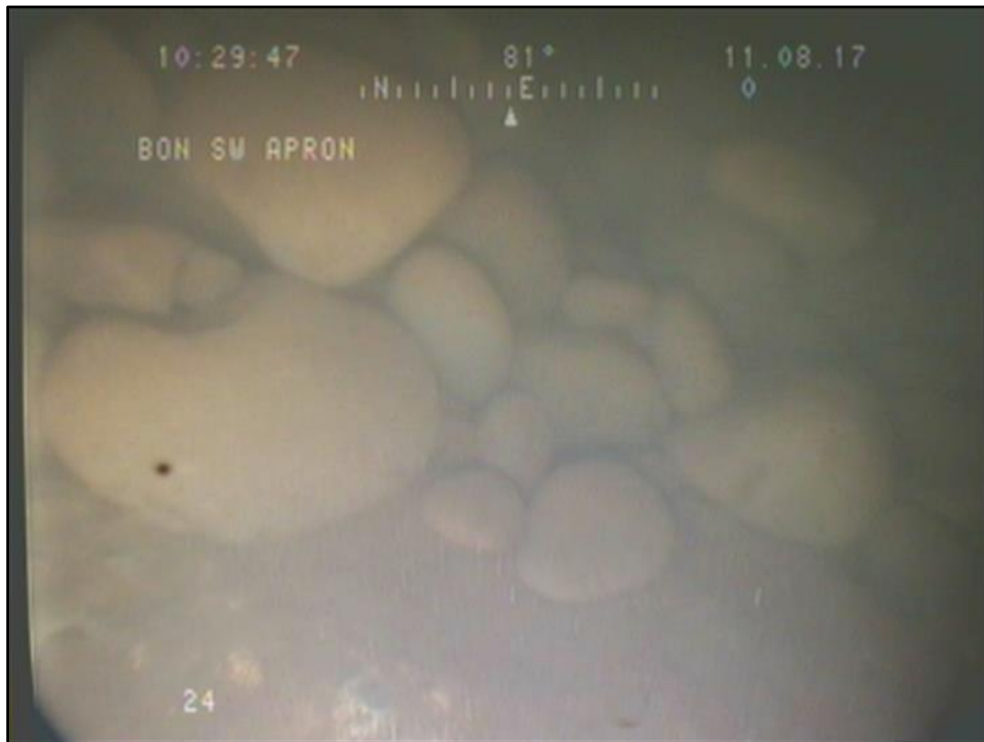
Figure 3 Rock found in SB 17 on the downstream side of the pile.

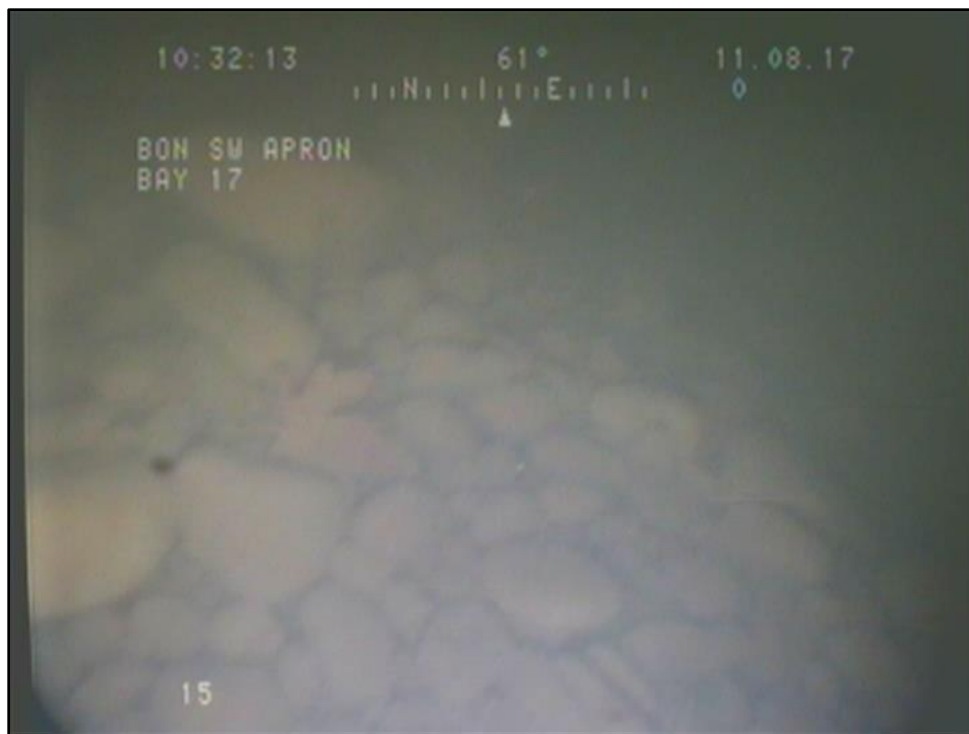
Figure 4 Rock pile in SB 17 on the shallower upstream edge.

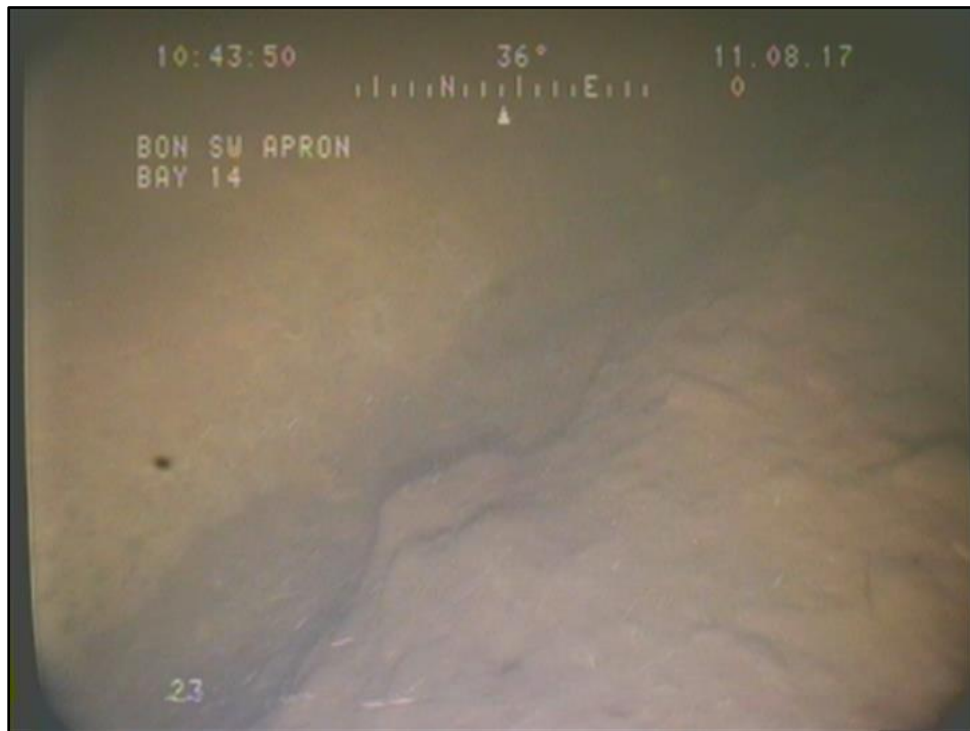
Figure 7 Erosion found in SB 14 between the 2012 concrete repair and the 13/14 dividing pier.

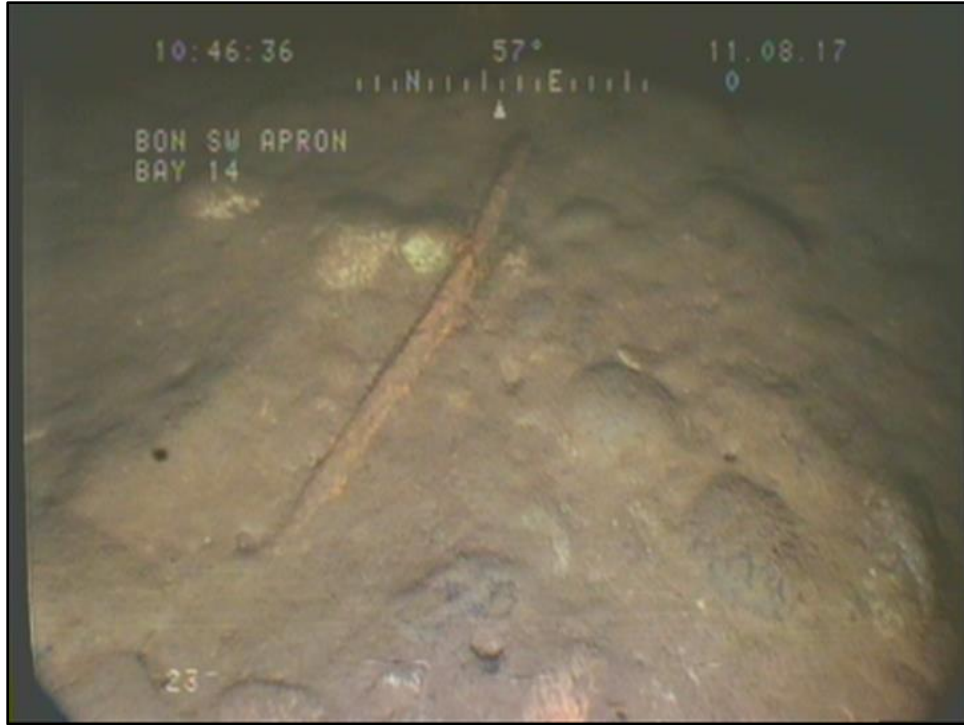
Figure 8 Exposed rebar in SB 14.

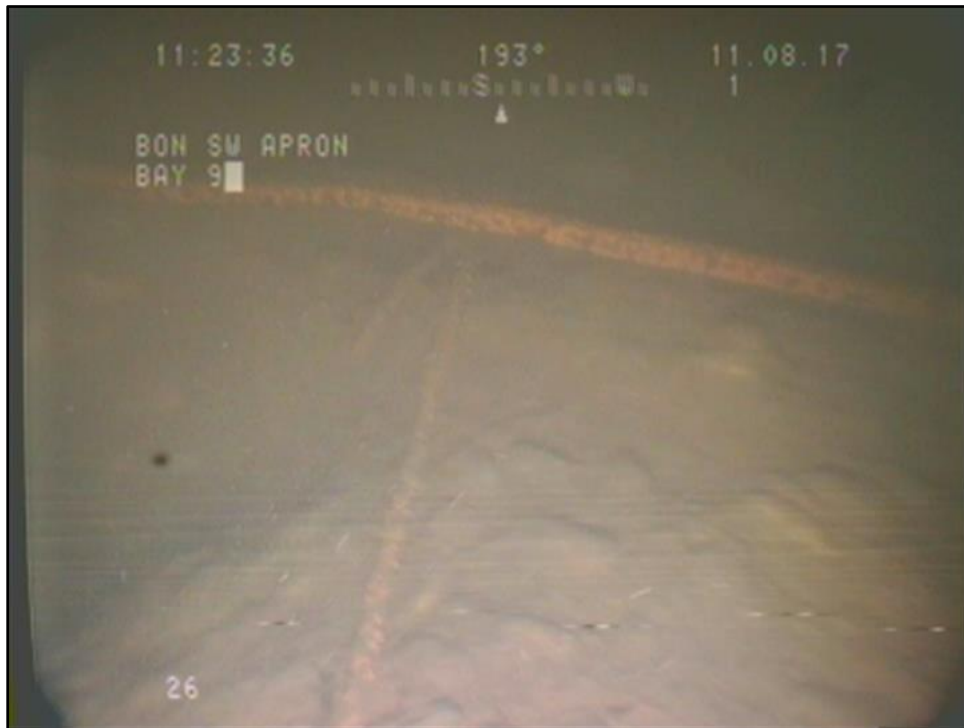
Figure 9 Significant erosion found between baffle rows at SB 9.

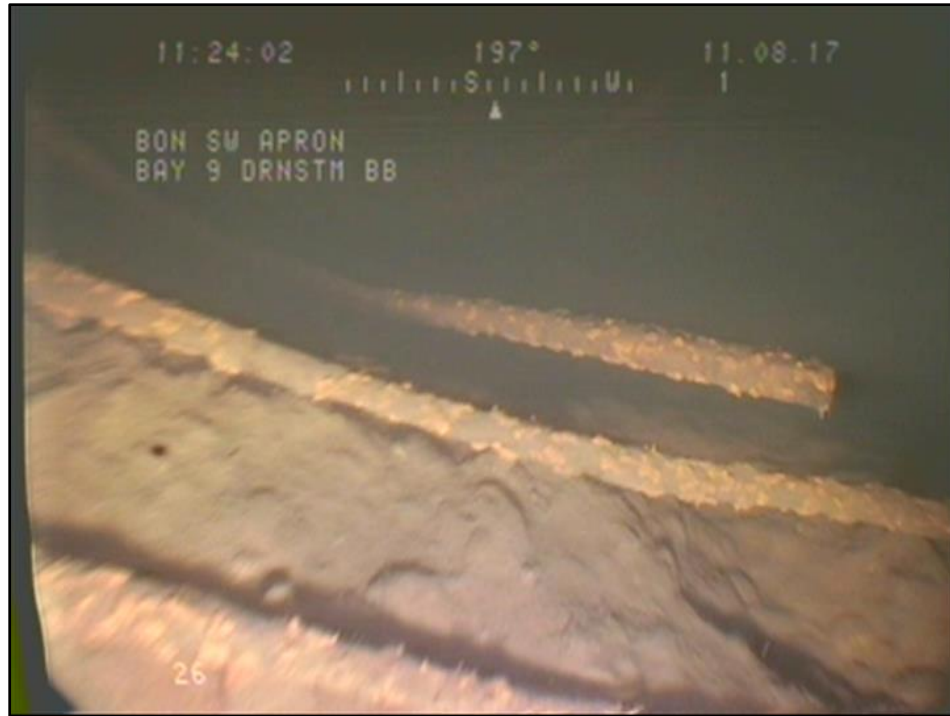
Figure 10 Additional imagery of erosion on downstream side of baffle blocks at SB 9.

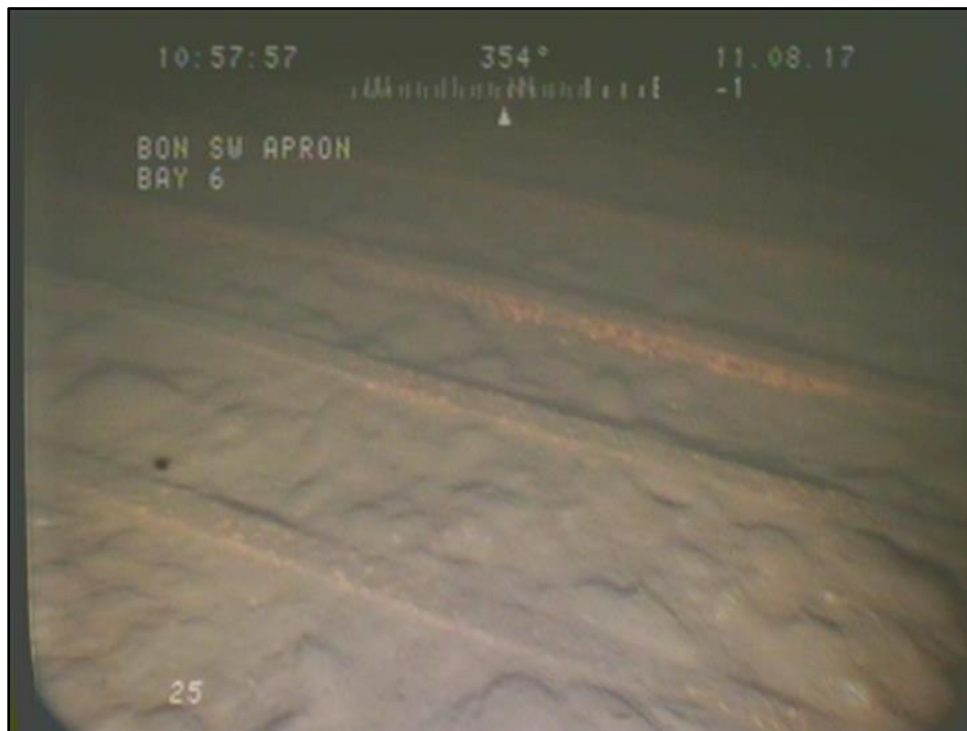
Figure 11 Erosion and rebar found upstream of baffles at SB 6.

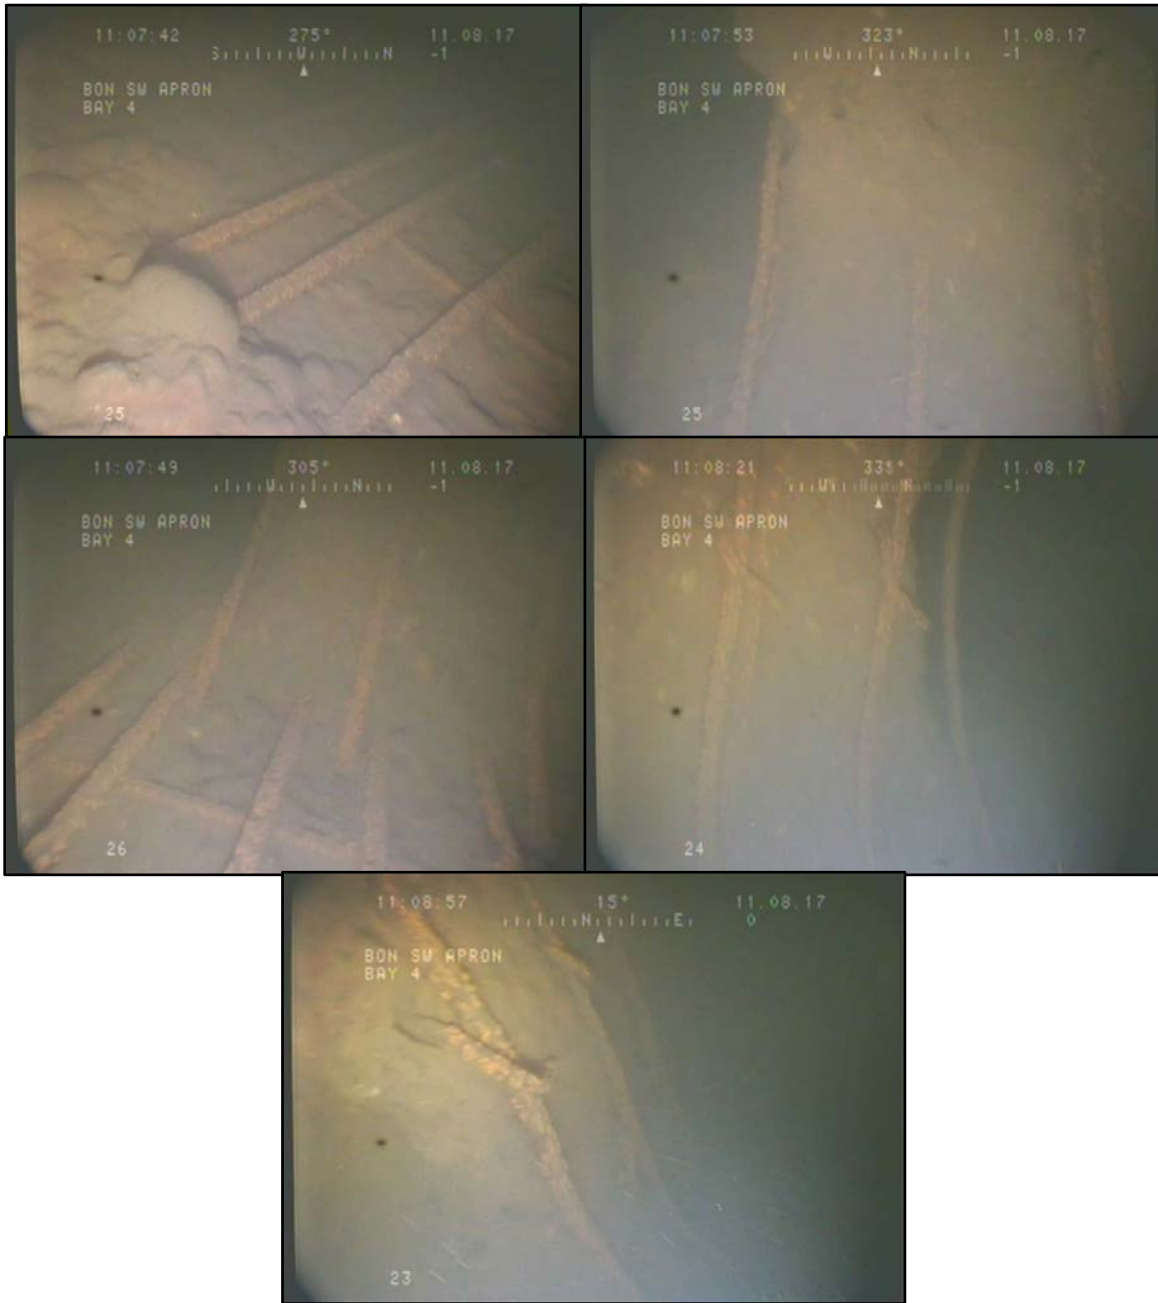
Figure 12 Images of erosion and exposed rebar of apron and baffles just downstream of SB 4.

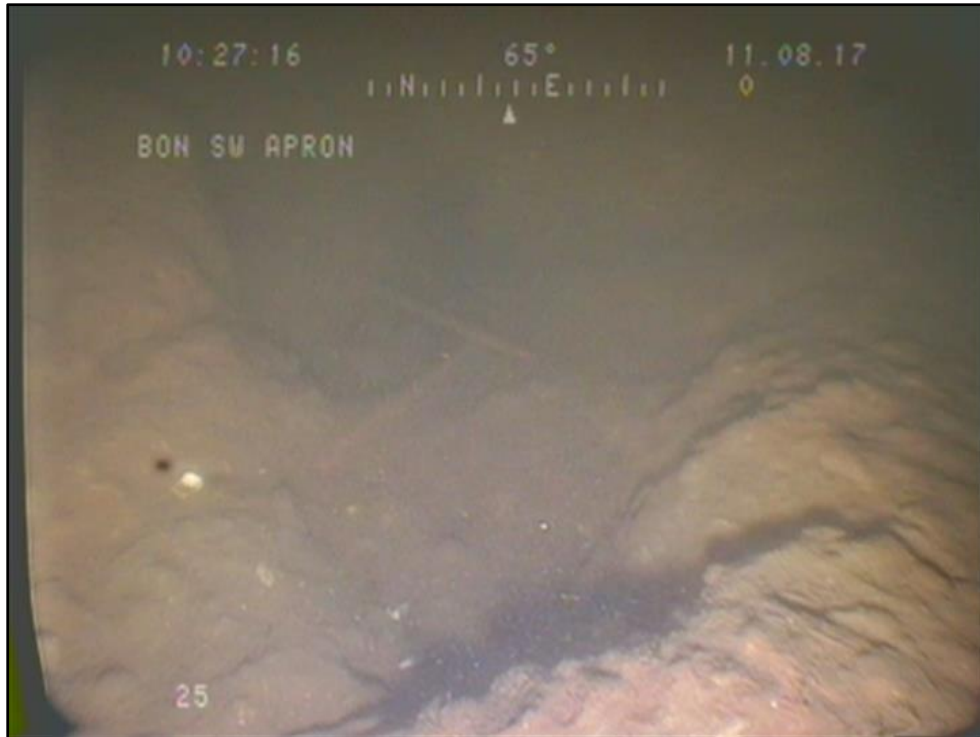
Figure 13 Typical erosion and exposed rebar found at the downstream corners of all baffles in the first row.

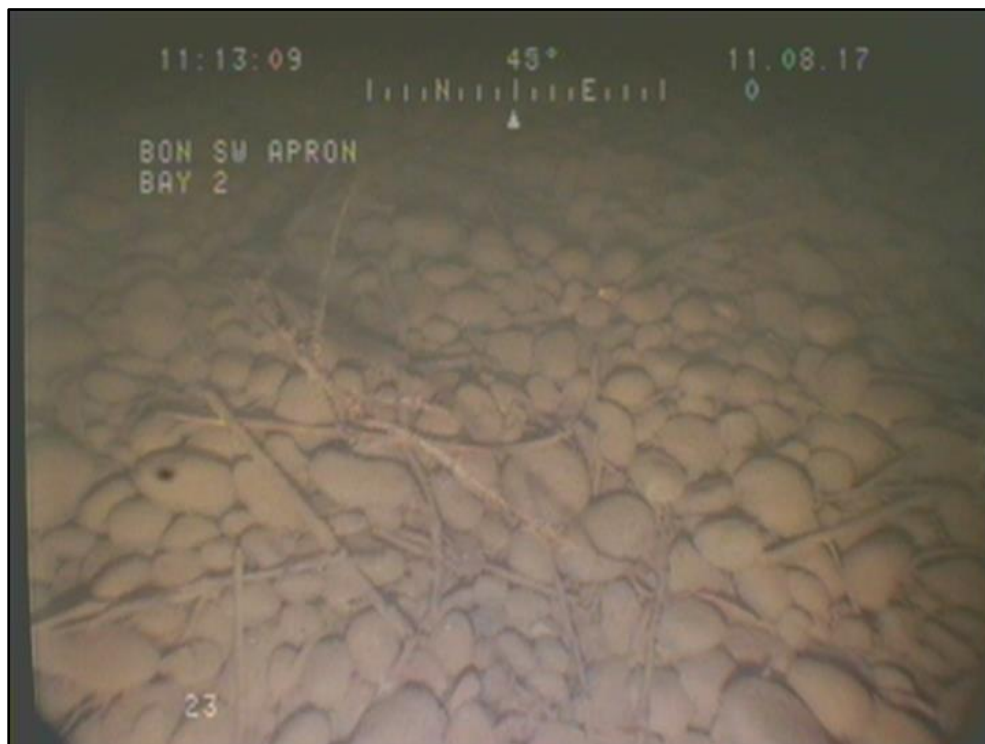
Figure 14 Rock debris and pieces of rebar found in SB 2.

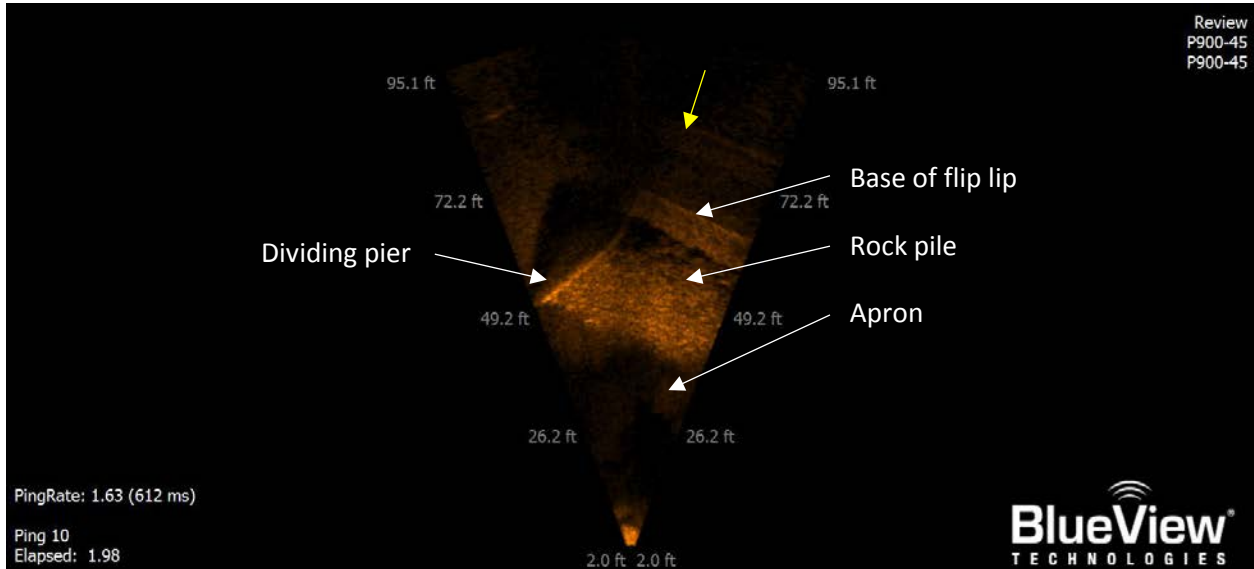
Figure 15 Sonar image of rock in SB 17.

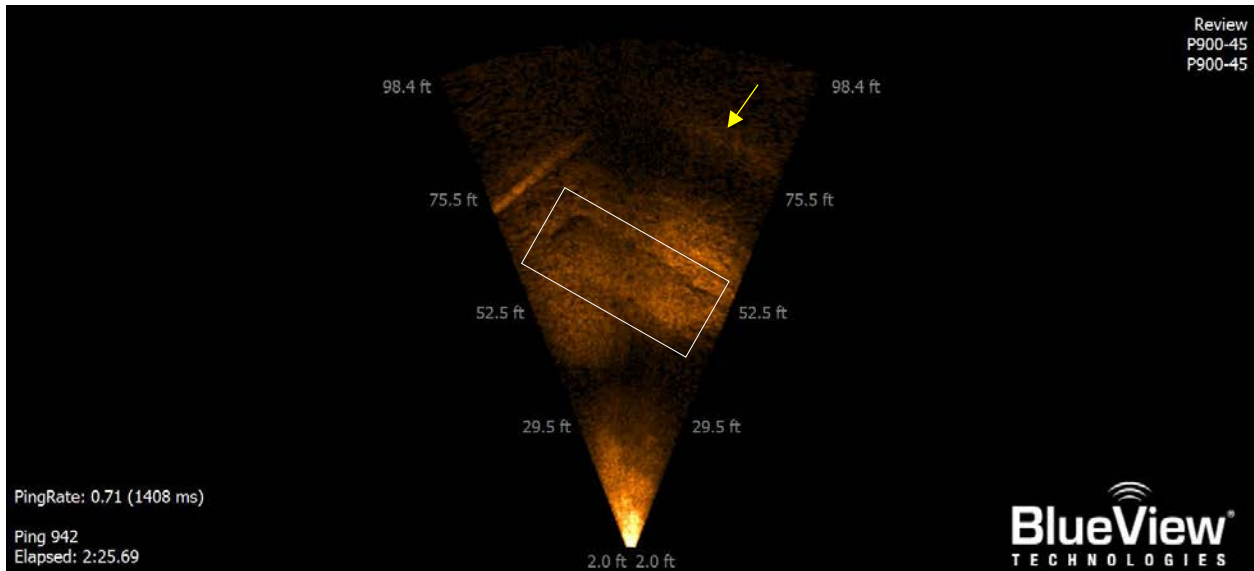
Figure 20 Imagery of SB 12 concrete repair from 2012.

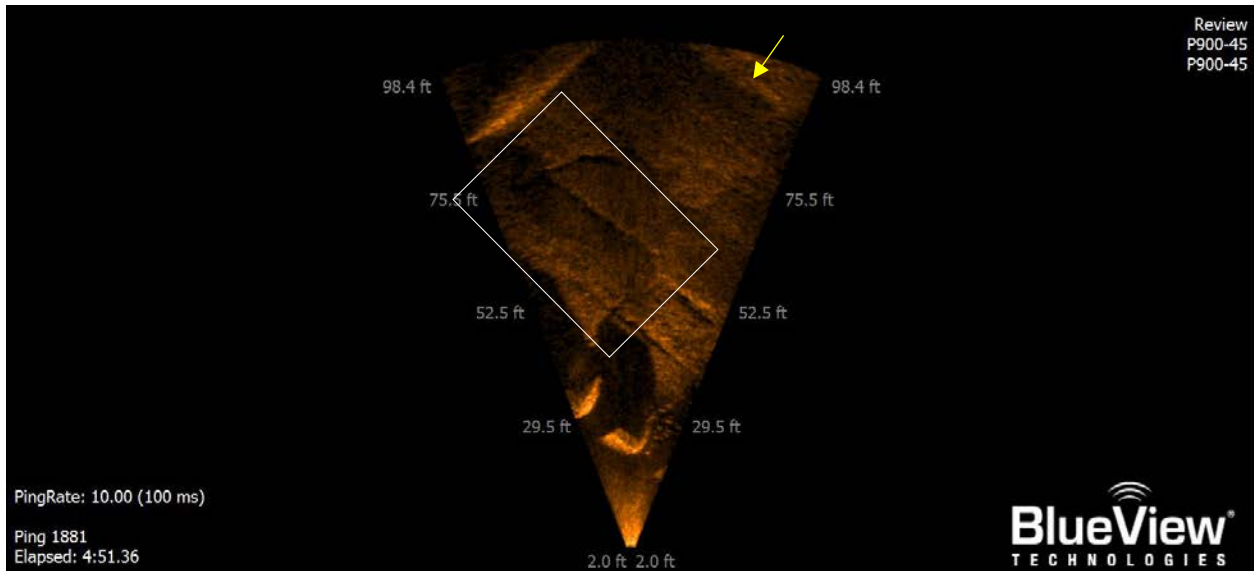
Figure 21 Imagery of SB 9 concrete repair.

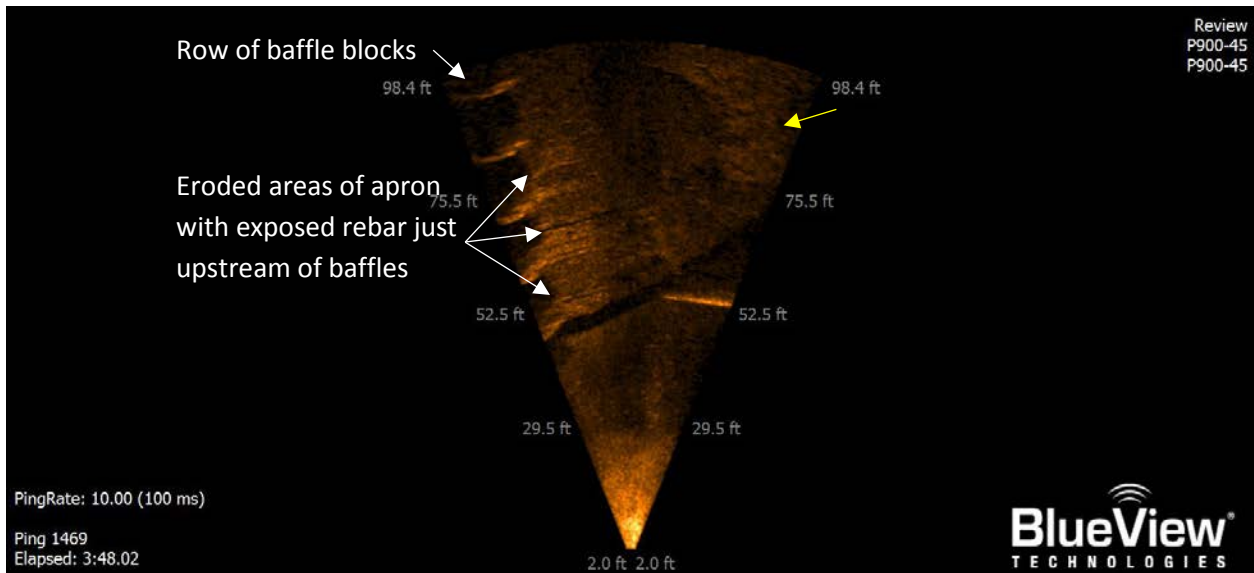
Figure 22 Imagery of apron, baffle block erosion & exposed rebar at SB 9.
