2018 BON Spillway Apron ROV Inspection Report

Inspection date: 12/13/2018;

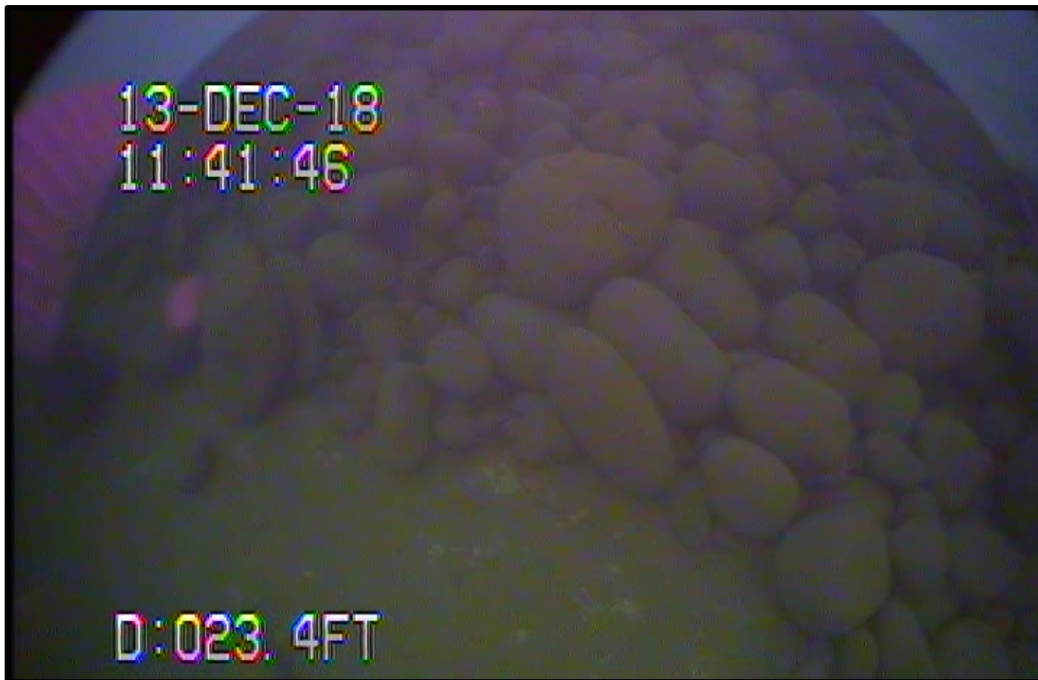
Figure 3 Rock found in SB 17 on the downstream side of the pile.

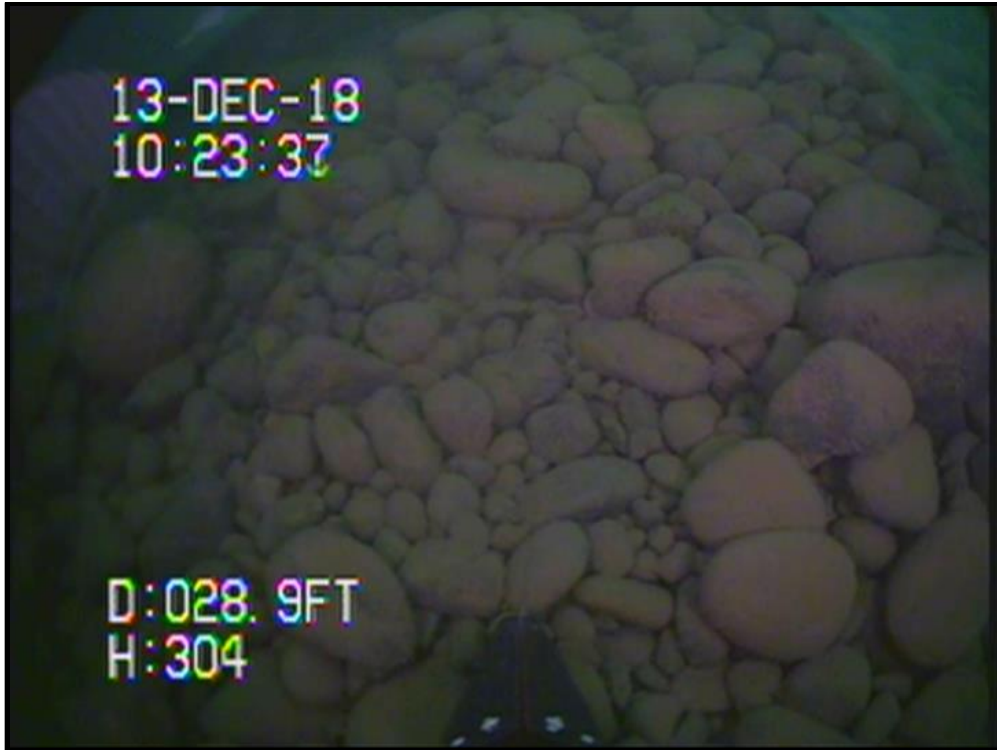
Figure 8 Rock found at SB 2.

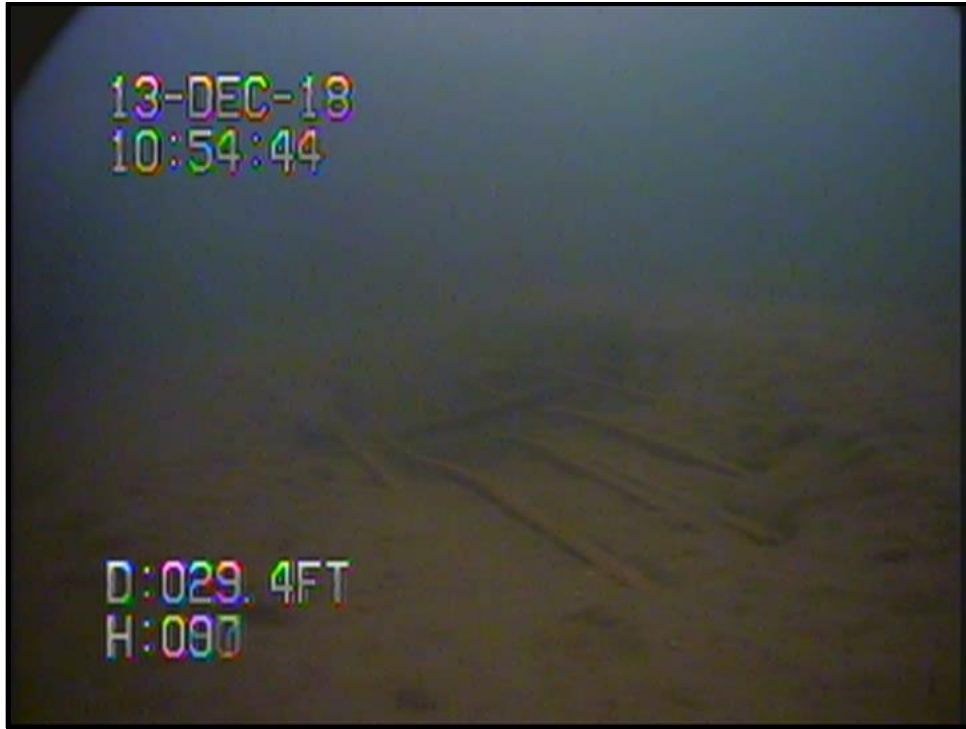
Figure 10 Typical apron erosion damage found downstream and between baffle block rows.

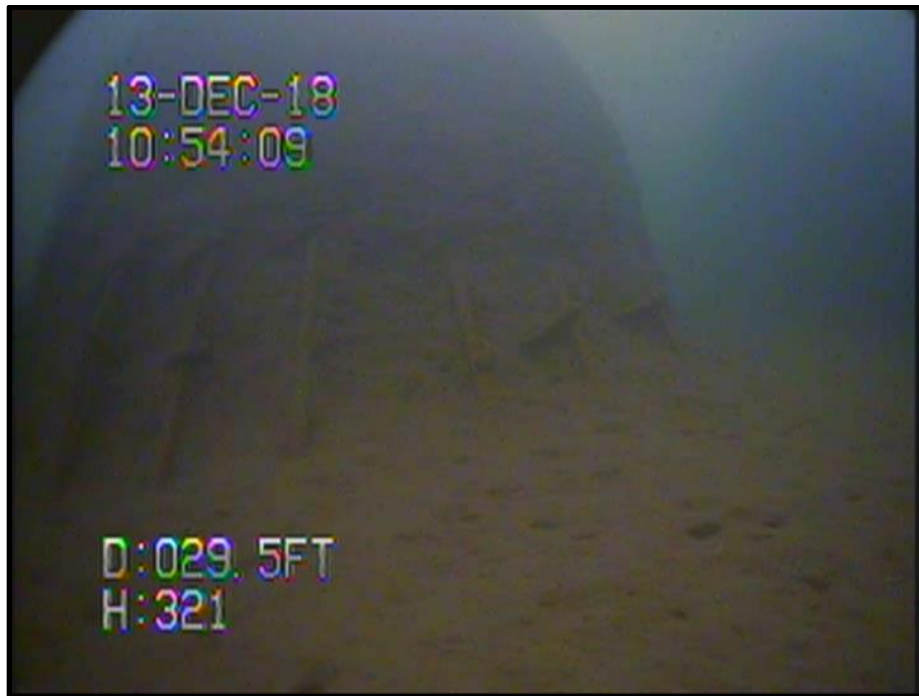
Figure 11 Erosion and rebar found on the downstream side of baffle blocks.

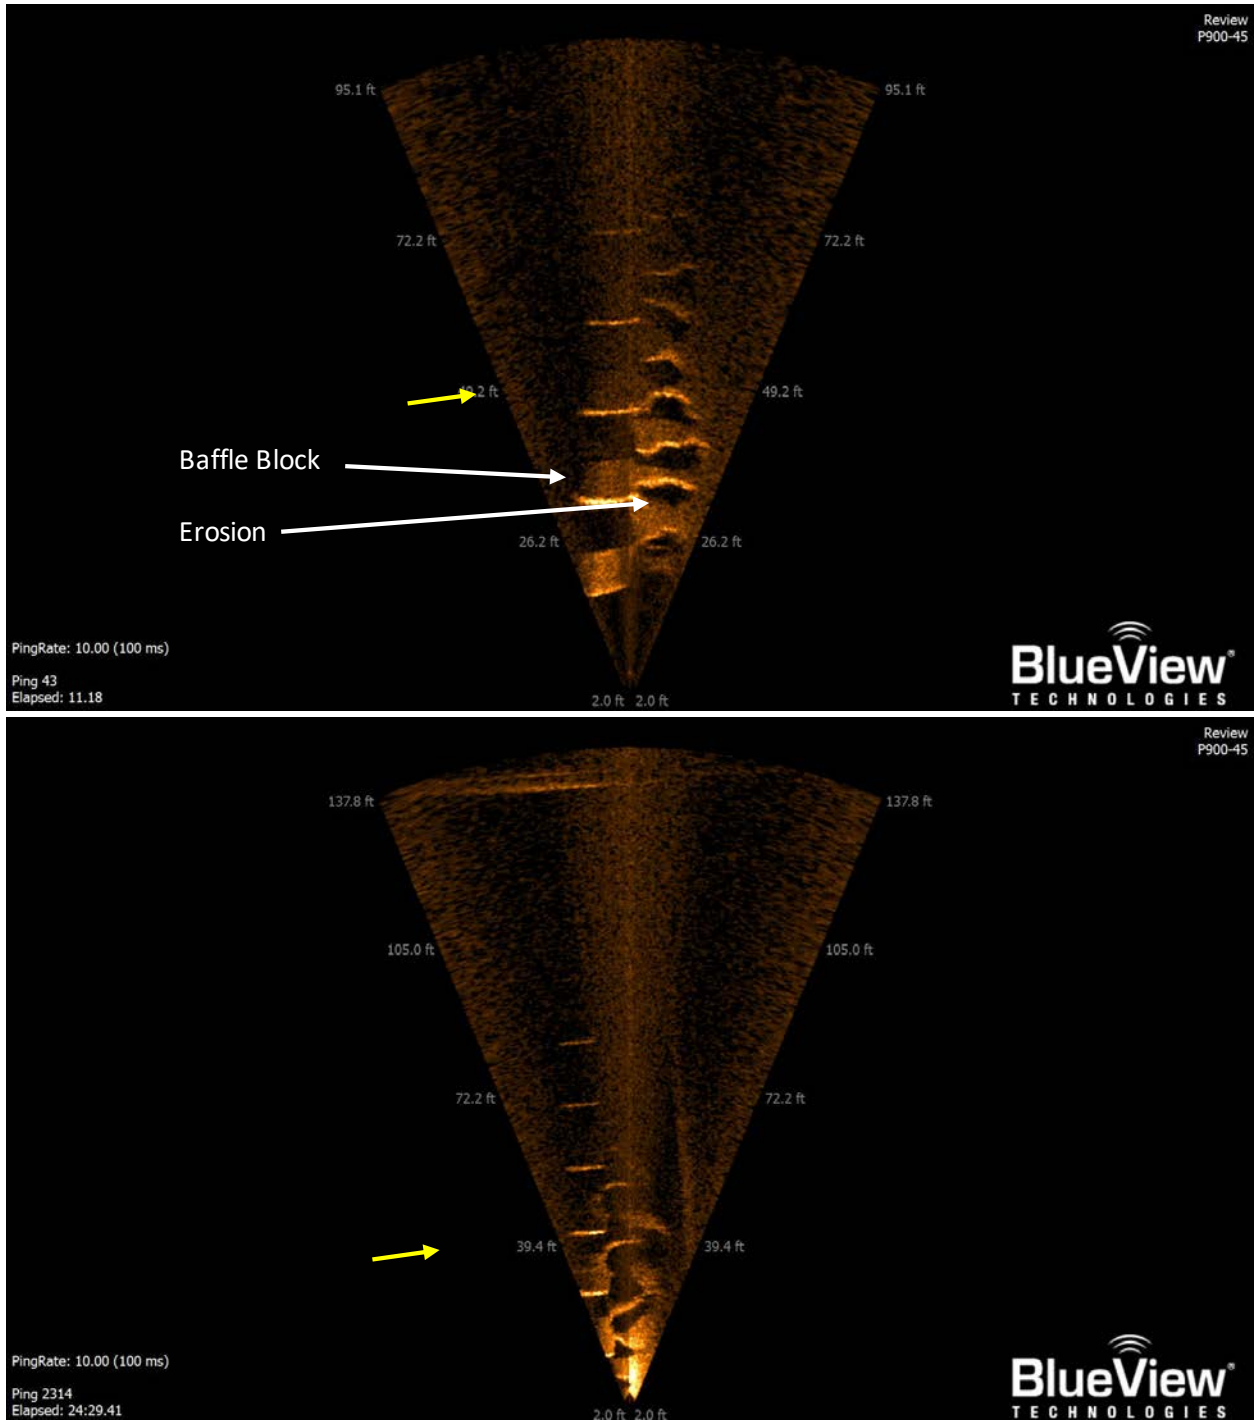
Figure 13 Sonar images showing erosion found at the downstream corners of all baffles in the first row.

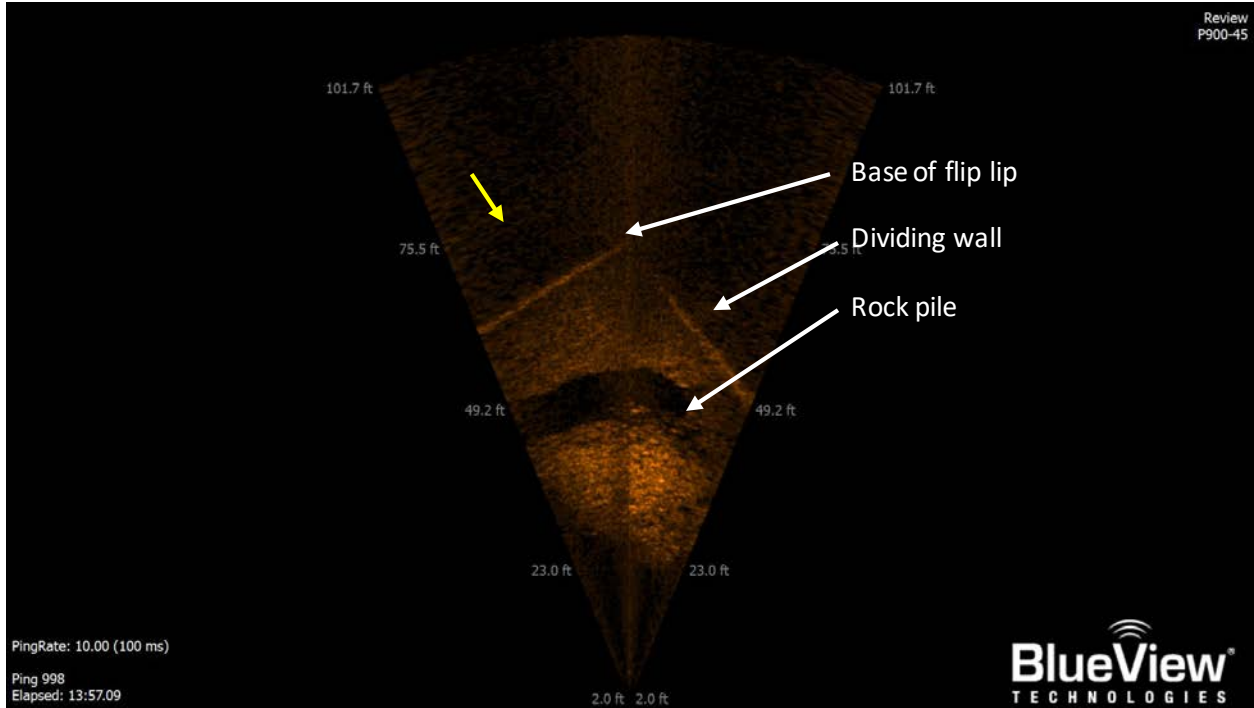
Figure 14 Sonar image of rock in SB 17.
